## DEBRIS AND UTILITY IDENTIFICATION AND SURVEY REPORT REVISION 1

## **REMEDIAL DESIGN SERVICES SWAN ISLAND BASIN PROJECT AREA CERCLA DOCKET NO. 10-2021-001**

# PORTLAND HARBOR SUPERFUND SITE PORTLAND, MULTNOMAH COUNTY, OREGON

April 2024

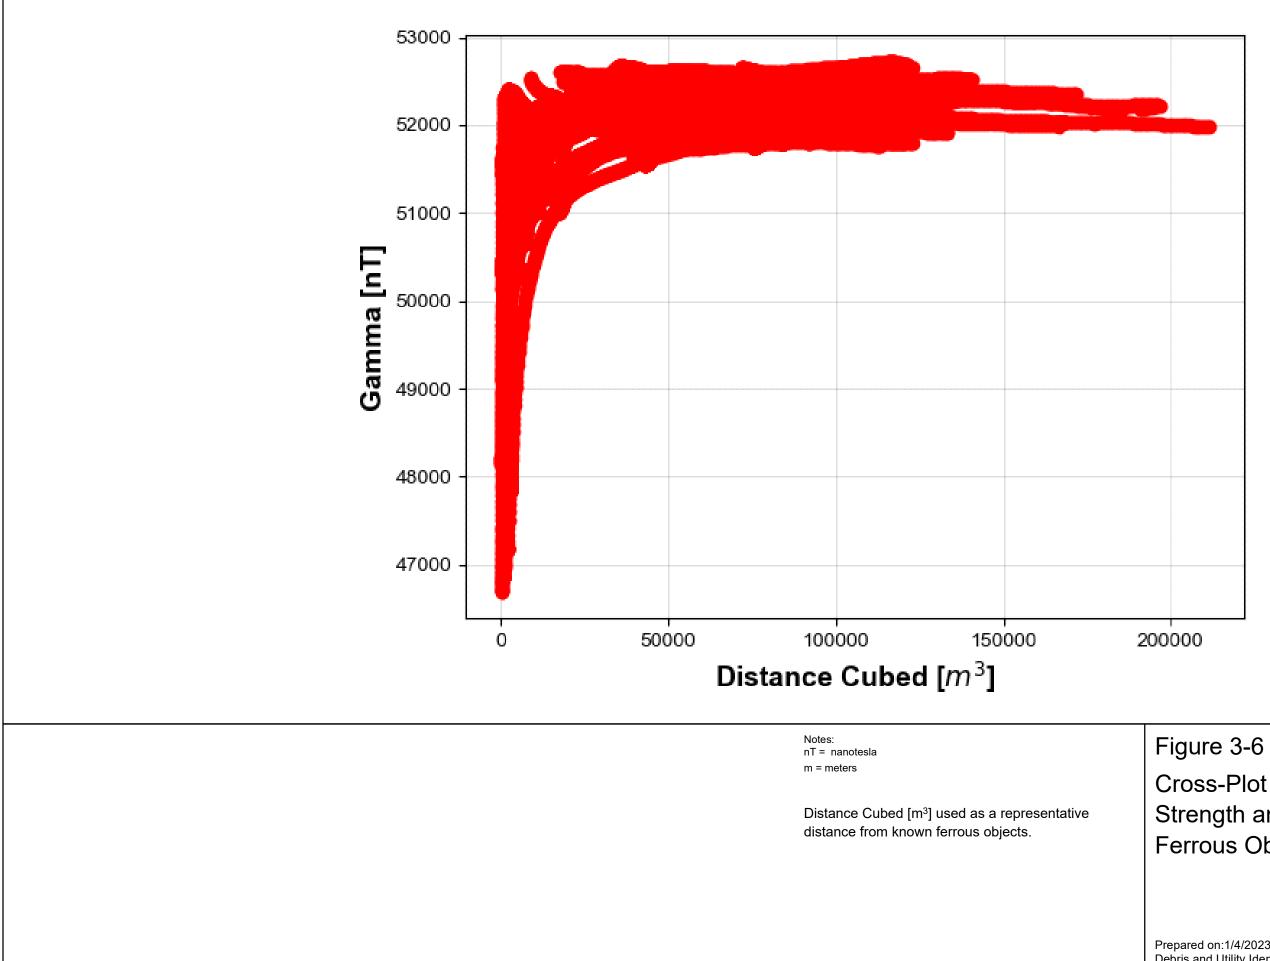
# **Cross-Plot of Magnetic Field** Strength and Proximity to Known Ferrous Objects

Figure 3-6 shows a cross-plot of the relationship between recorded gamma values and proximities to the closest known ferrous object. The data indicate a logical relationship, with lower values (anomalies) found near known ferrous objects. Low gamma values at relatively large distances from known ferrous objects would suggest the presence of unknown ferrous objects. However, gamma values indicative of large unknown ferrous objects were not observed in the survey data. The significant number and size of large ferrous objects (e.g., ships) in SIB limits the capability of the magnetometer technology to identify small adjacent ferrous objects. The challenges of remote detection of small ferrous objects were anticipated and represent an uncertainty that will be addressed during RD. There are no known magnetometer technologies that could be used to better identify small ferrous objects. Therefore, the uncertainty associated with small ferrous objects will be addressed by planning for potential additional debris removal and disposal during construction, similar to other buried debris.

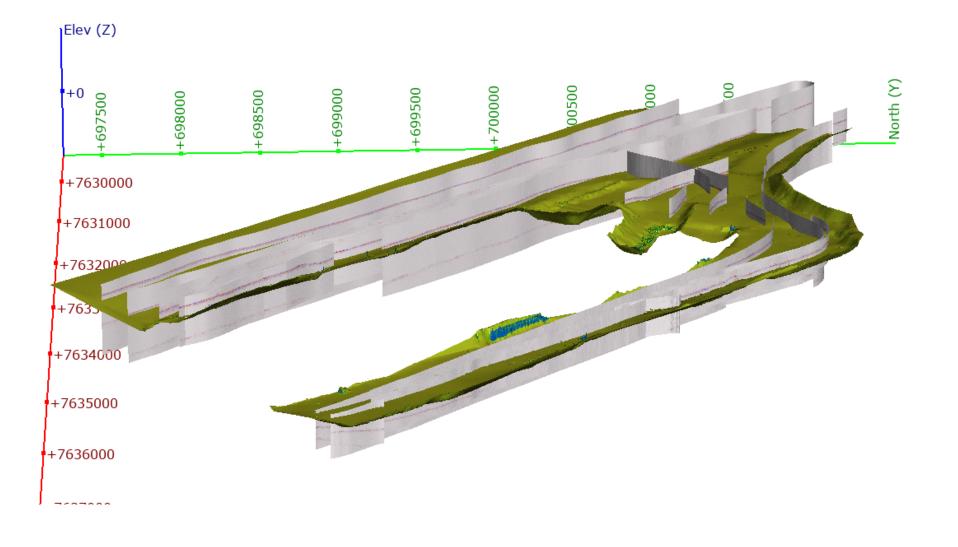
Figure 3-7 3D View Prepared on:1/4/2023 Debris and Utility Identification and Survey Report Swan Island Basin

Anomalies were identified near the Dry Dock Basin that correspond to surface "drag marks" observed in the MBES survey, but these anomalies were not interpreted to be buried cables. Transect A-A', running down the centerline of the SIB interior, shows typical conditions of soft sediment over a denser return and a lack of apparent buried debris (Figure 3-8). Transect B-B', in the main channel of the Willamette River near Berth 312, shows typical uniform returns, with less apparent stratigraphy, and a lack of apparent buried debris (Figure 3-9). No buried debris or utilities (or other objects) were identified in any of the sub-bottom profile transect data.

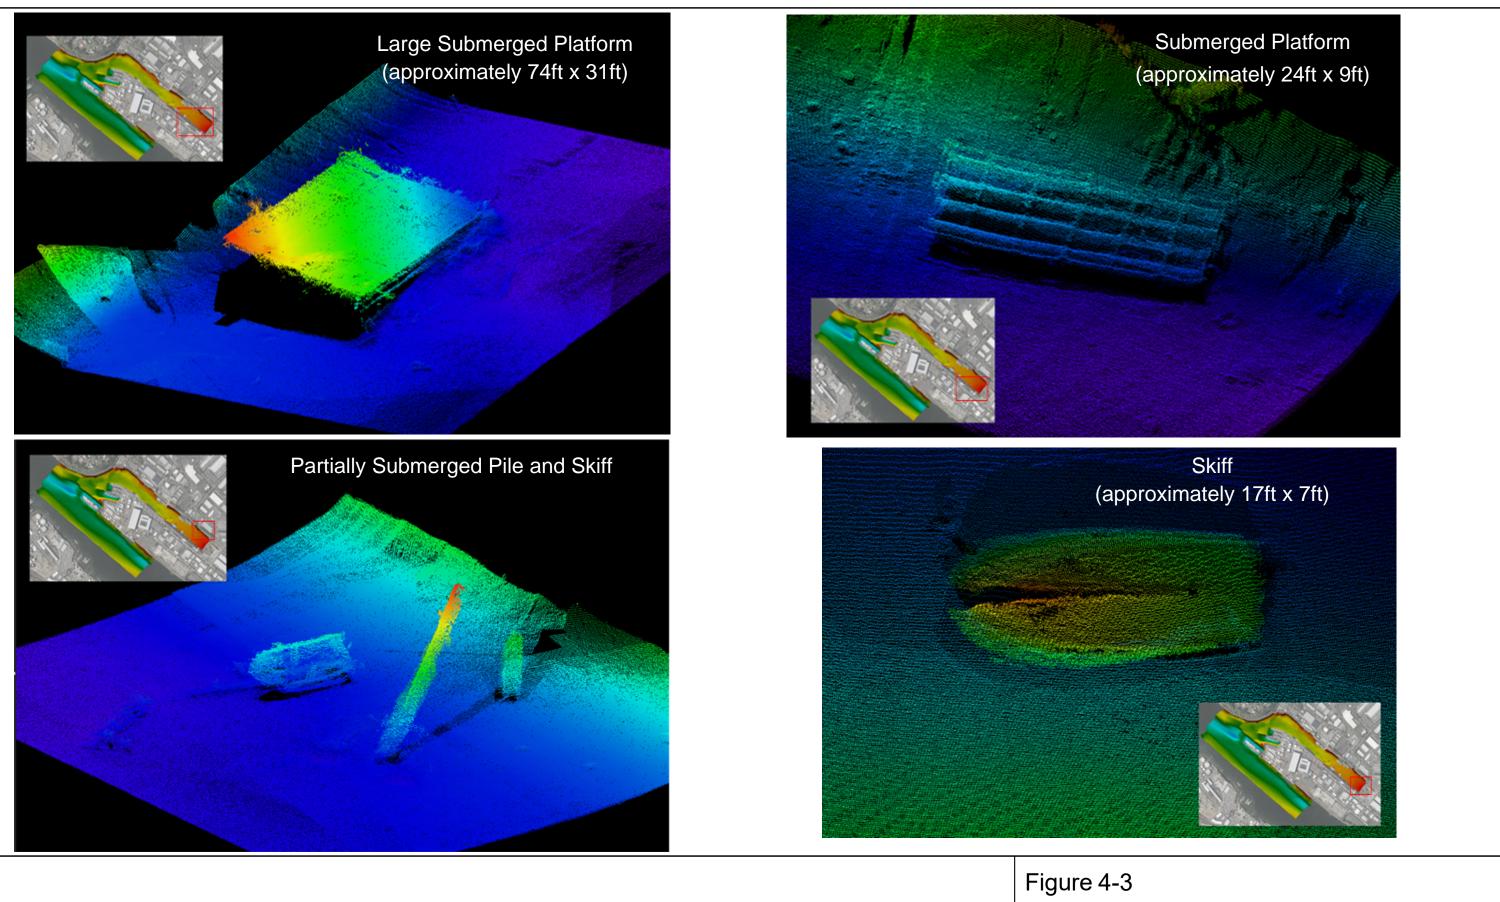
# Example Debris Identified in Multibeam EchoSounder (MBES) Data

Figure 4-3 shows example closeup 3D views of several objects identified in the SIB, including small skiffs and platforms.

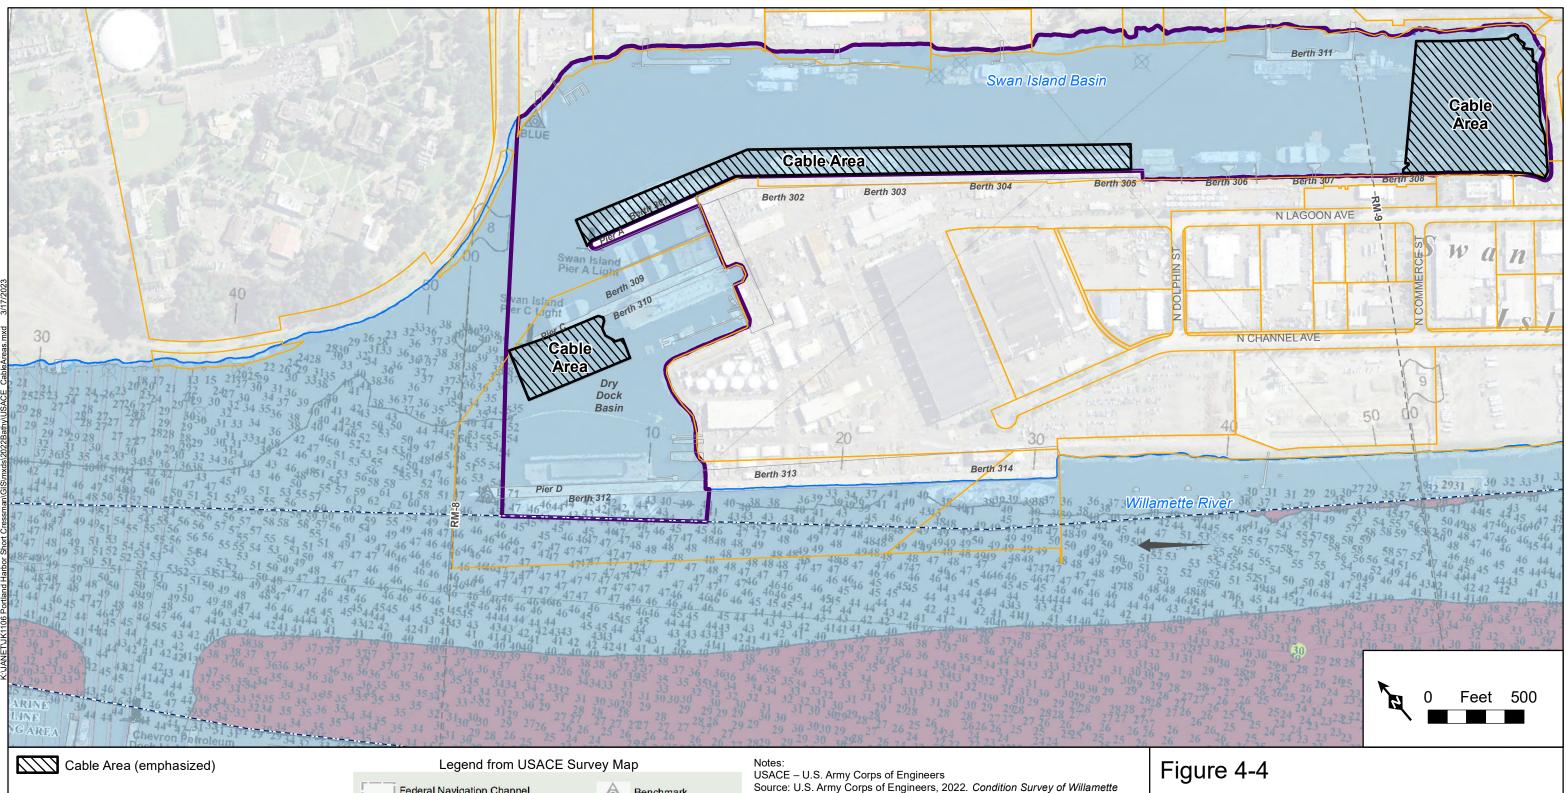
Excerpt from USACE Survey Map Showing "Cable Areas" (Not Identified During Survey)

U.S. Army Corps of Engineers (USACE) hydrographic survey charts and National Oceanic and Atmospheric Administration (NOAA) navigation charts describe three "cable areas" in the SIB Project Area. The 2022 USACE survey did not identify cables as the survey did not extend inside the SIB; the notation is carried over from historical charts that call out previously designated cable areas.

The USACE cable areas do not correspond to any known submarine cable or potential objects identified from sub-bottom profiles or magnetometer transects at the head of SIB, or from a sub-bottom profile near Pier C. This information is included here out of an abundance of caution; there is no evidence from surveys (i.e., sub-bottom profiler and magnetometer) or utility locate responses that buried cables exist in the areas shown on USACE charts.
