**STRUCTURE CONDITION ASSESSMENT REPORT
REVISION 0**

**REMEDIAL DESIGN SERVICES
SWAN ISLAND BASIN PROJECT AREA
CERCLA Docket No. 10-2021-001**

**PORTLAND HARBOR SUPERFUND SITE
PORTLAND, MULTNOMAH COUNTY, OREGON**

November 2023

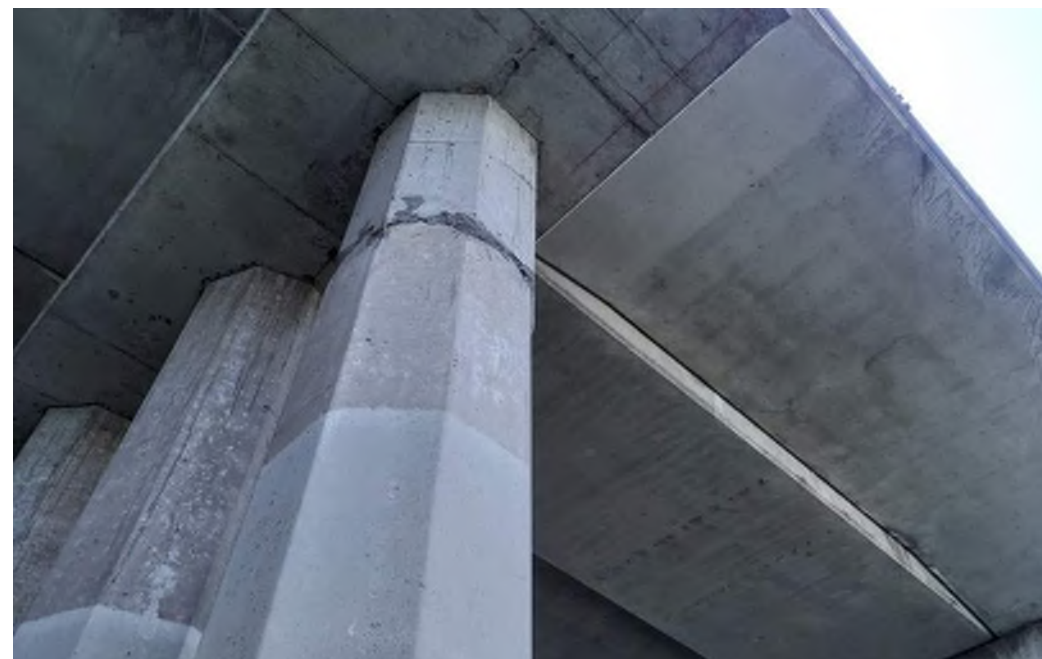
Photo 05: Pier D Substructure
Pile K at Bent 43
Concrete spall around full diameter of the pile
Moata ID: 74344

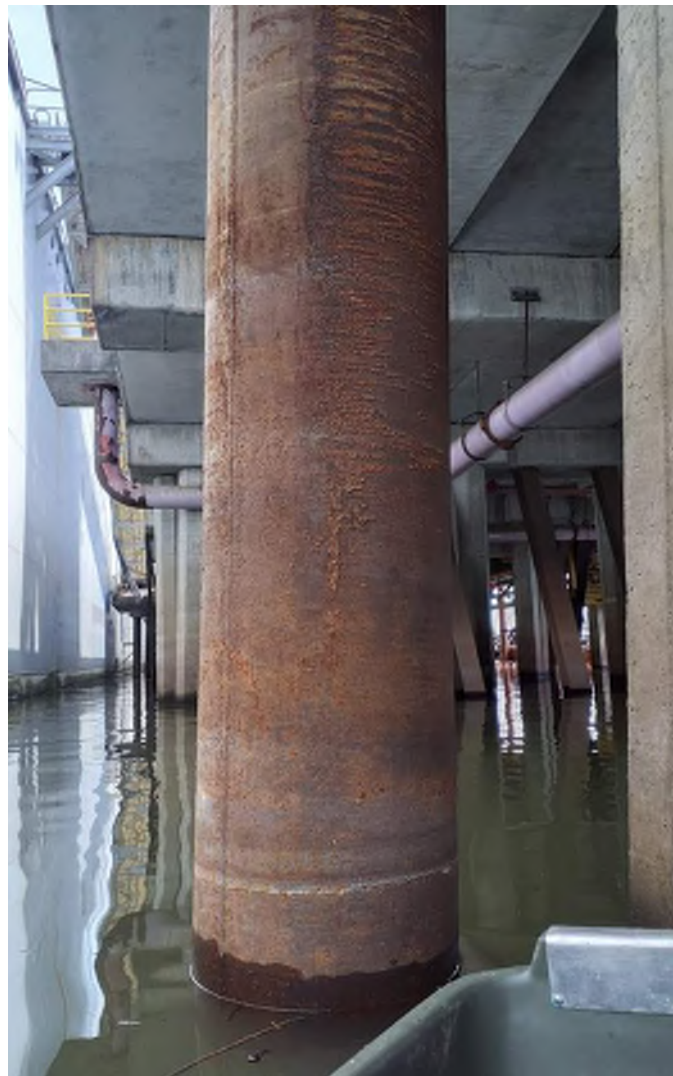
Photo 06: Pier D Substructure
Pile K at Bent 21
Typical condition of steel piles above water
Moata ID: 74360

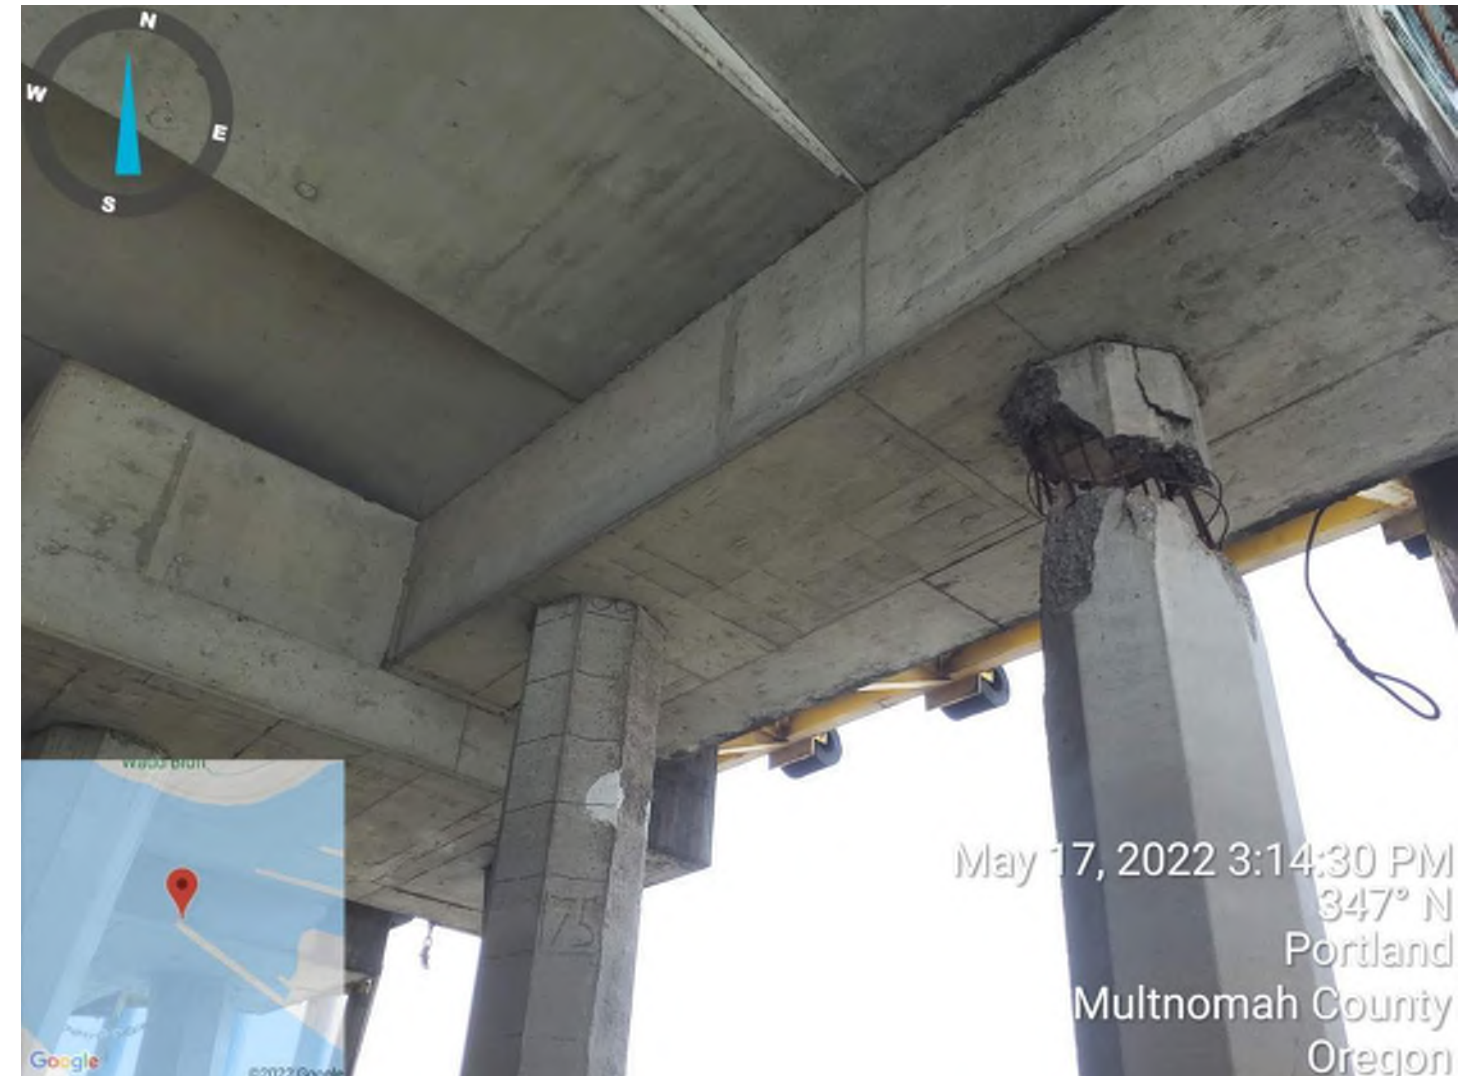
Photo 07: Pier D Substructure
Pile K at Bent 1
Complete breakage at the top of Pile K
Moata ID: Not Applicable

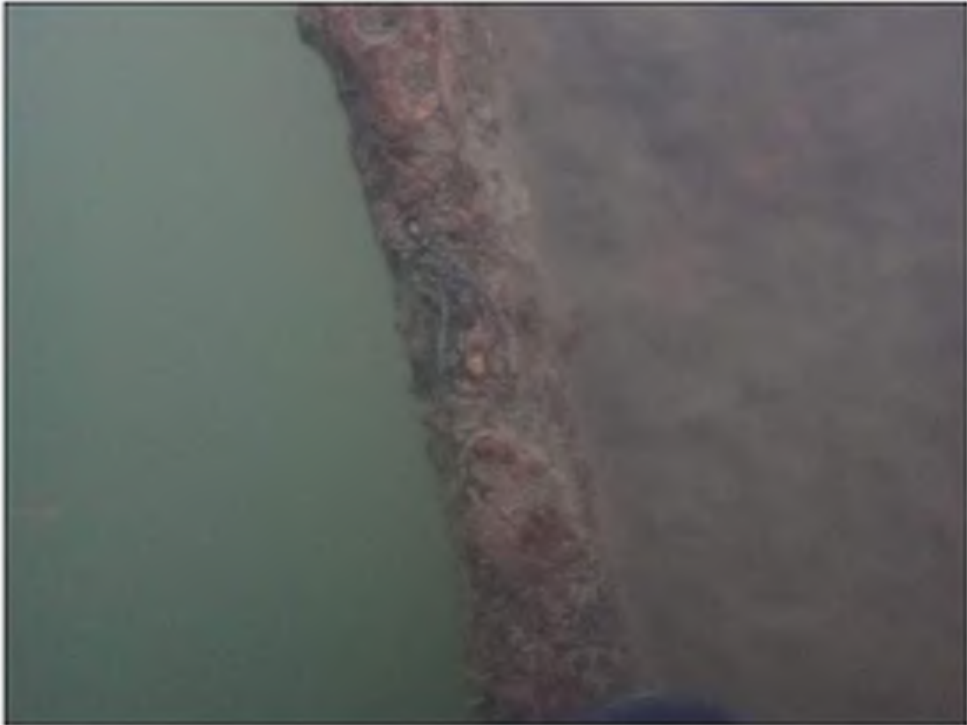
Photo 04: Pier D Substructure
Typical condition of steel batter piles flange below waterline

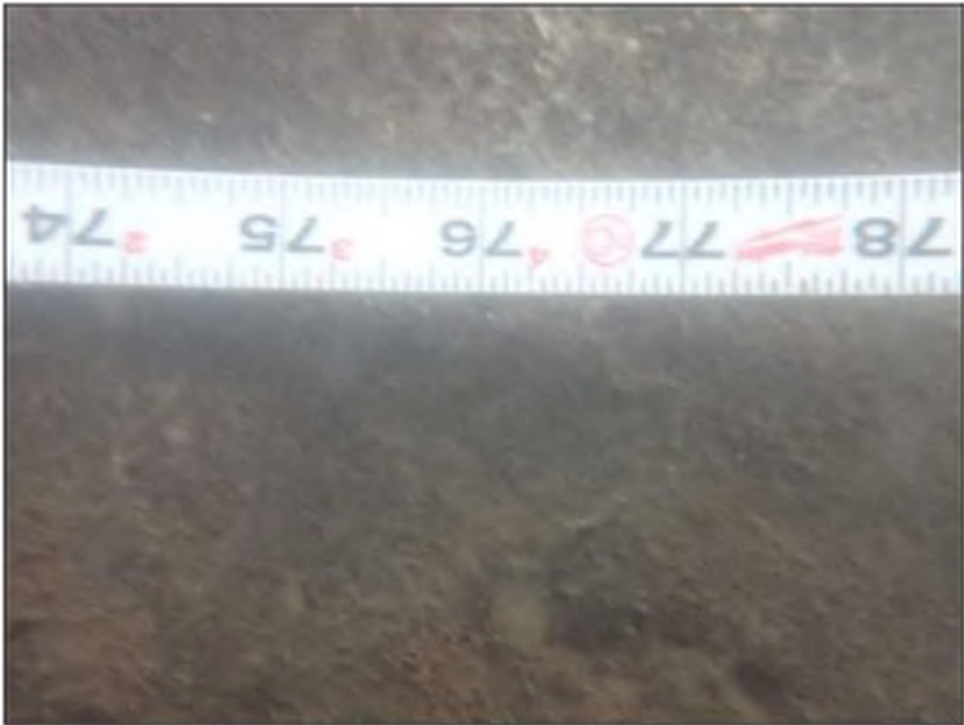
Photo 05: Pier D Substructure
Cleaned concrete piles at mid-depth

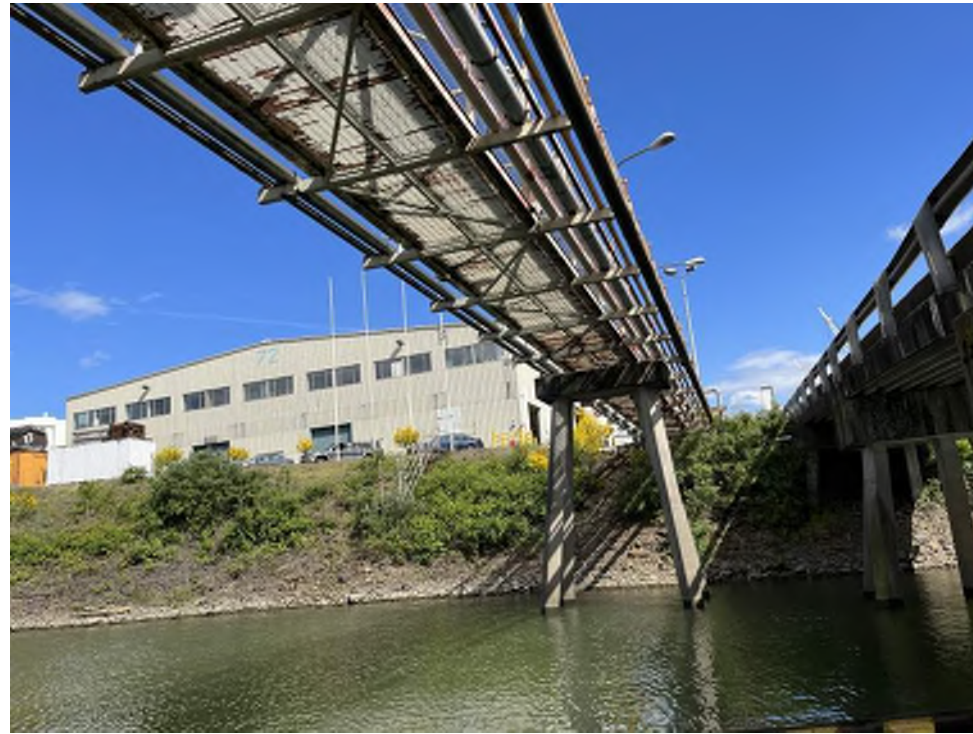
Photo 01: East Pier Substructure
Substructure between Bent 1 and Bent 2
Typical configuration of substructure
Moata ID: Not Applicable

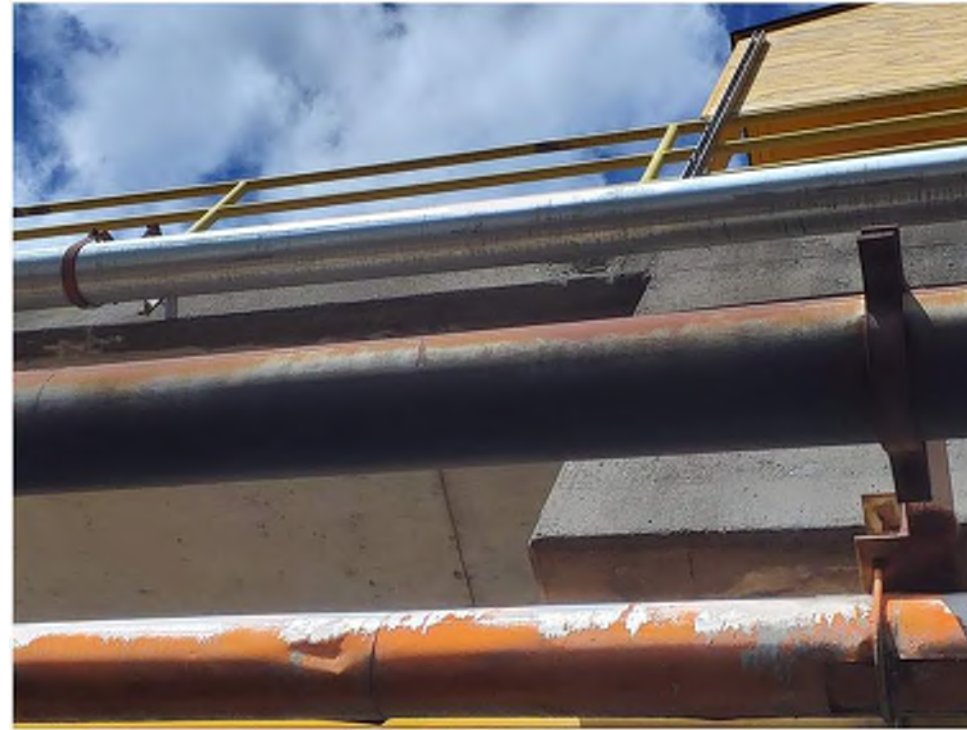
Photo 02: East Pier Superstructure
Deck between Bents 2 and 3
Concrete spall exposing reinforcement
Moata ID: 74981

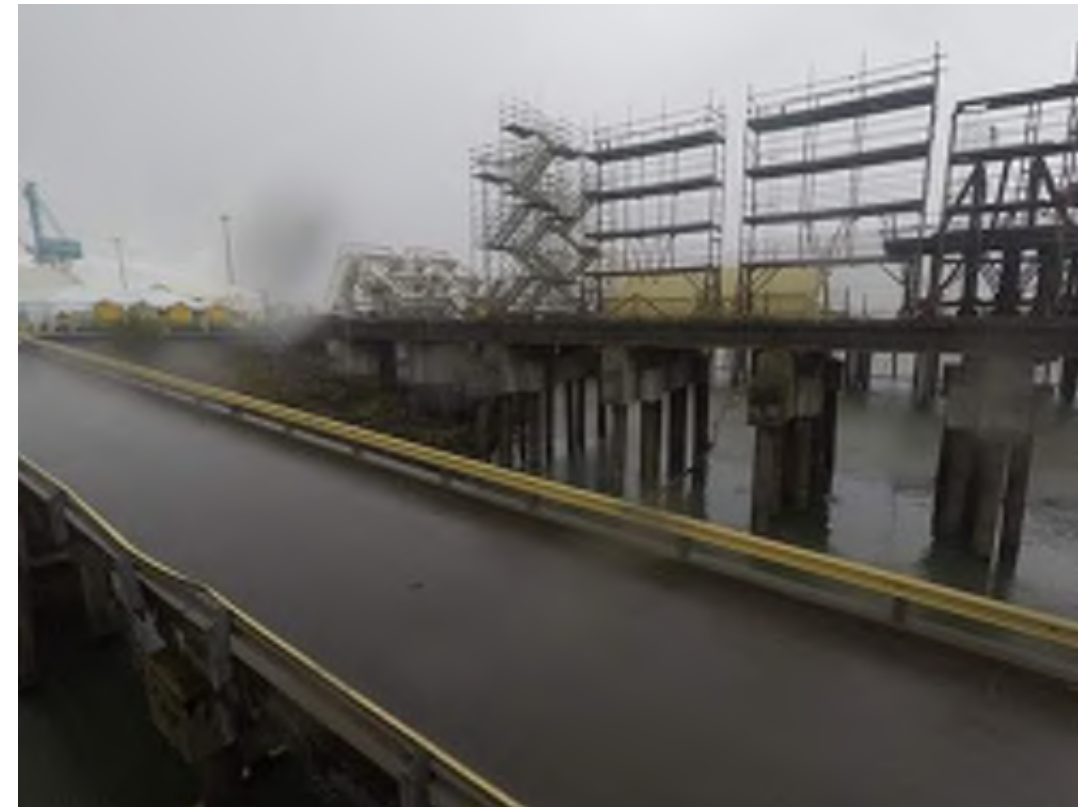
Photo 02: West Pier Superstructure
Overview of the Concrete Deck
Typical condition of the concrete deck
Moata ID: Not Applicable

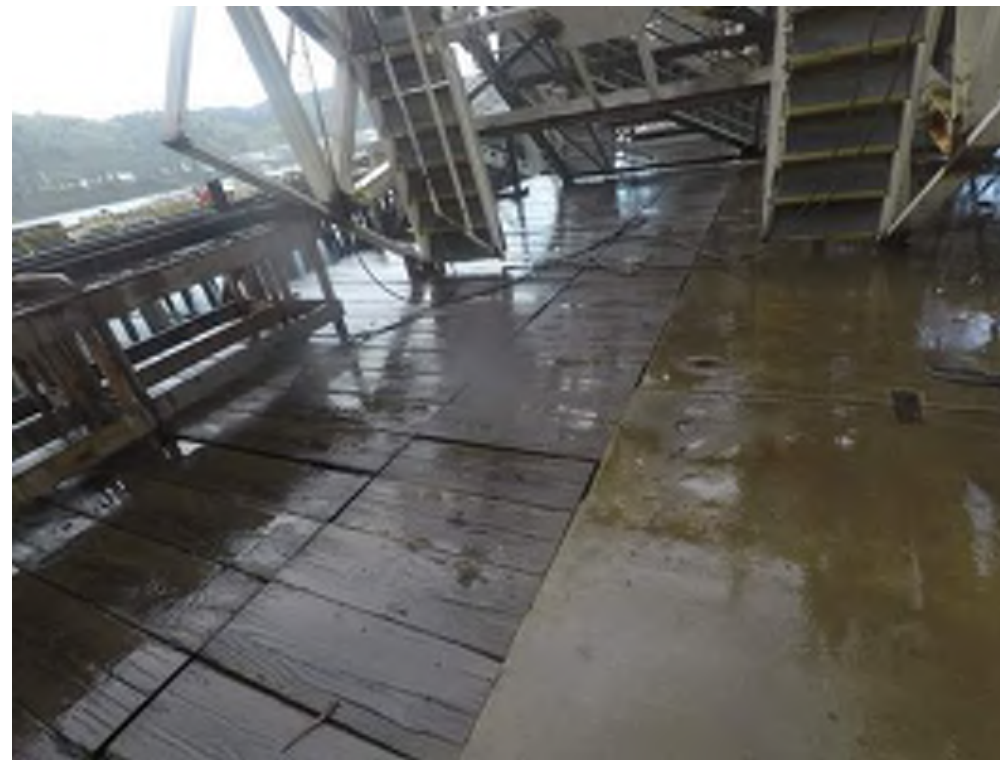
Photo 02: Demo Pier Superstructure
Timber Deck Between Bents 1 and 2
Typical condition of timber deck
Moata ID: Not Applicable

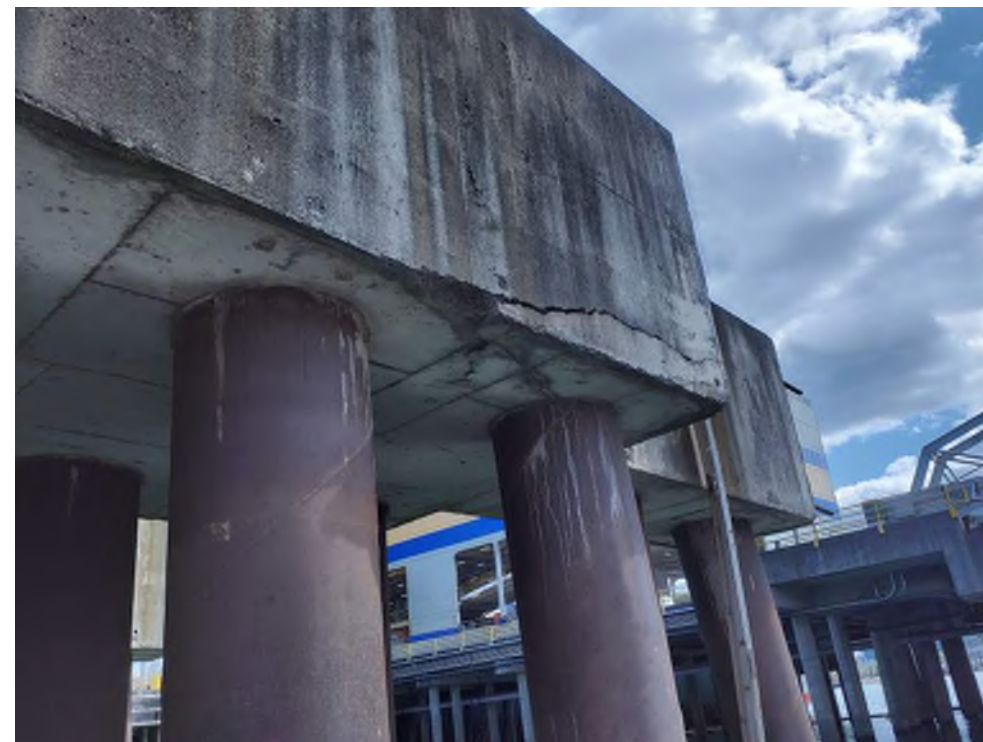
Photo 04: Demo Pier Substructure
Pile Cap at Bents 7 Pile C1
Closed spall at corner of the pile cap
Moata ID: 74979

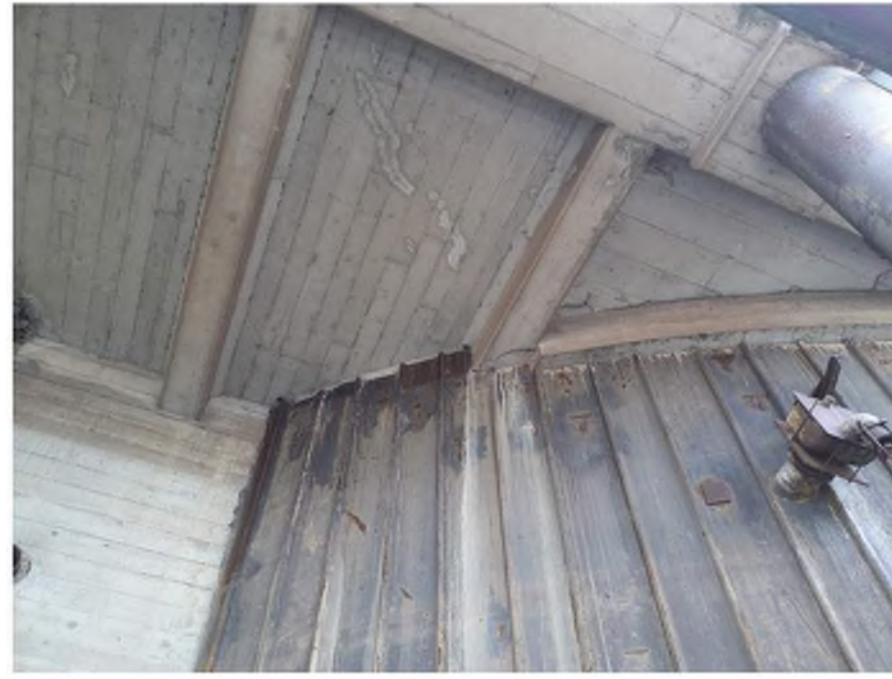
Photo 02: Quay Wall Substructure
Concrete Pile Cap between Sheet Piles F-F and E-E
Crack on the bottom of the concrete beam
Moata ID: 74941

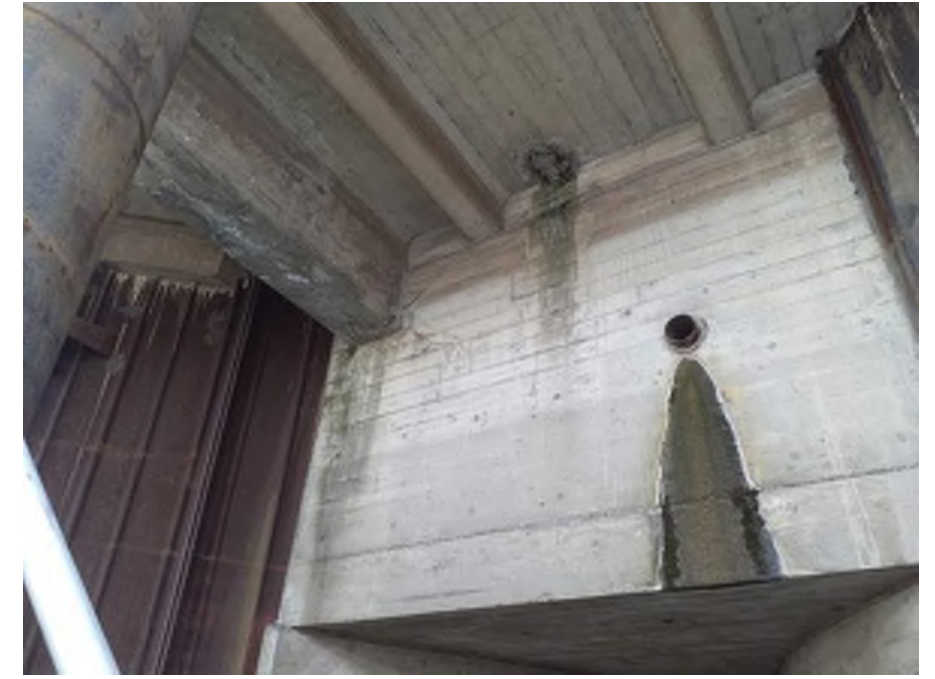
Photo 03: Quay Wall Substructure
Concrete Pile Cap between Sheet Piles F-F and E-E
Closed spall on the bottom of the concrete pile cap
Moata ID: 74941

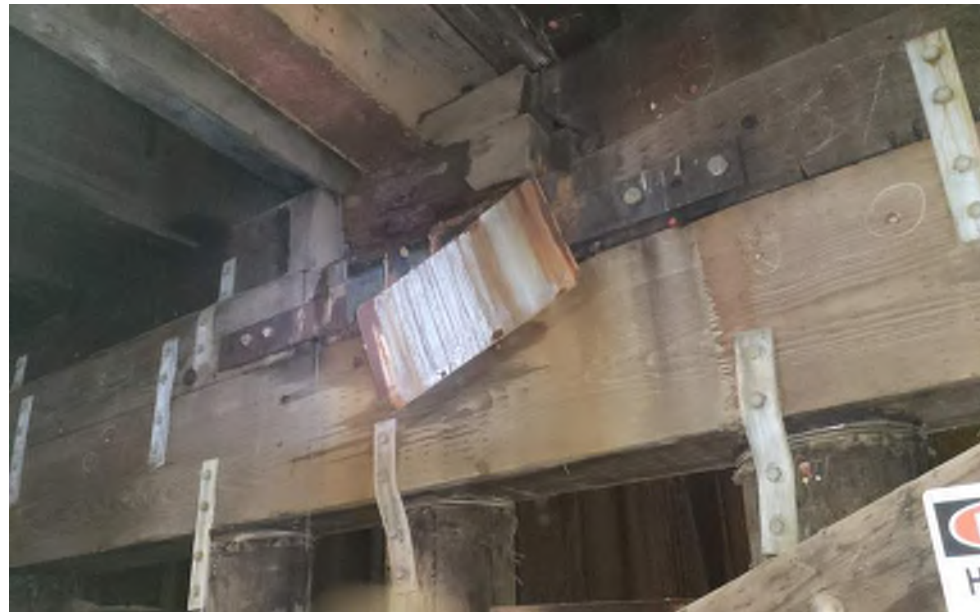
Photo 05: Lagoon Wharf Substructure
Adjacent to Bent 3
Bearing plate severely corroded
Moata ID: 73587

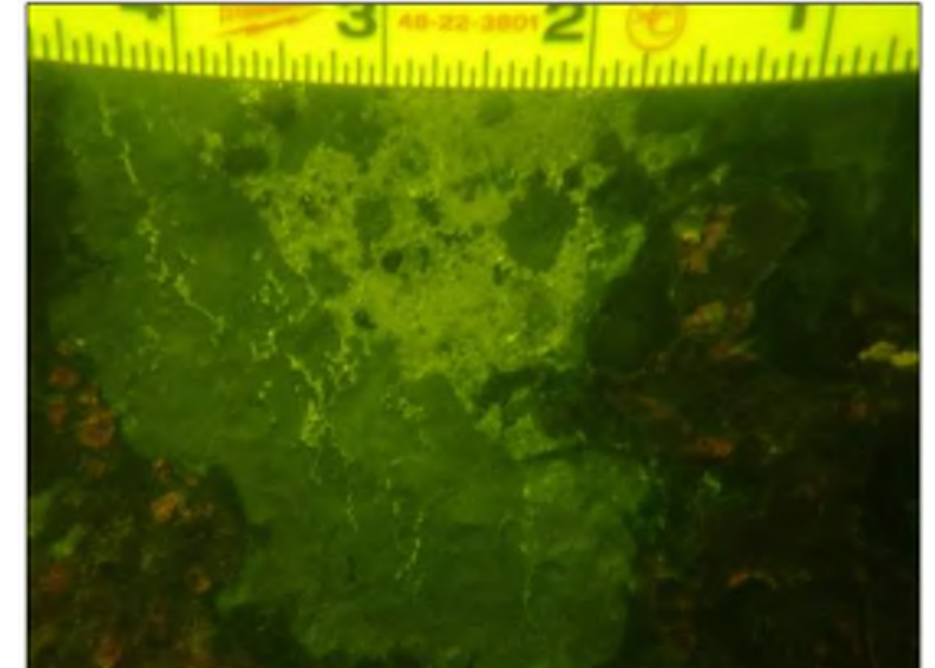
Photo 03: Lagoon Wharf Substructure
Typical cleaned surface of steel sheet pile below waterline

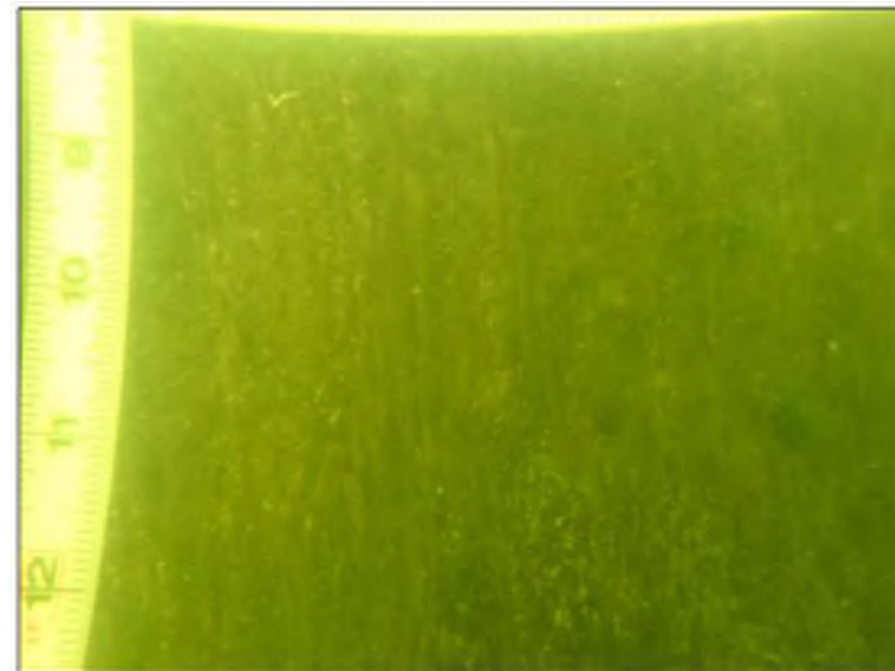
Photo 04: Lagoon Wharf Substructure
Typical condition of timber piles below waterline

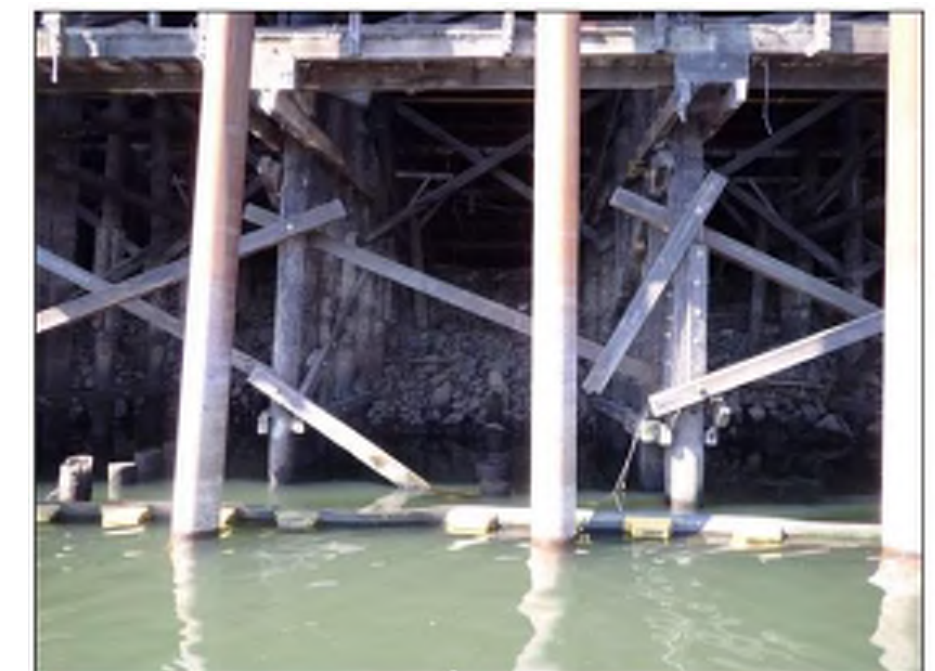
Photo 06: Lagoon Wharf Substructure
Typical damaged cross-bracing

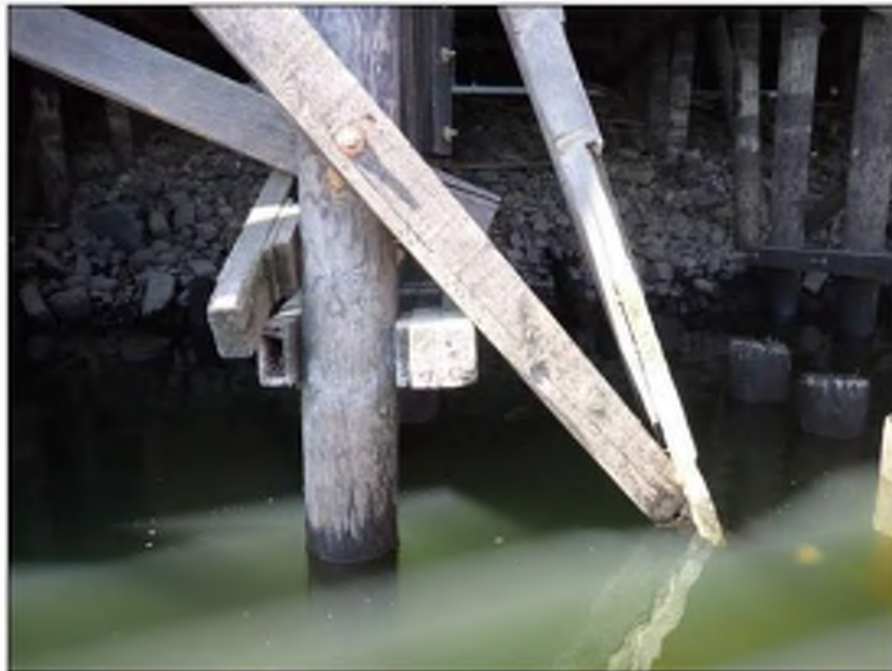
Photo 08: Lagoon Wharf Substructure
Typical timber decay in walers and cross-bracing

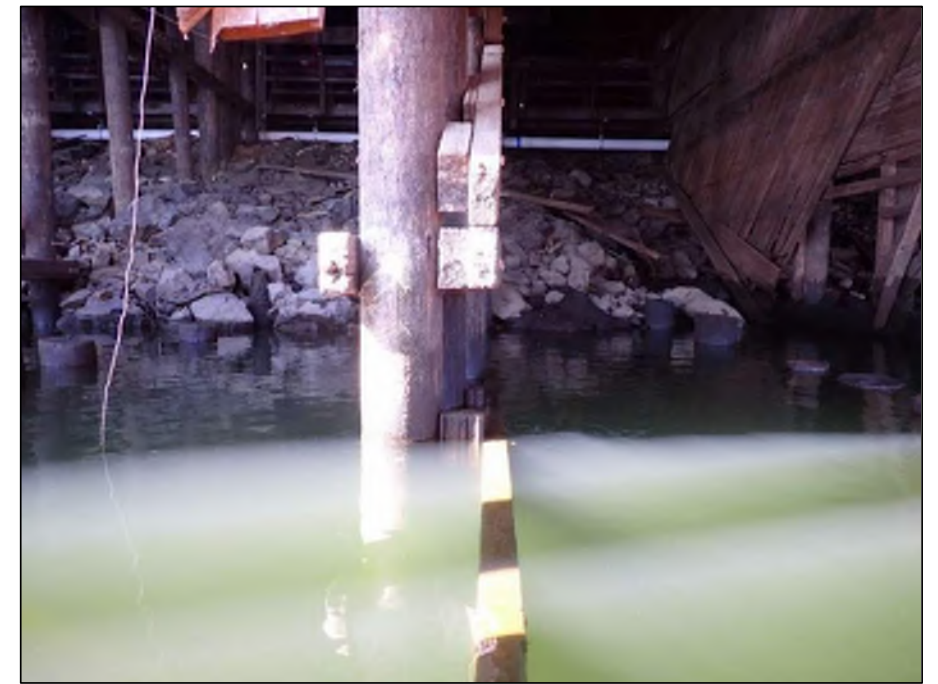
Photo 09: Lagoon Wharf Substructure
Typical timber decay in walers and cross-bracing

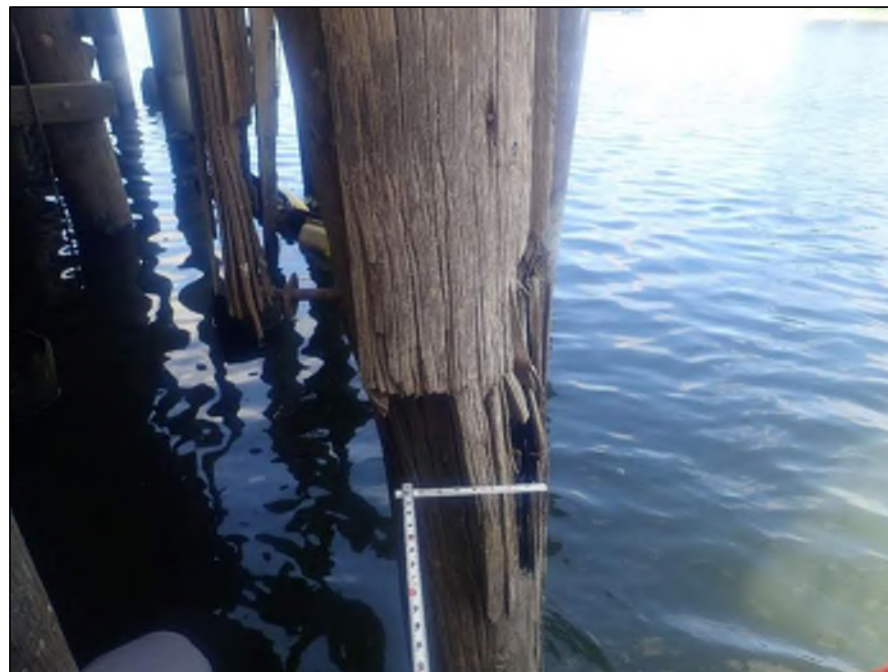
Photo 10: Lagoon Wharf Substructure
Bent 135, Pile A
Broken pile

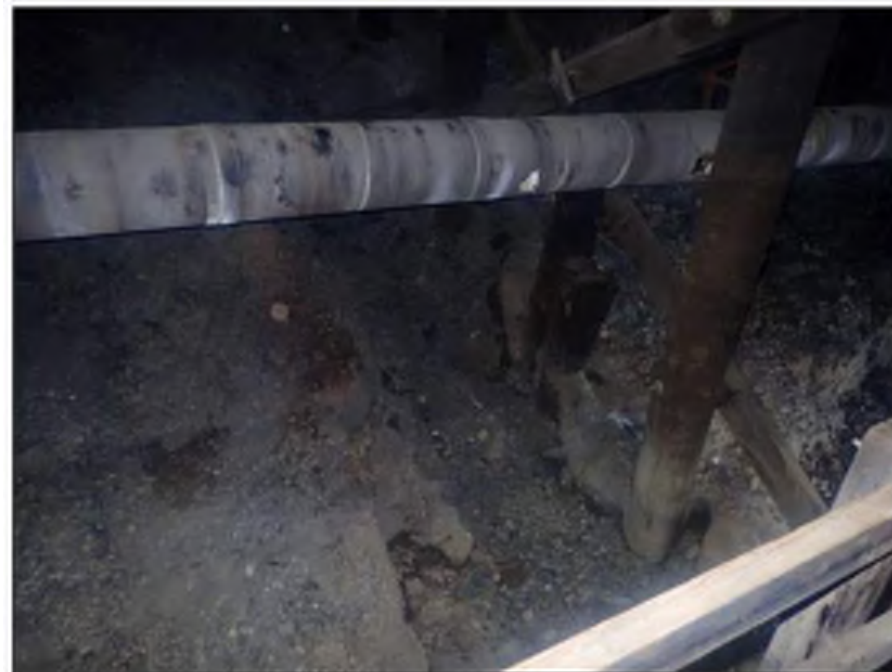
Photo 11: Lagoon Wharf Embankment
Typical condition of embankment

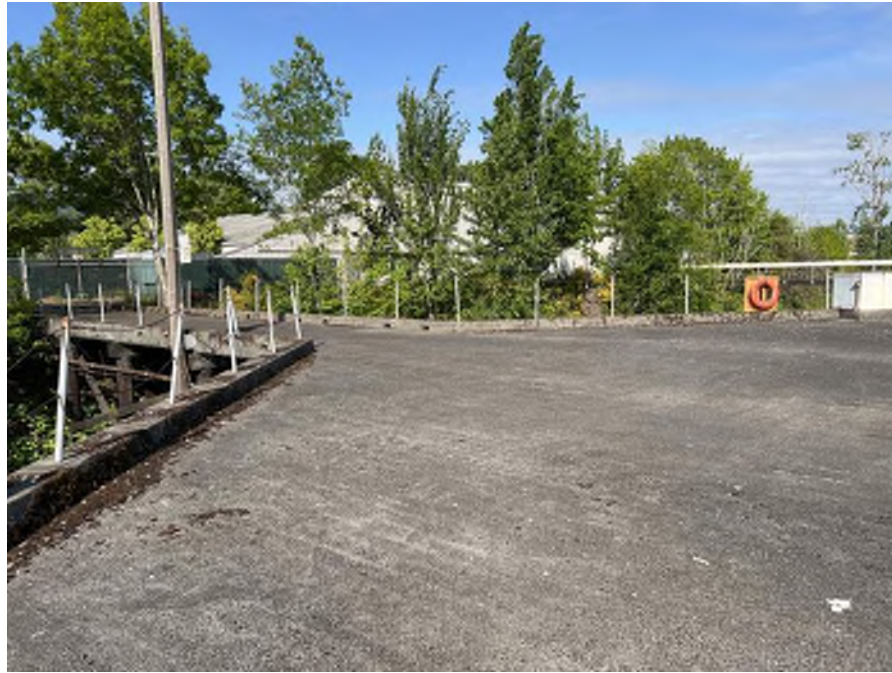
Photo 01: Lay Berth 308 Superstructure
Overview of Concrete Deck
Typical condition of concrete deck
Moata ID: 74934

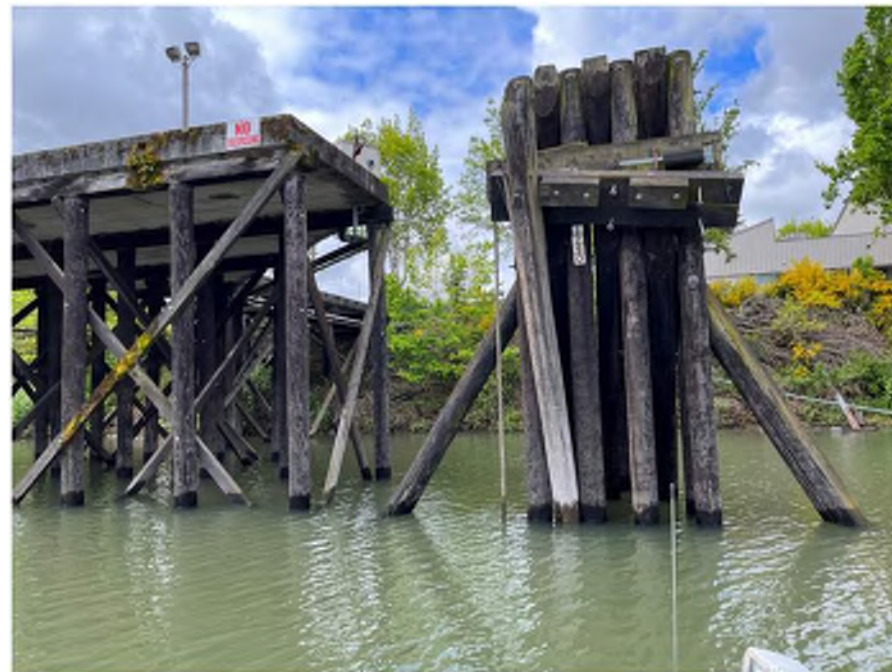
Photo 03: Lay Berth 308 Dolphin
Dolphin D11
Broken piles at Dolphin D11
Moata ID: Not Applicable

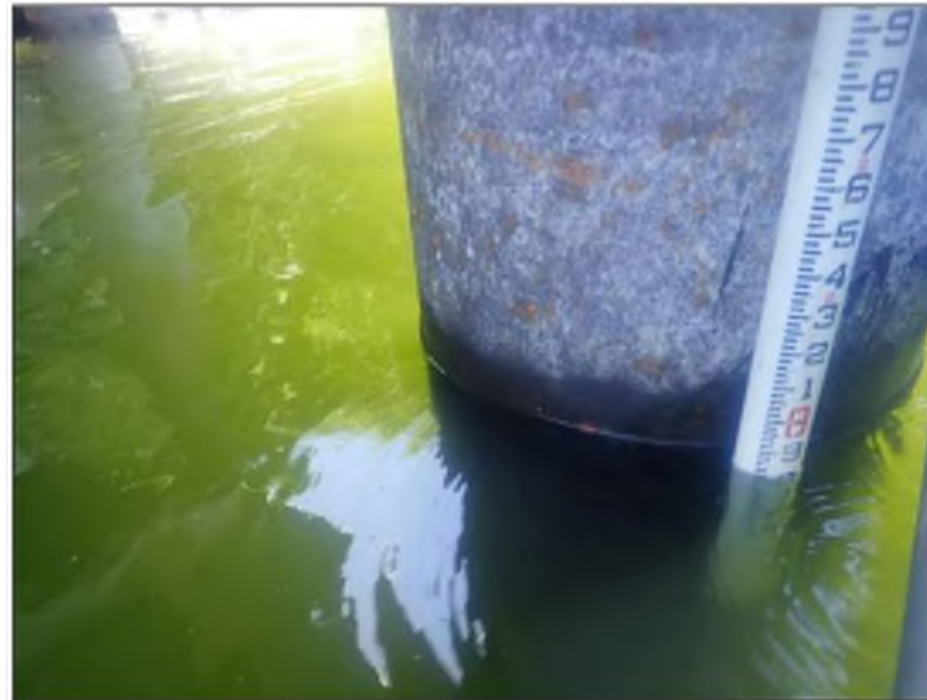
Photo 02: Wind Tunnel Substructure
Typical condition of steel piles at waterline

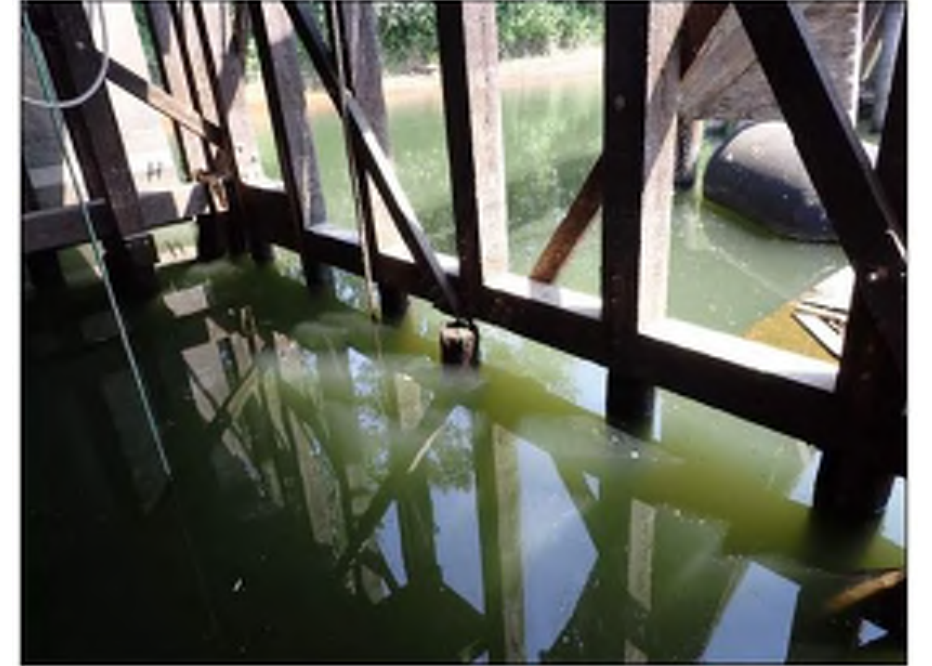
Photo 03: Berth 311 Substructure
Pile 4 Bent 31
Pile non-bearing

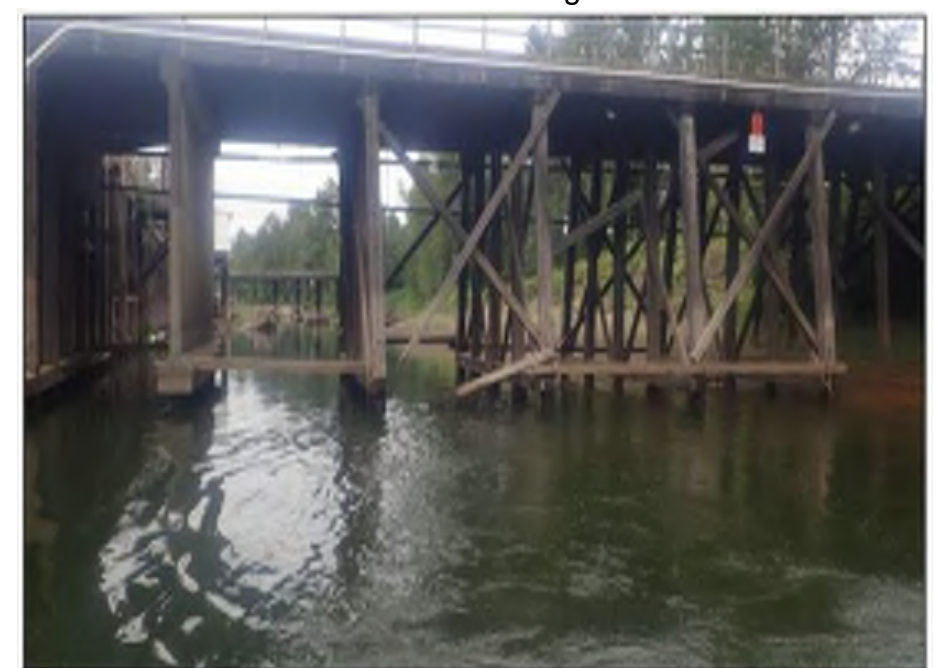
Photo 06: Berth 311 Trestles
East Trestle
Broken cross-bracing

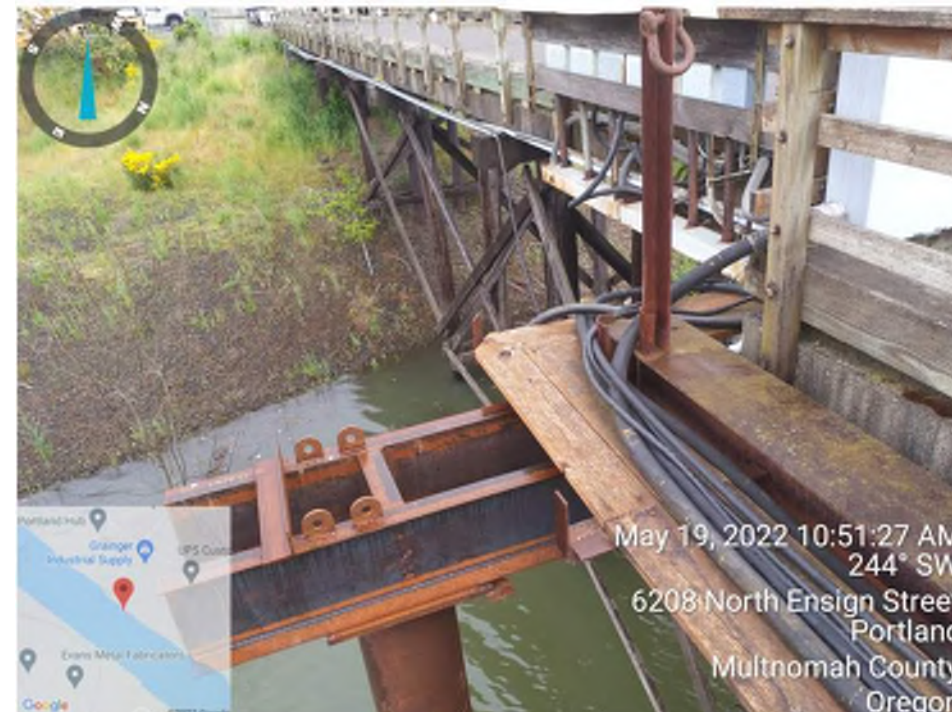
Photo 05: Dredge Base Substructure
Pile Cap at Bents 5
Typical condition of pile cap
Moata ID: Not Applicable

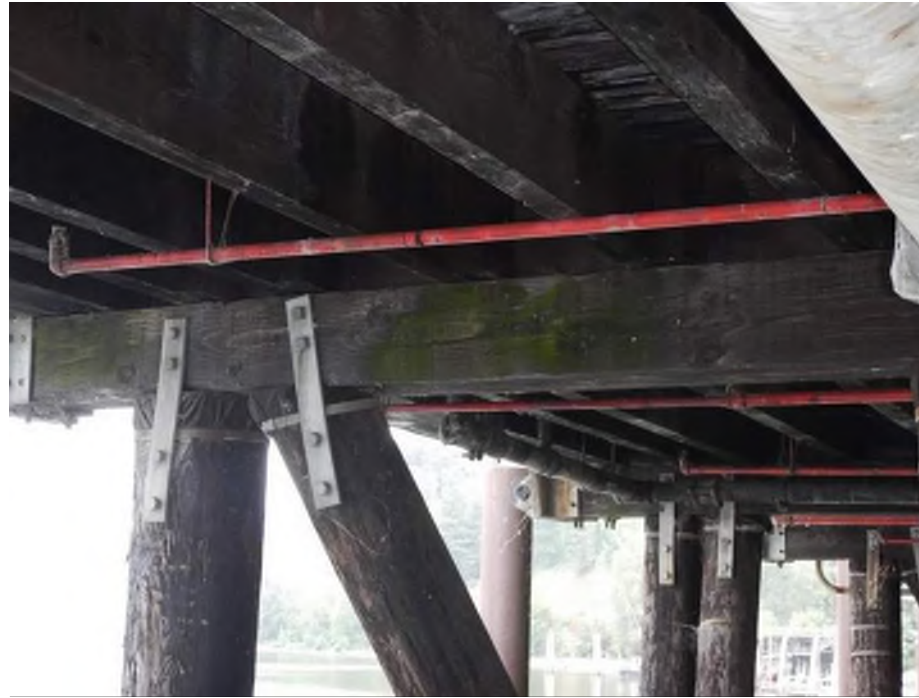
Photo 02: U.S. Navy Pier Substructure
Typical condition of timber pile cap
Source: AME 2019 Report

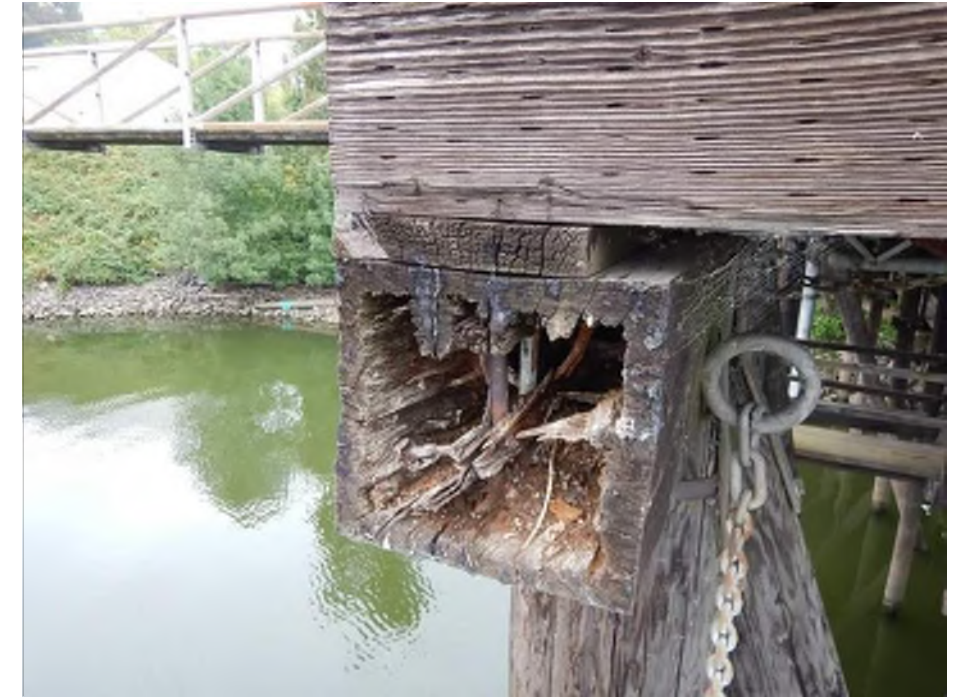
Photo 03: U.S. Navy Pier Substructure
Timber pile cap with severe end grain fungal decay
Source: AME 2019 Report

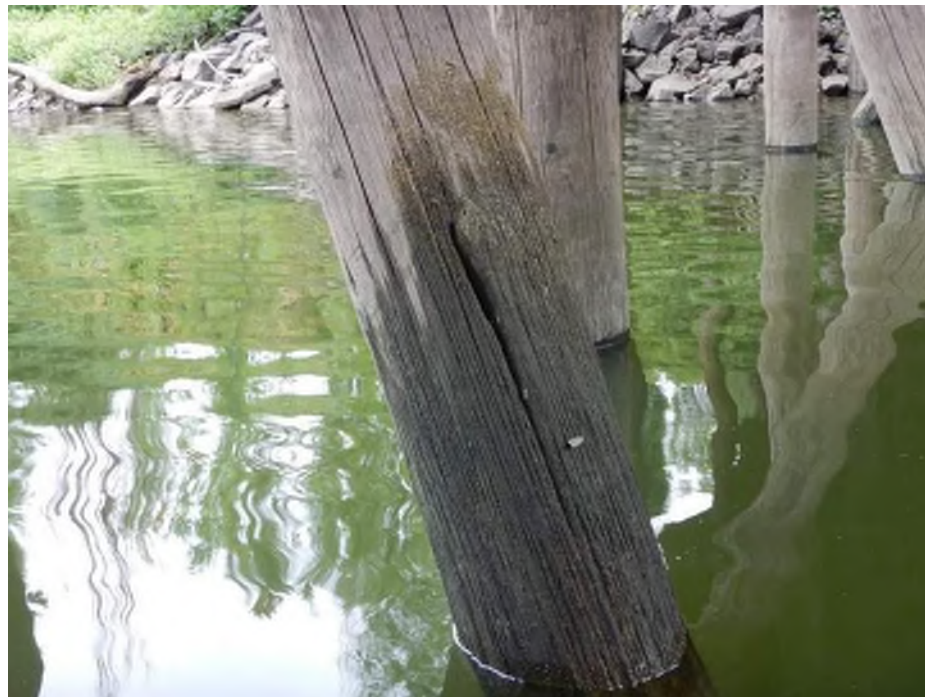
Photo 04: U.S. Navy Pier Dolphins
Typical condition of timber batter pile
Source: AME 2019 Report

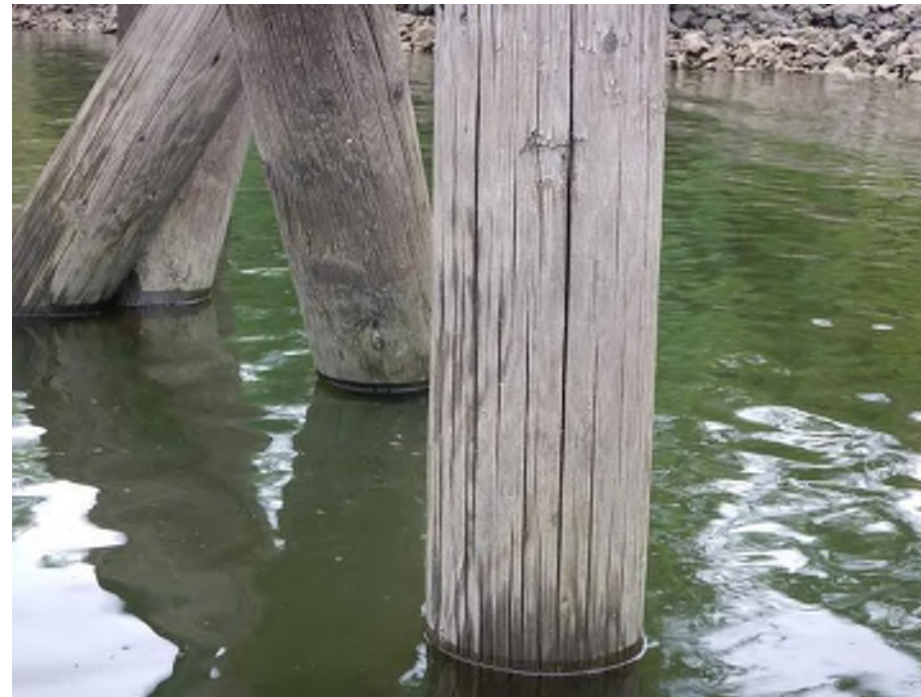
Photo 05: U.S. Navy Pier Substructure
Typical condition of timber pile
Source: AME 2019 Report

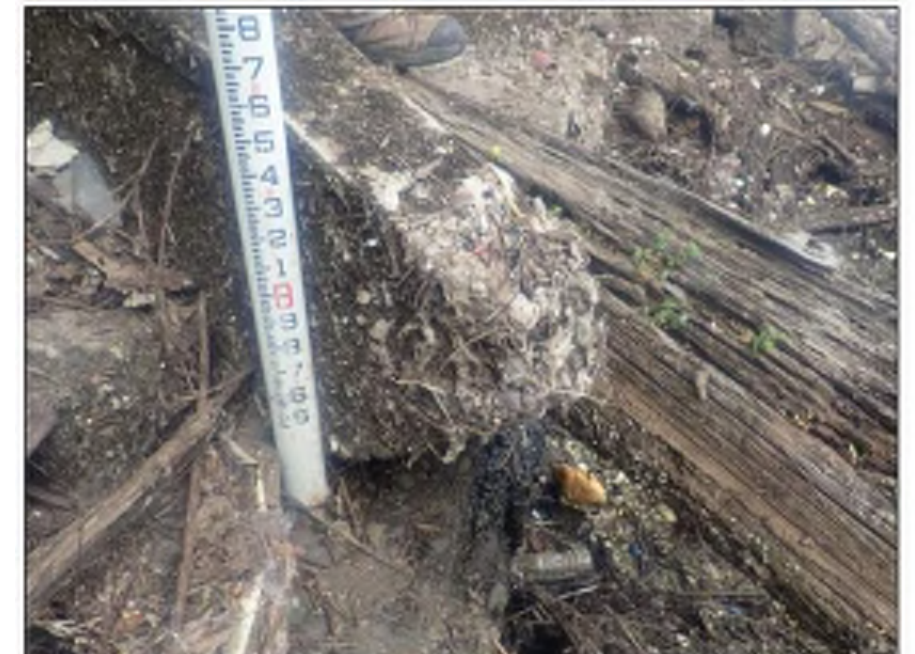
Photo 03: City Stormwater Outfall S2 Wingwalls
Typical spalling at edge of wingwalls

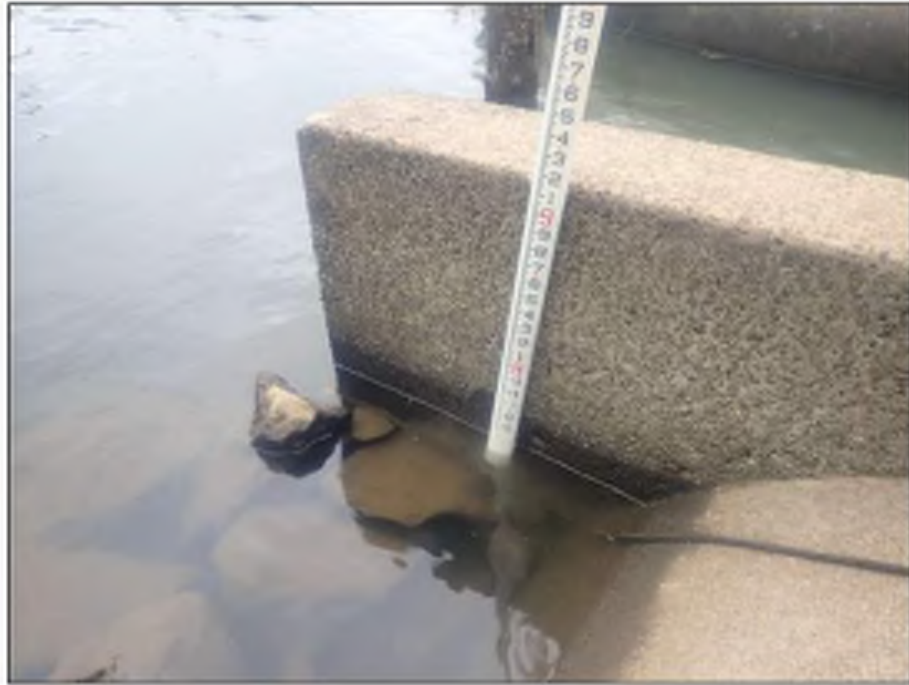
Photo 01: City Stormwater Outfall M3 Wingwalls
Typical condition of concrete at waterline
