**STRUCTURE CONDITION ASSESSMENT REPORT
REVISION 0**

**REMEDIAL DESIGN SERVICES
SWAN ISLAND BASIN PROJECT AREA
CERCLA Docket No. 10-2021-001**

**PORTLAND HARBOR SUPERFUND SITE
PORTLAND, MULTNOMAH COUNTY, OREGON**

November 2023

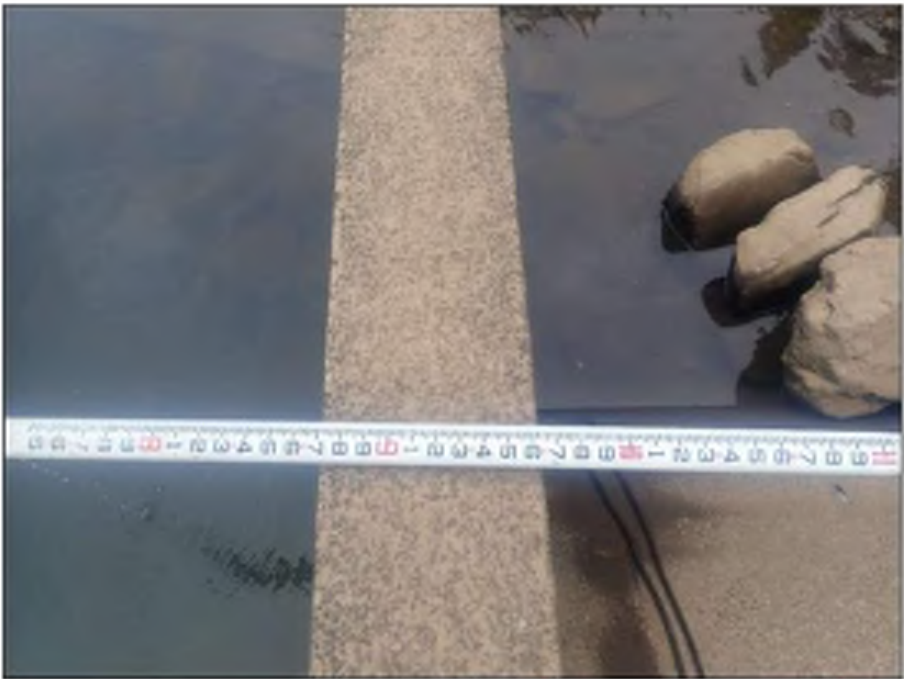
Photo 02: City Stormwater Outfall M3 Headwall
Top of concrete headwall
