PRE-DESIGN INVESTIGATION EVALUATION REPORT REVISION 1

**REMEDIAL DESIGN SERVICES
SWAN ISLAND BASIN PROJECT AREA
CERCLA DOCKET NO. 10-2021-001**

**PORTLAND HARBOR SUPERFUND SITE
PORTLAND, MULTNOMAH COUNTY, OREGON**

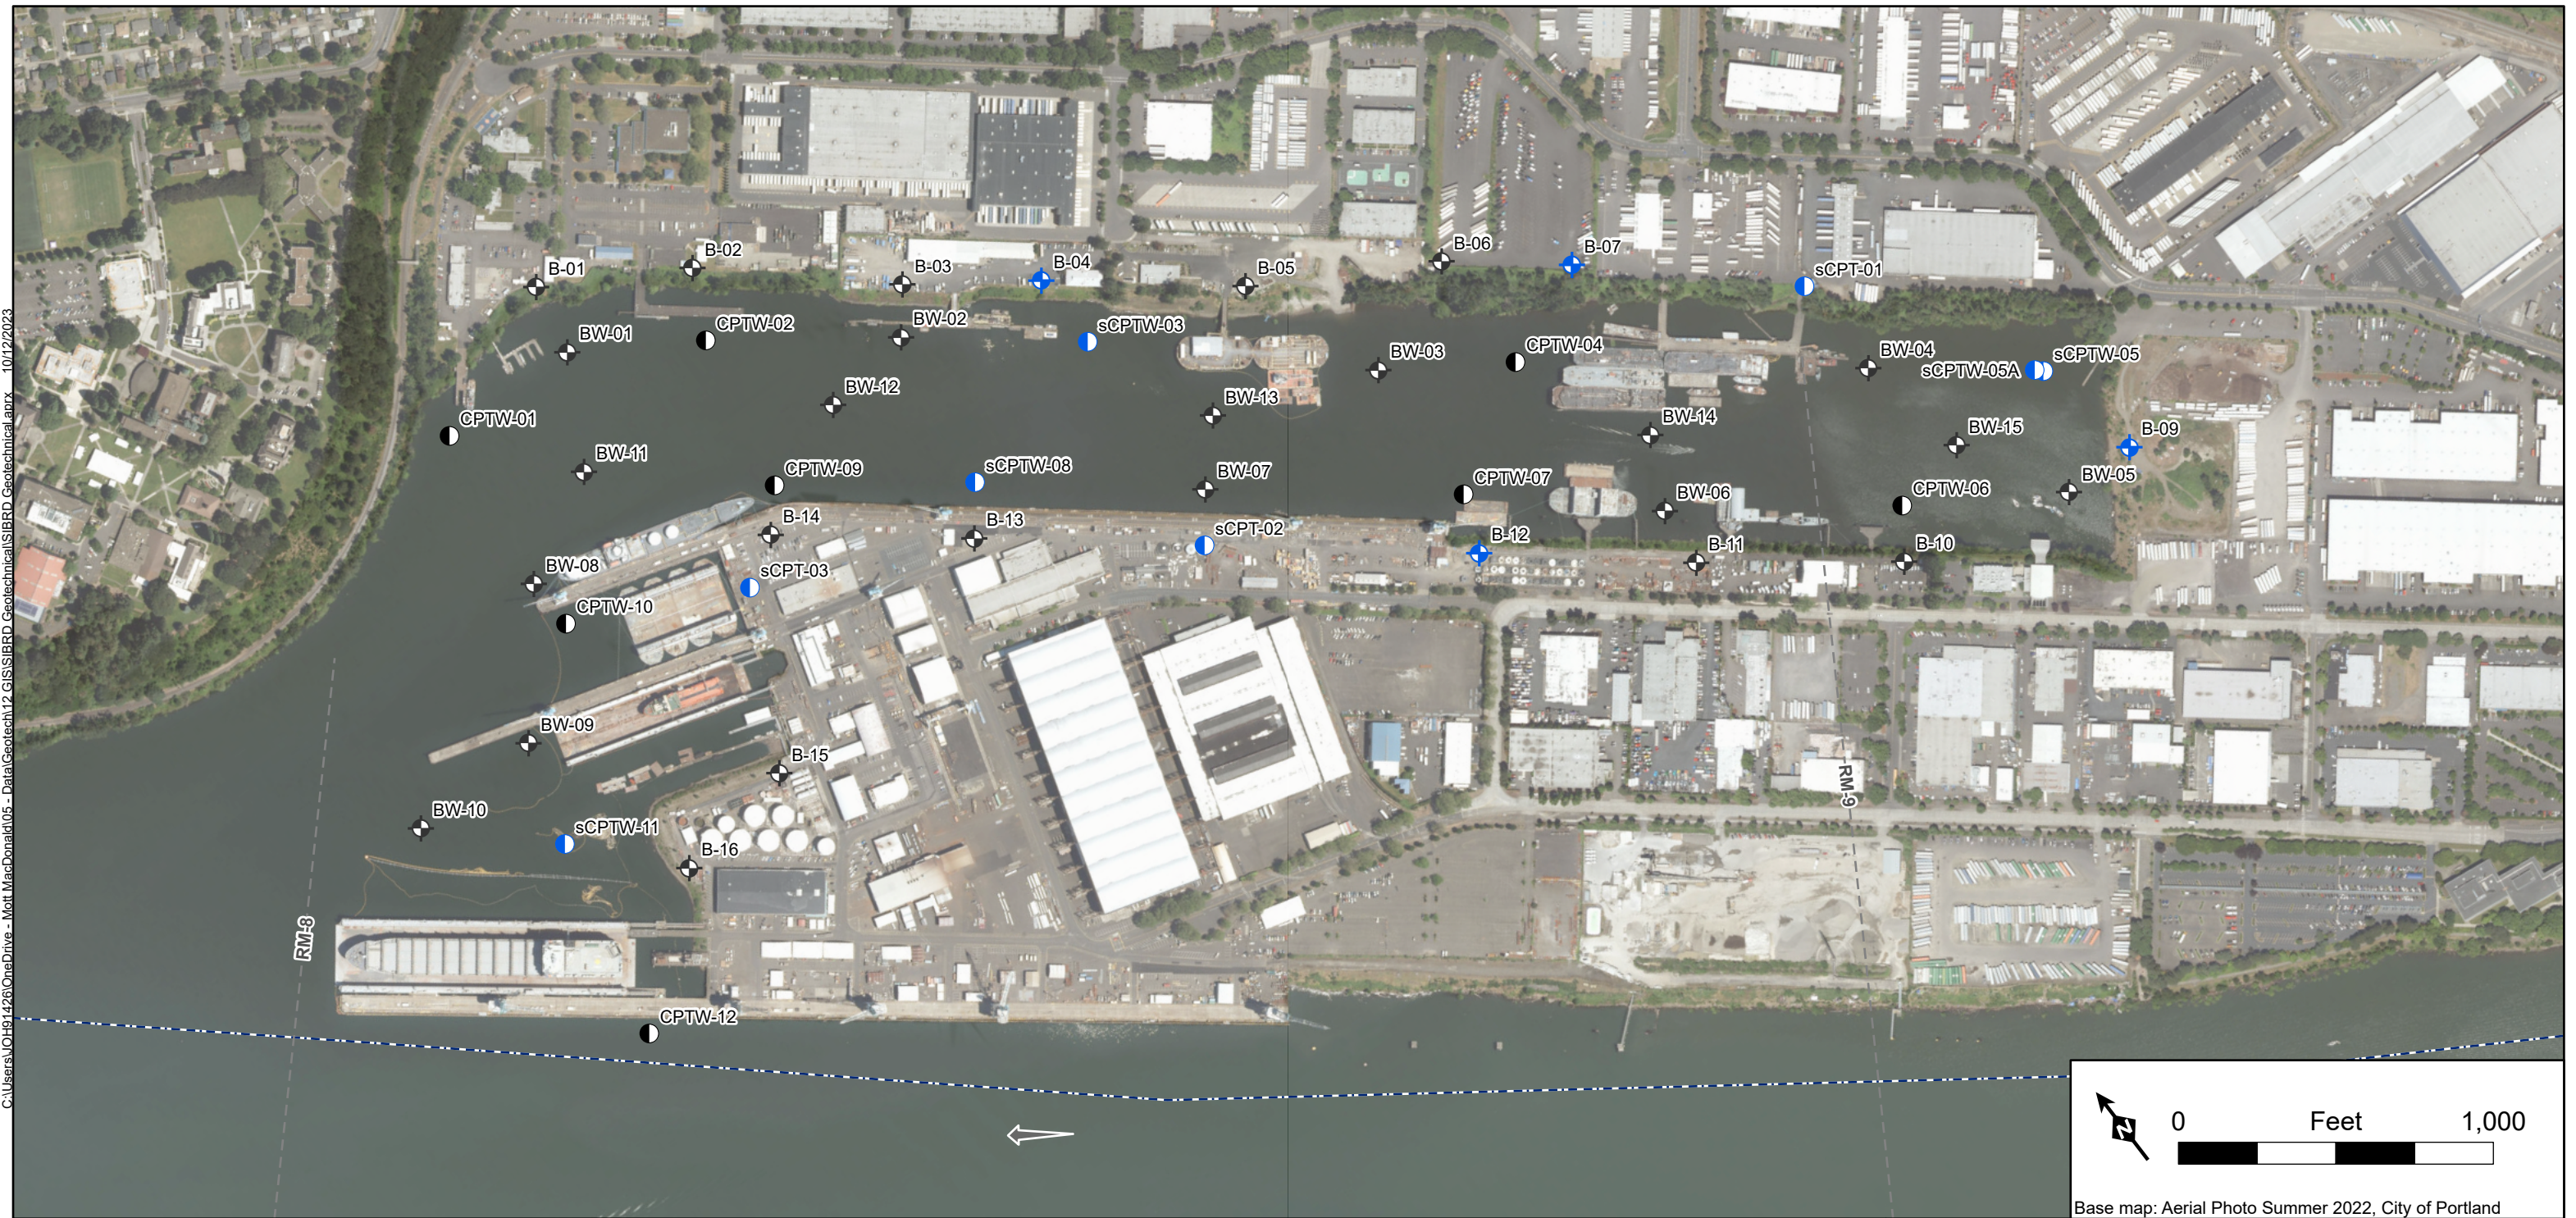
Figure 2-5
Geotechnical Investigation Locations

- Geotechnical Boring
- Geotechnical Boring with PS-Logging
- Cone Penetration Test
- Seismic Cone Penetration Test
- River Mile (RM)
- Federal Navigation Channel (USACE, 2020)
- ← River Flow Direction

A site-specific geotechnical sampling program consisting of soil borings and cone penetration tests (CPTs), and geophysical logging was performed to explore the SIB Project Area's subsurface conditions and to obtain samples for geotechnical laboratory testing program (Appendix F).

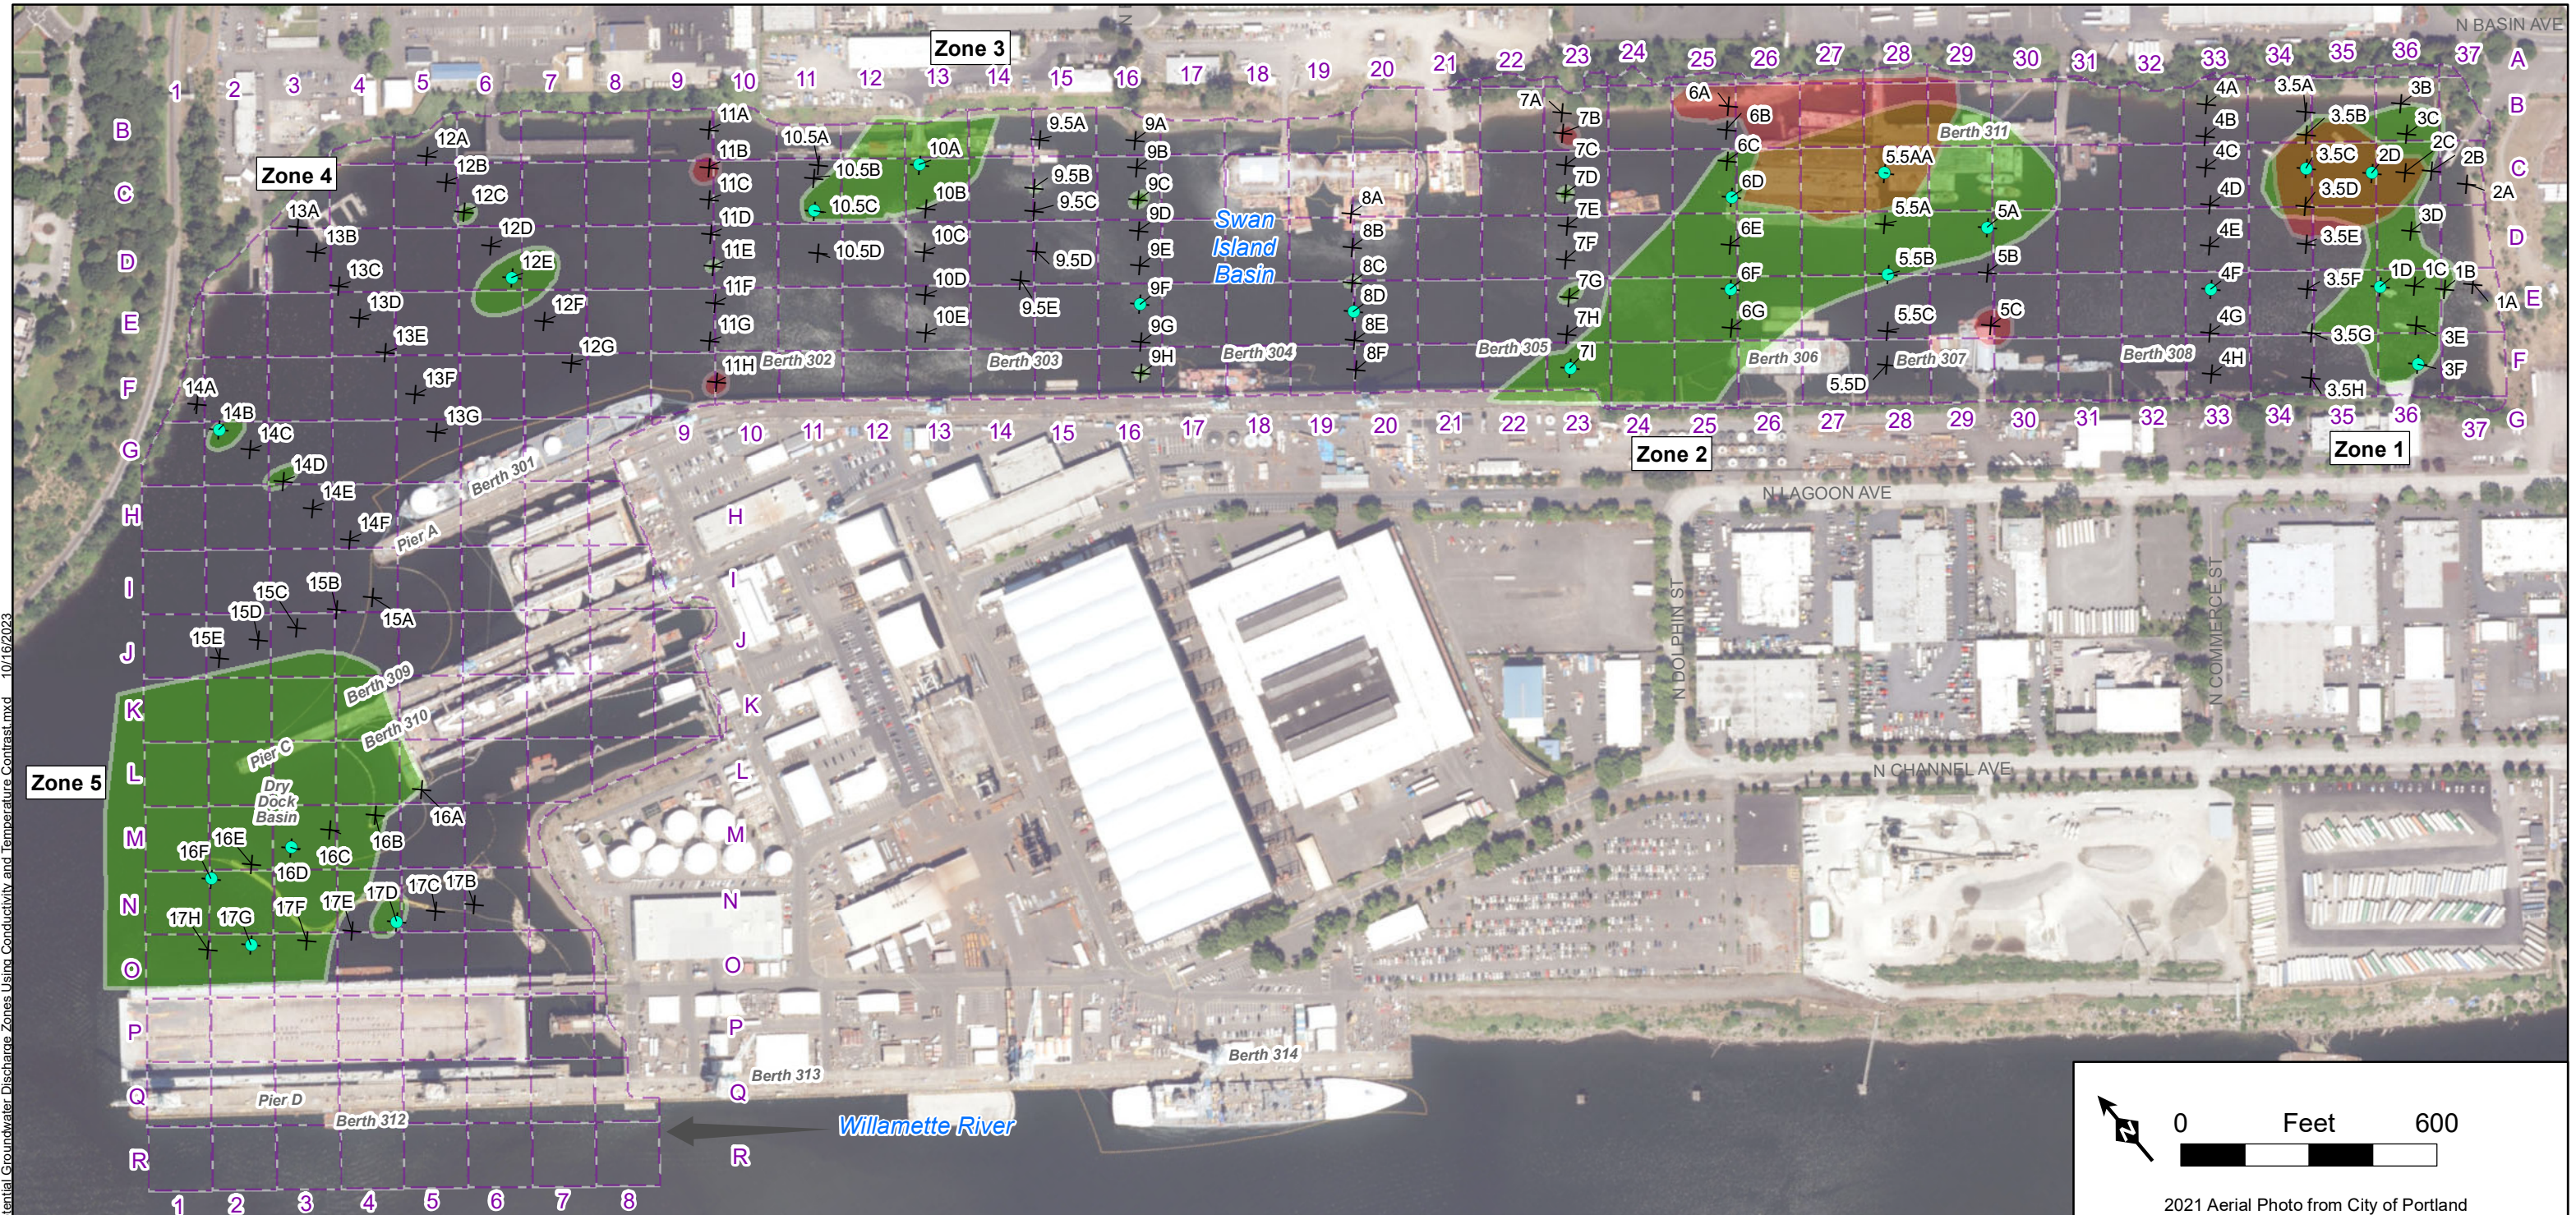
Figure 3-4
Potential Groundwater Discharge
Zones Using Conductivity and
Temperature Contrast

- Target Station for Quantitative Assessment
- + Trident Survey Mapping Station
- ➔ River Flow Direction
- Conductivity Contrast exceeding 750 µS/cm
- Temperature Contrast exceeding 0.25 °C
- Project Area Grid Cell Boundary

The results of the TZW screening survey conducted during the first phase of the work were used to identify the locations where porewater upwelling was most likely occurring within SIB. In the second phase of the work, specific porewater velocity was measured with the UltraSeep system at 21 target stations during a timeframe that corresponds to the maximum groundwater discharge condition in SIB. Average velocities ranged from a recharge of 0.001 centimeters per day (cm/day) to a discharge of 0.22 cm/day, with an overall average discharge of 0.06 cm/day across all stations. Upwelling ranged from low (less than 0.033 cm/day) to moderately high (up to 0.22 cm/day) across SIB. High upwelling (average discharge greater than 1 cm/day) was not observed at any of the surveyed locations.

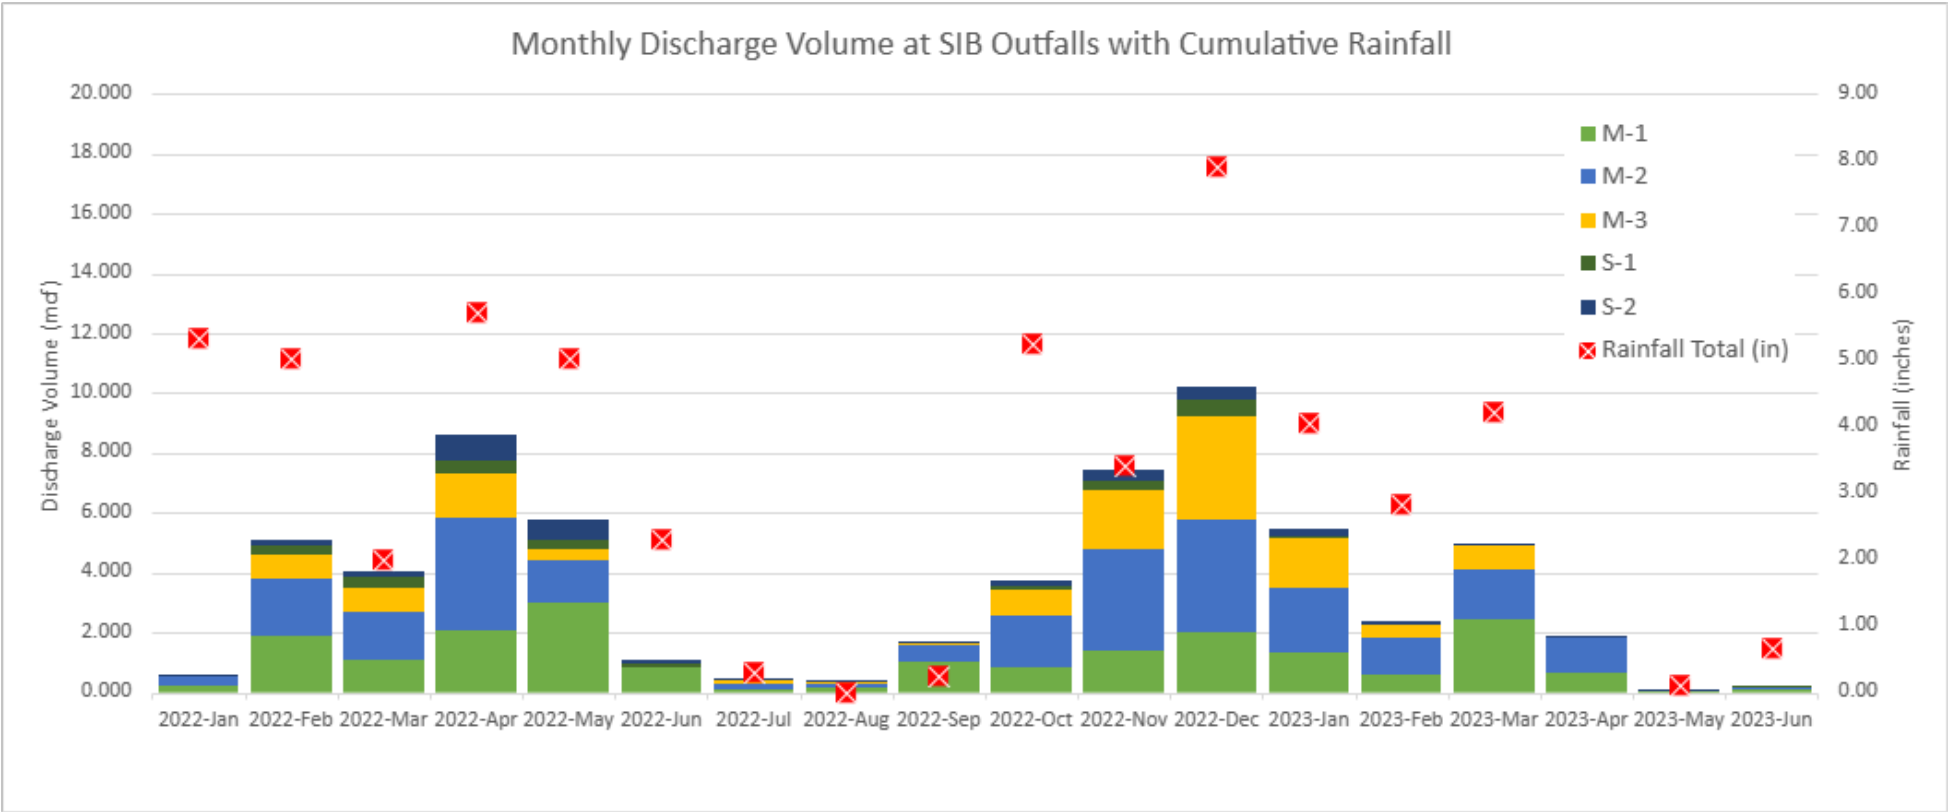
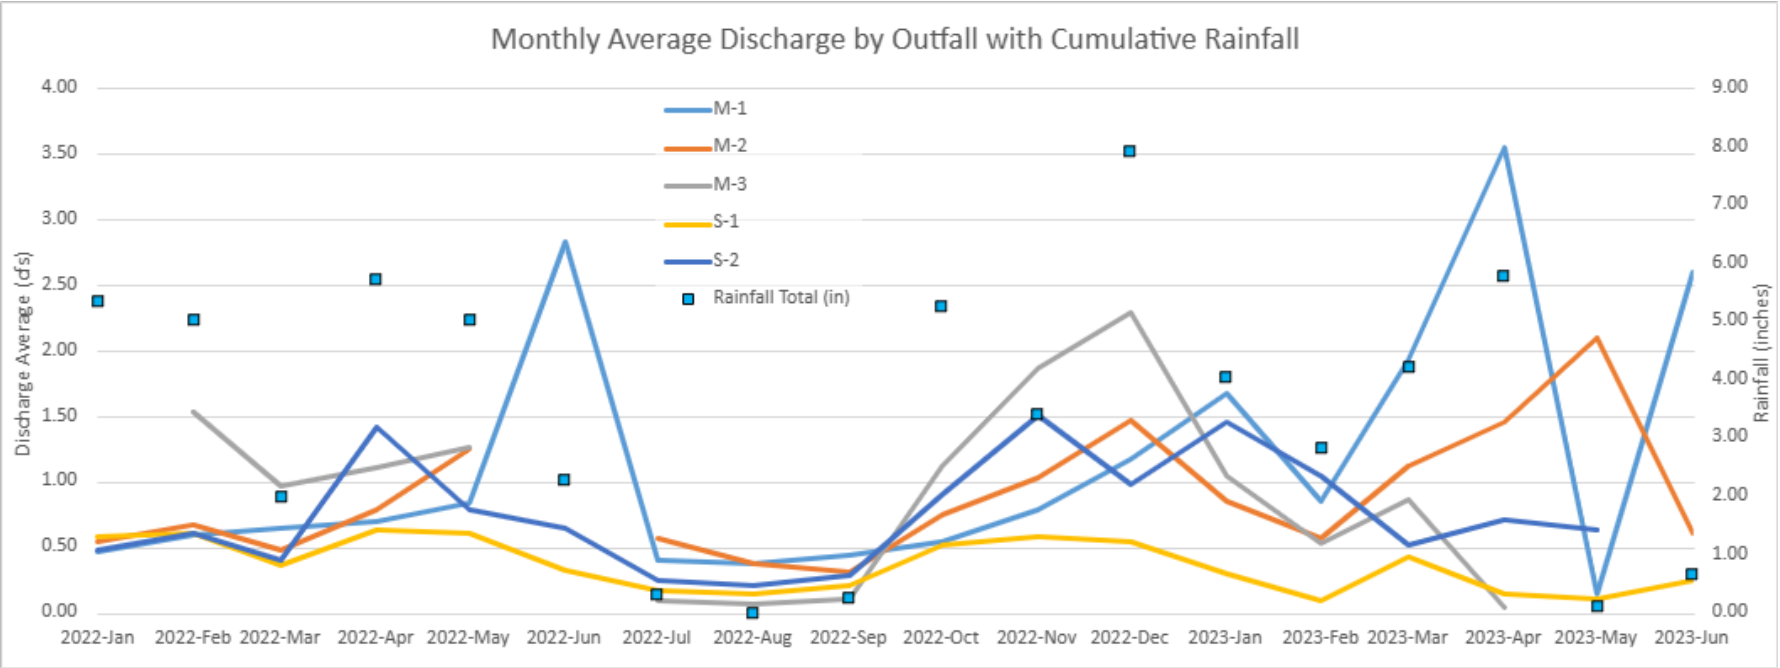
Figure 3-7
City of Portland Conveyance System Flows –
February 2022 – June 2023

Flow data from water-level-velocity sensors deployed in city of Portland conveyance systems with inundation periods removed (see Attachment A.7)
