PRE-DESIGN INVESTIGATION EVALUATION REPORT REVISION 2

**REMEDIAL DESIGN SERVICES
SWAN ISLAND BASIN PROJECT AREA
CERCLA DOCKET No. 10-2021-001**

**PORTLAND HARBOR SUPERFUND SITE
PORTLAND, MULTNOMAH COUNTY, OREGON**

December 2024

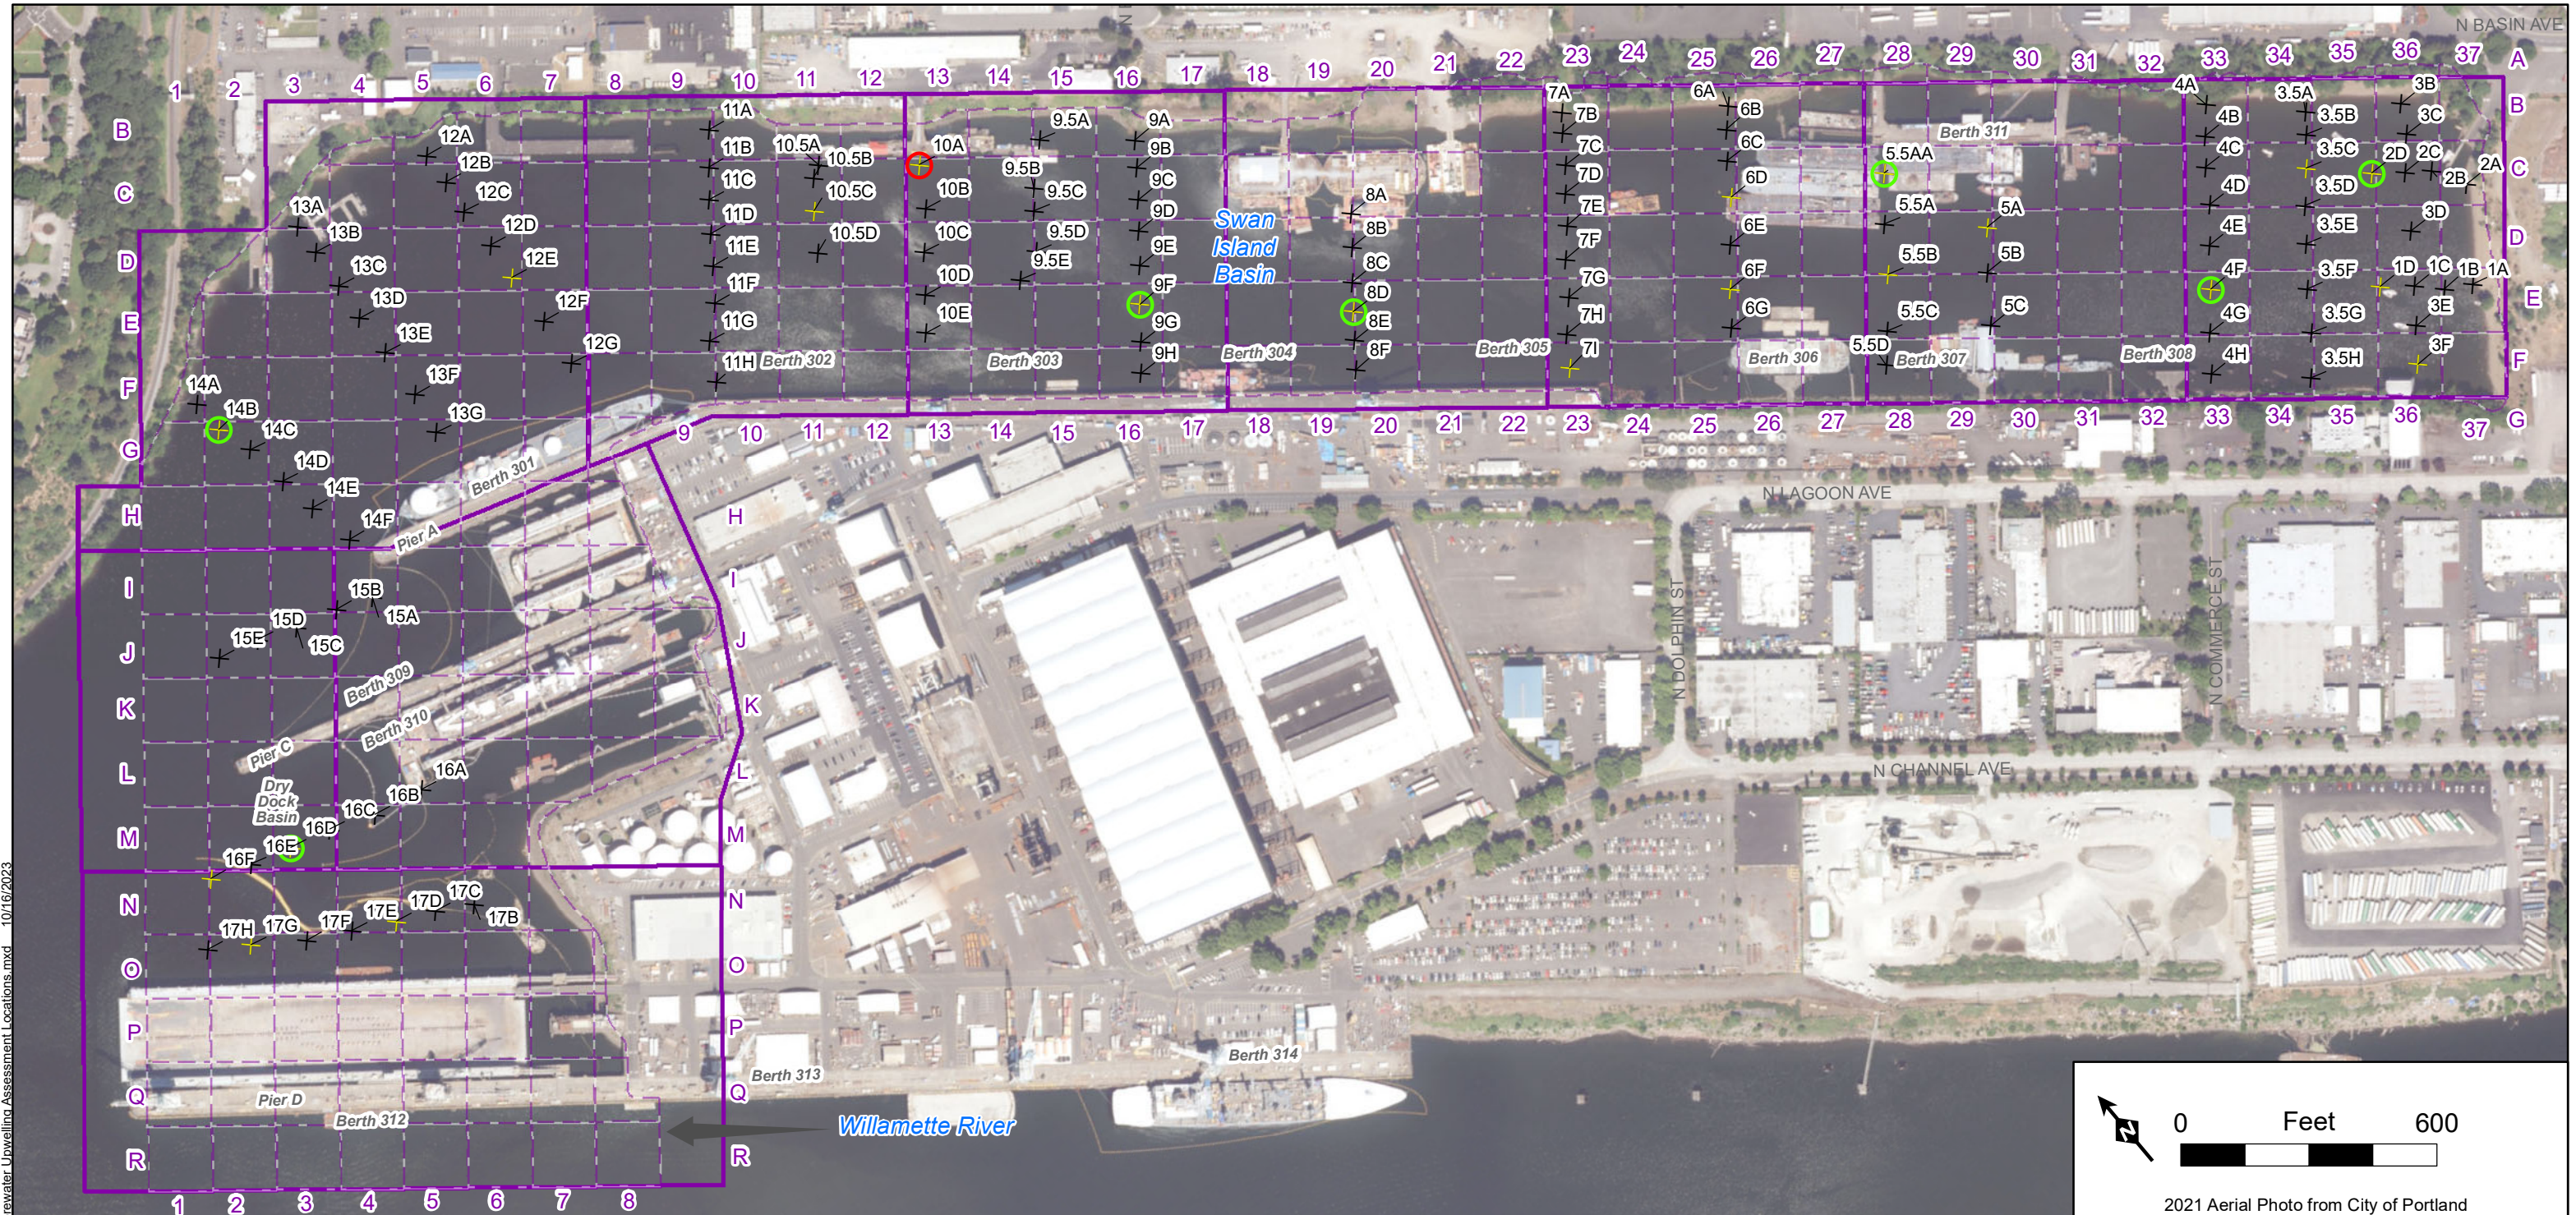
\srv-gst-01\HGL\GIS\Portland_Harbor_DT2020\GIS\IB\PDI_ER\Figure 2-2_Porewater Upwelling Assessment Locations.mxd 10/16/2023

- + UltraSeep Location
- + Trident Survey Mapping Station
- DPZ Location
- DPZ Location with Sensor Failure (no data collected)
- ← River Flow Direction
- Project Area Grid Cell Boundary
- Project Area Grid Boundary

The results of the TZW screening survey conducted during the first phase of the work were used to identify the locations where porewater upwelling was most likely occurring within SIB. In the second phase of the work, specific porewater velocity was measured with the UltraSeep system at 21 target stations during a timeframe that corresponds to the maximum groundwater discharge condition in SIB. Average velocities ranged from a recharge of 0.001 centimeters per day (cm/day) to a discharge of 0.22 cm/day, with an overall average discharge of 0.06 cm/day across all stations. Upwelling ranged from low (less than 0.033 cm/day) to moderately high (up to 0.22 cm/day) across SIB. High upwelling (average discharge greater than 1 cm/day) was not observed at any of the surveyed locations.

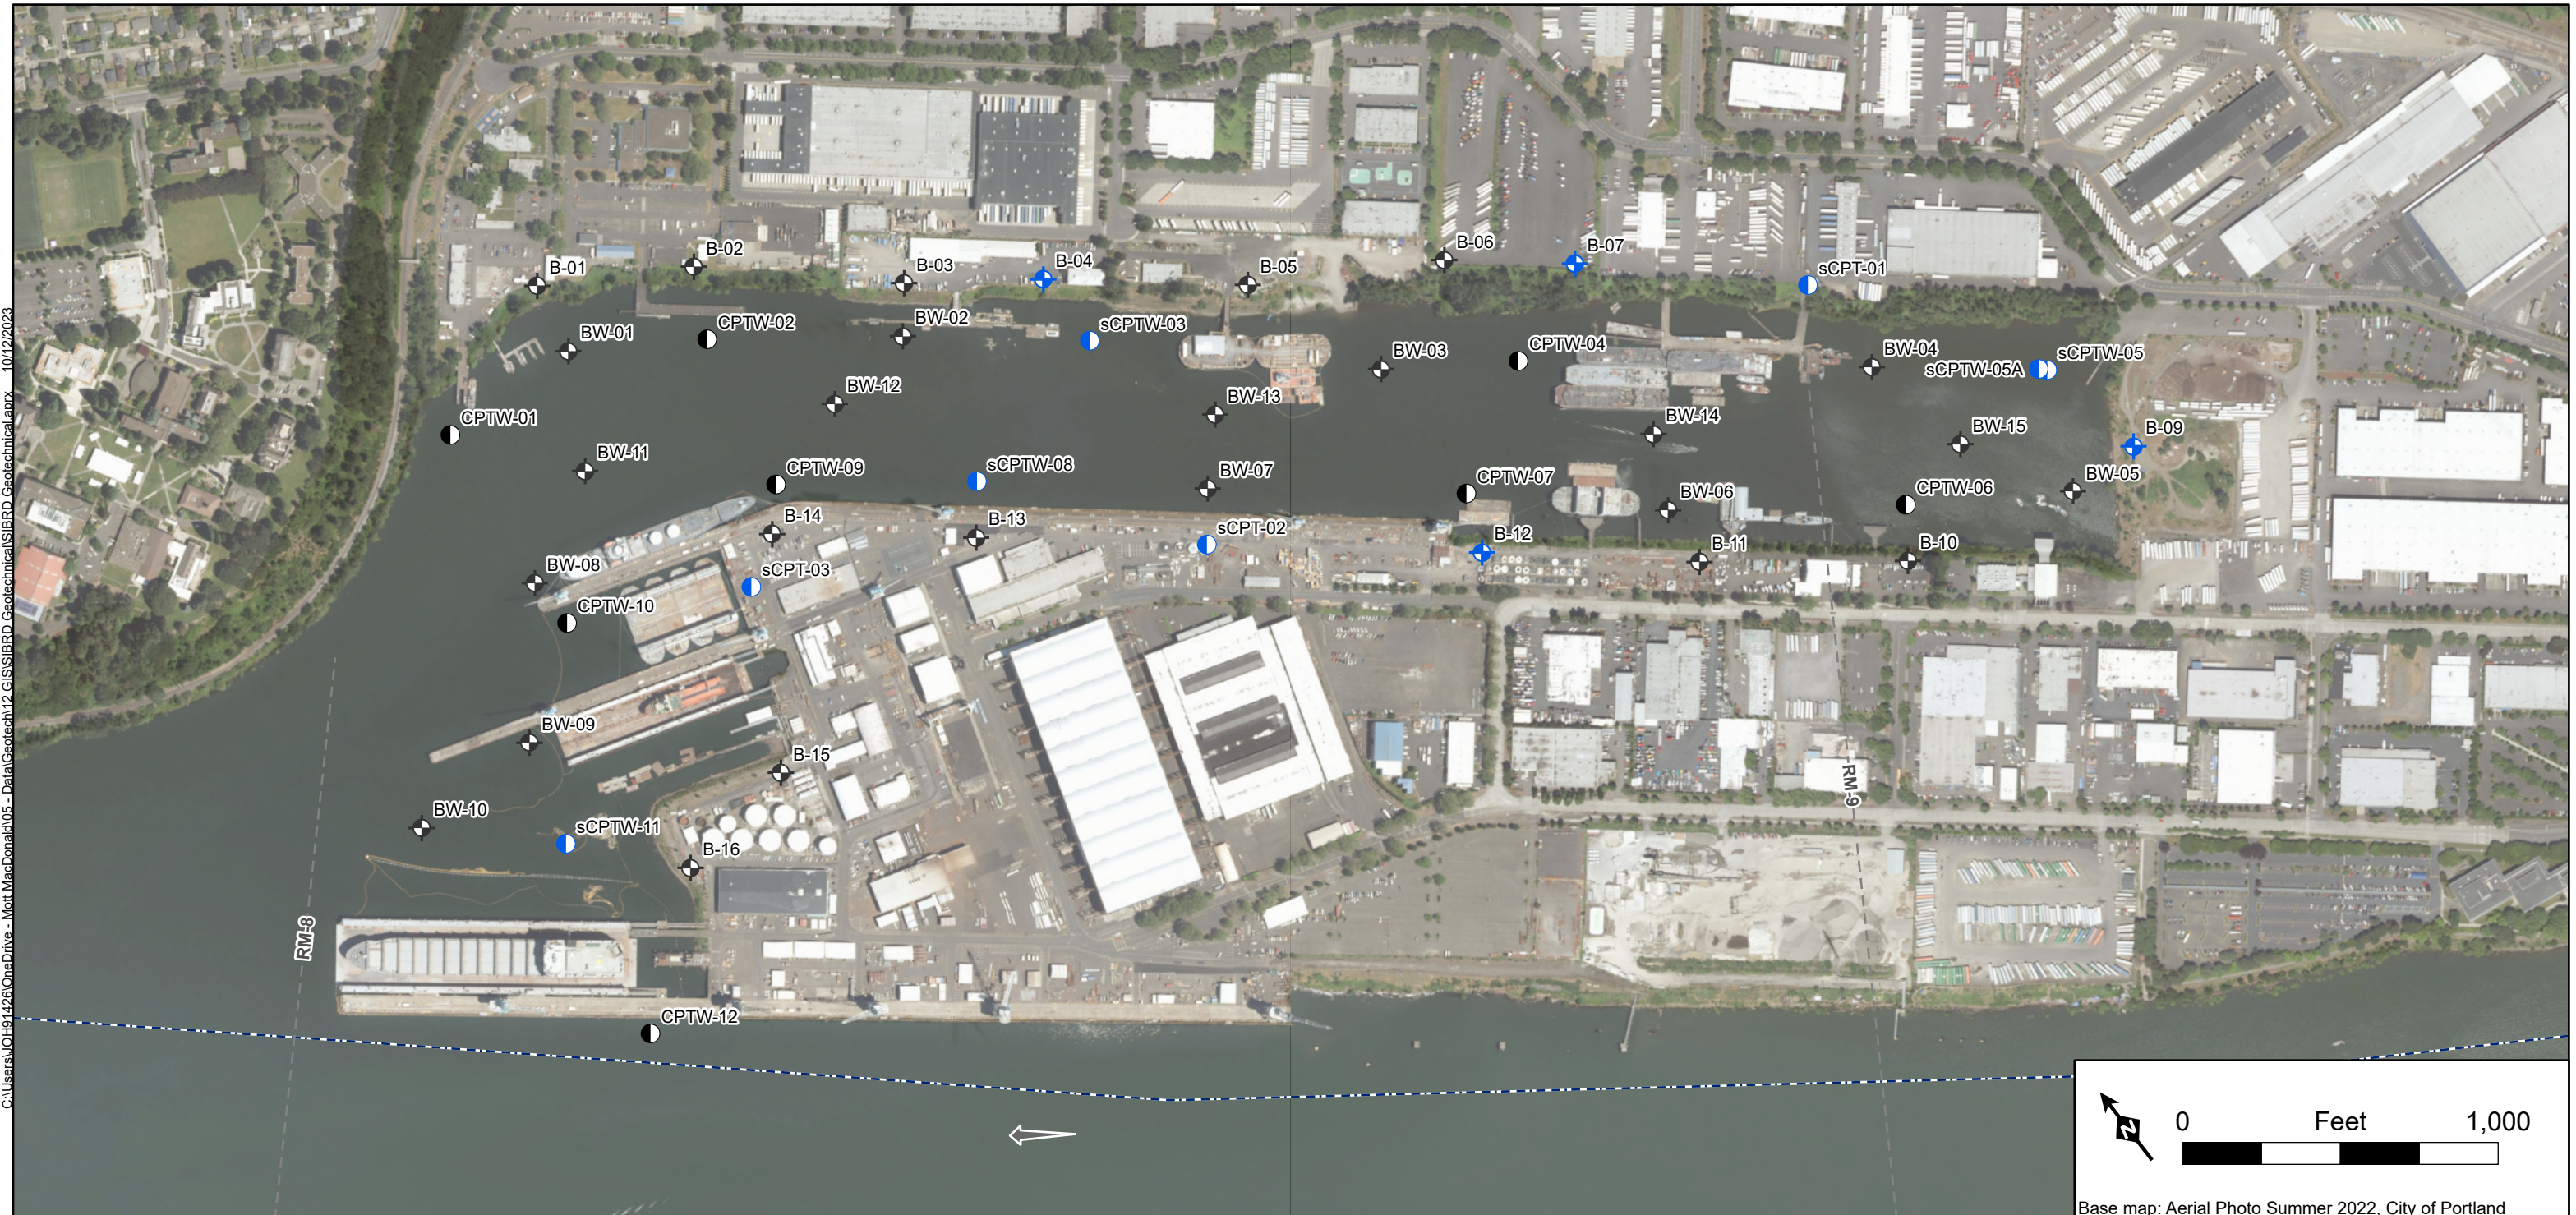
A site-specific geotechnical sampling program consisting of soil borings and cone penetration tests (CPTs), and geophysical logging was performed to explore the SIB Project Area's subsurface conditions and to obtain samples for geotechnical laboratory testing program (Appendix F).

- Geotechnical Boring
- Geotechnical Boring with PS-Logging
- Cone Penetration Test
- Seismic Cone Penetration Test
- River Mile (RM)
- Federal Navigation Channel (USACE, 2020)
- River Flow Direction

The geotechnical investigation program entailed advancement of 30 exploratory borings, both in SIB (15 in-water) and the surrounding upland areas (15), from May 12, 2022 through August 14, 2022. The geotechnical investigation was performed to characterize the geotechnical conditions in and around the SIB Project Area and provide the foundational geotechnical data necessary to support RD development and evaluation. Geotechnical testing found that near surface soils consist of artificial fills (both within SIB and at the riverbank and upland areas), sands, silts, and clays. The sediment within SIB is primarily soft elastic silt with variable sand content. The site seismic setting indicates the SIB Project Area may be subject to strong earthquake-induced ground motions during the design life of the selected Remedial Action (RA). Additionally, based on the potential for strong earthquake-induced ground motions, the presence of saturated soils within SIB, and relatively shallow ground water in the areas surrounding SIB, the potential for soil liquefaction and lateral spreading is present.

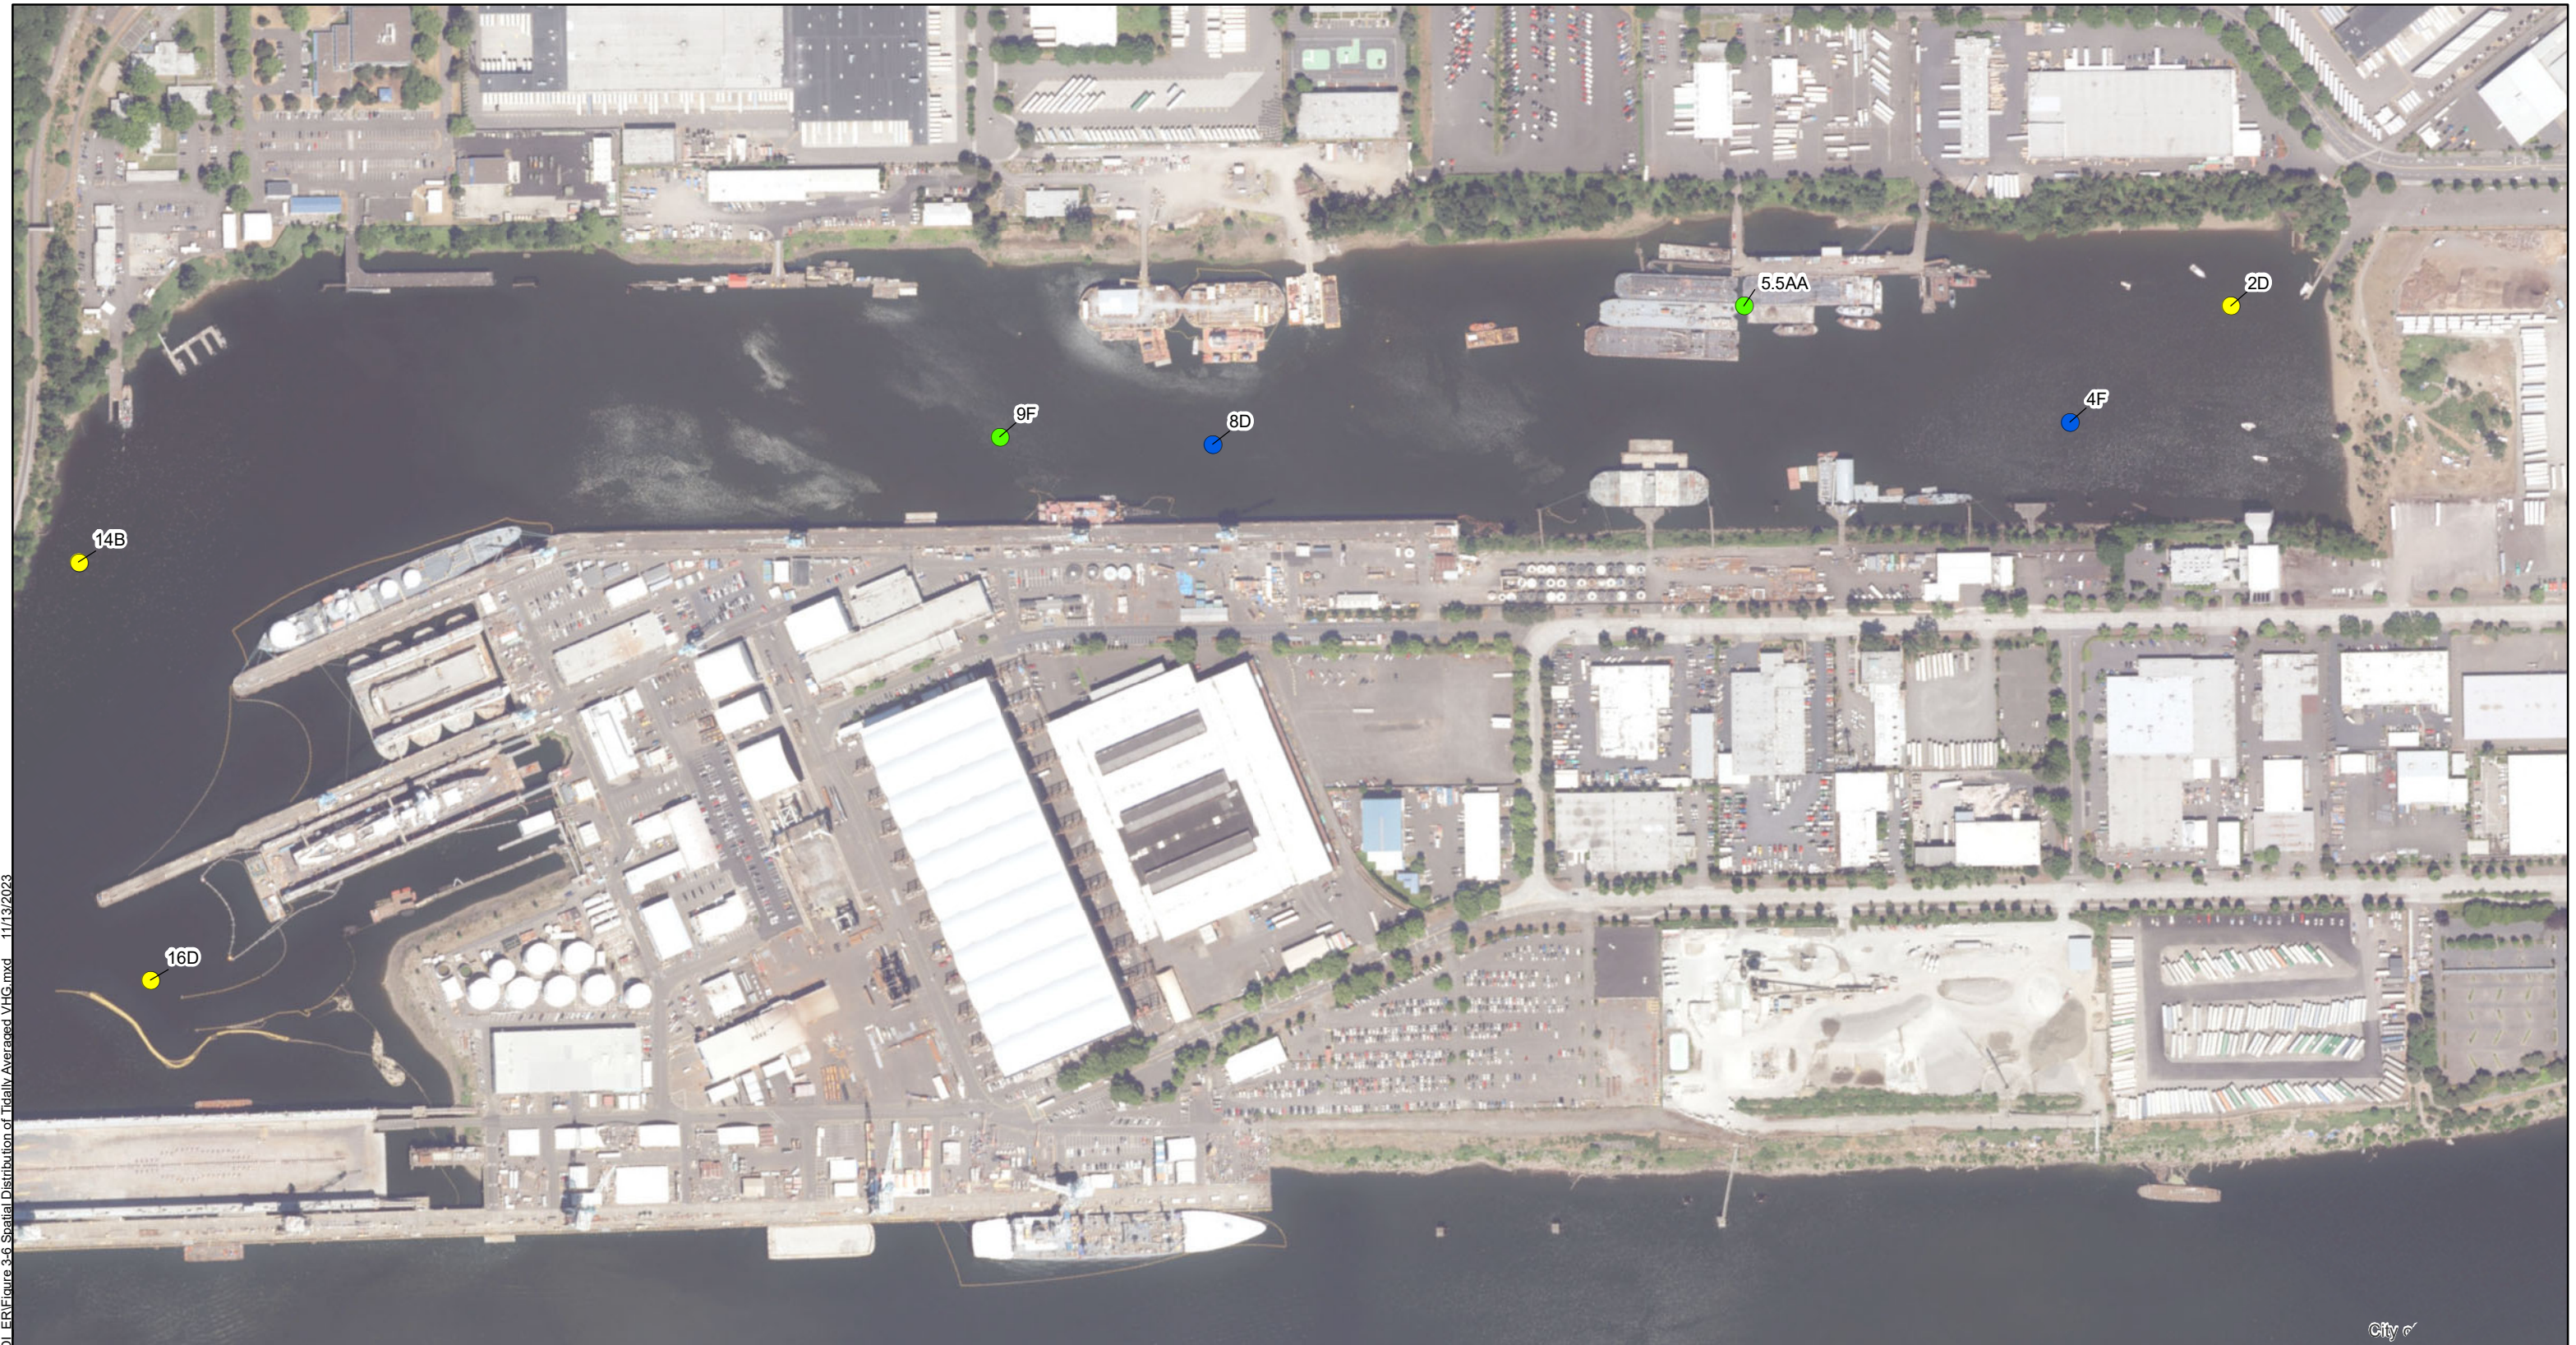
\\svr-gst-01\hgl\gis\portland_harbor_DT2020\SIB\PDI_ER\Figure 3-6_Spatial Distribution of Tidally Averaged VHG.mxd 11/13/2023

Tidally Averaged Vertical Hydraulic Gradient (cm per meter):

Tidally averaged vertical hydraulic gradients (VHGs) were measured using DPZs. The highest VHGs were generally observed at stations near the mouth of the basin and the head of the basin, with lower to moderate gradients otherwise observed in the central and southeastern portions of SIB. Porewater upwelling assessment resulted in SIB-wide mapping of porewater upwelling locations, measurements of pressure gradients that drive porewater migration, and the resulting porewater velocities and flow rates at those specific locations. Volumetric flowrates, combined with porewater concentrations estimated from bulk sediment concentrations and partitioning coefficients, will be used to calculate mass flux. This calculation will be used to evaluate the effectiveness of a cap to prevent breakthrough of COCs through a chemical isolation layer of the cap, which will be applied to subsequent location-specific cap design.
