**BATHYMETRIC SURVEY SUMMARY REPORT  
REVISION 1**

**REMEDIAL DESIGN SERVICES  
SWAN ISLAND BASIN PROJECT AREA  
CERCLA DOCKET No. 10-2021-001**

**PORTLAND HARBOR SUPERFUND SITE  
PORTLAND, MULTNOMAH COUNTY, OREGON**

**June 2023**

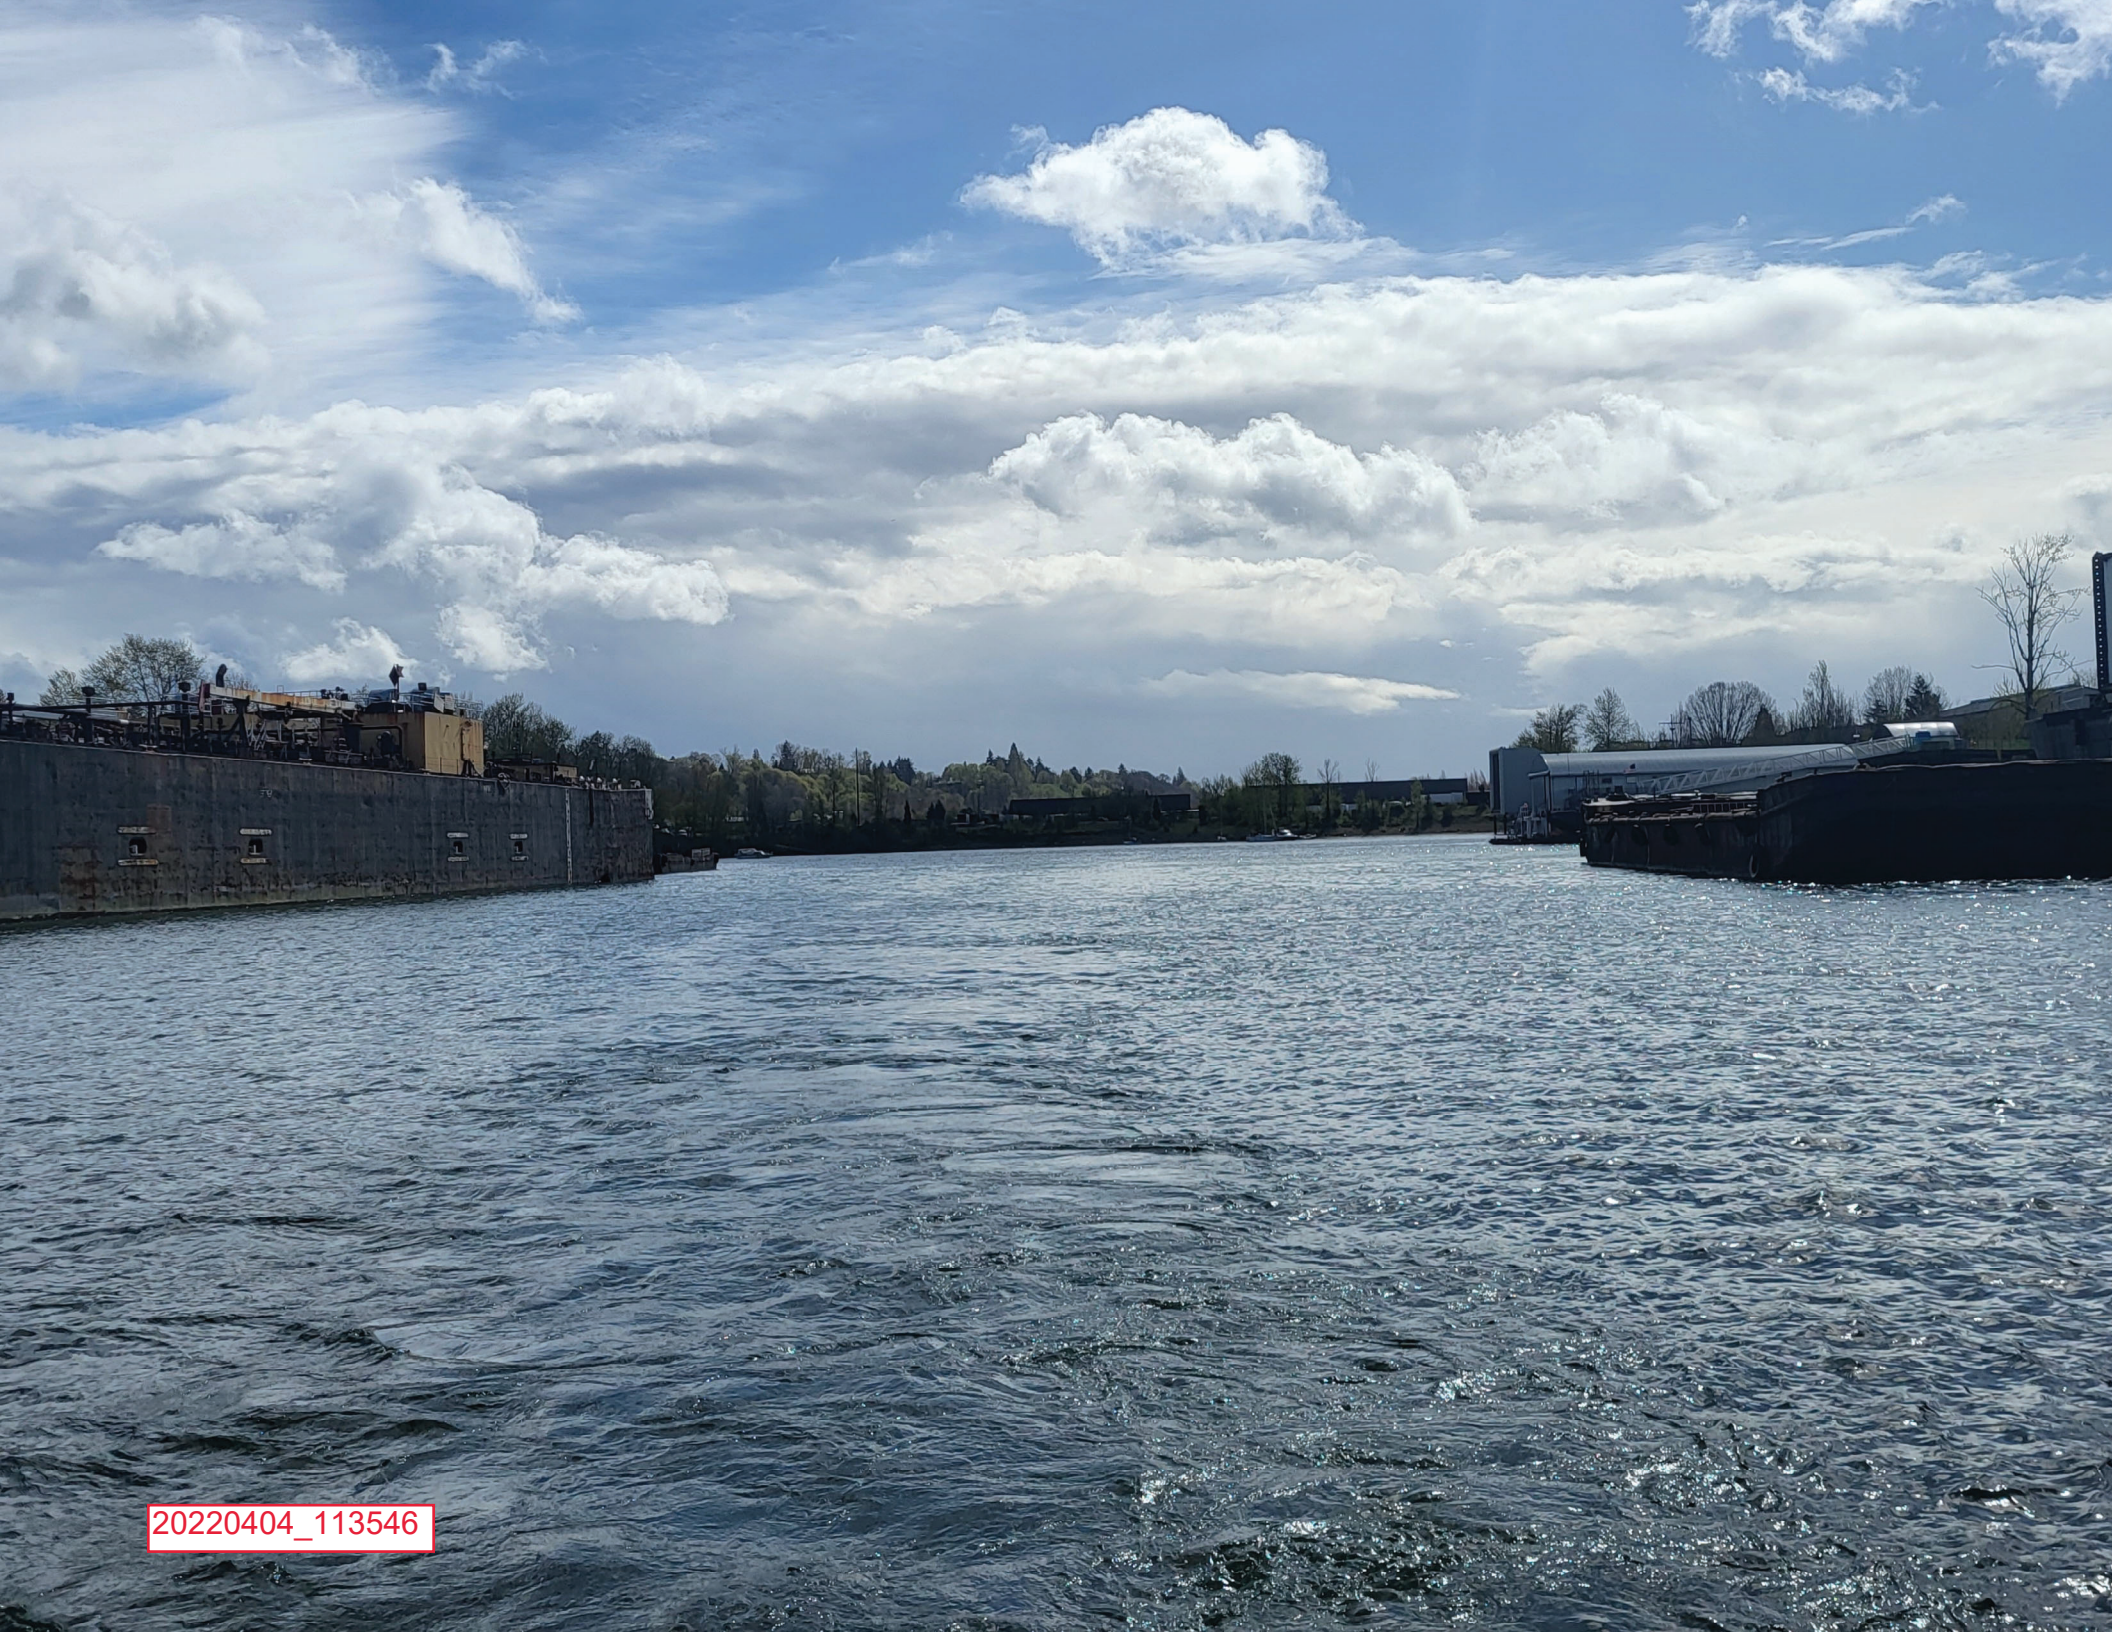
20220404\_113546

Photo Number (assigned by camera, or 1, 2..etc. but it then needs to be in the filename)	Taken By (initials)	Description	Direction	Date	Time	GPS Coordinates	
						Lat	Long
20220404_113533	CRG	Ships in the Survey Area	W	4/4/2022	1135	45 deg 33' 52.80" N	45 deg 33' 52.80" N
20220404_113546	CRG	Swan Island Basin Overview	S	4/4/2022	1135	45 deg 33' 52.80" N	122 deg 42' 44.34" W
20220404_113627	CRG	Barges and Ships within Survey Limits	NE	4/4/2022	1136	45 deg 33' 54.37" N	122 deg 42' 47.38" W
20220405_080627	CRG	Barges in Survey Area	NE	4/5/2022	0806	45 deg 33' 11.43" N	122 deg 43' 49.24" W
20220405_080652	CRG	Barges in Survey Area	N	4/5/2022	0807	45 deg 33' 11.43" N	122 deg 43' 49.24" W
20220405_092049	CRG	Piles and Deadhead in Northern Survey Area Shoreline	NW	4/5/2022	0921	45 deg 34' 14.23" N	122 deg 43' 21.13" W
20220406_082050	CRG	Ship Being Removed from Vigor Dry-Dock	E	4/6/2022	0820	45 deg 37' 11.59" N	122 deg 48' 18.67" W

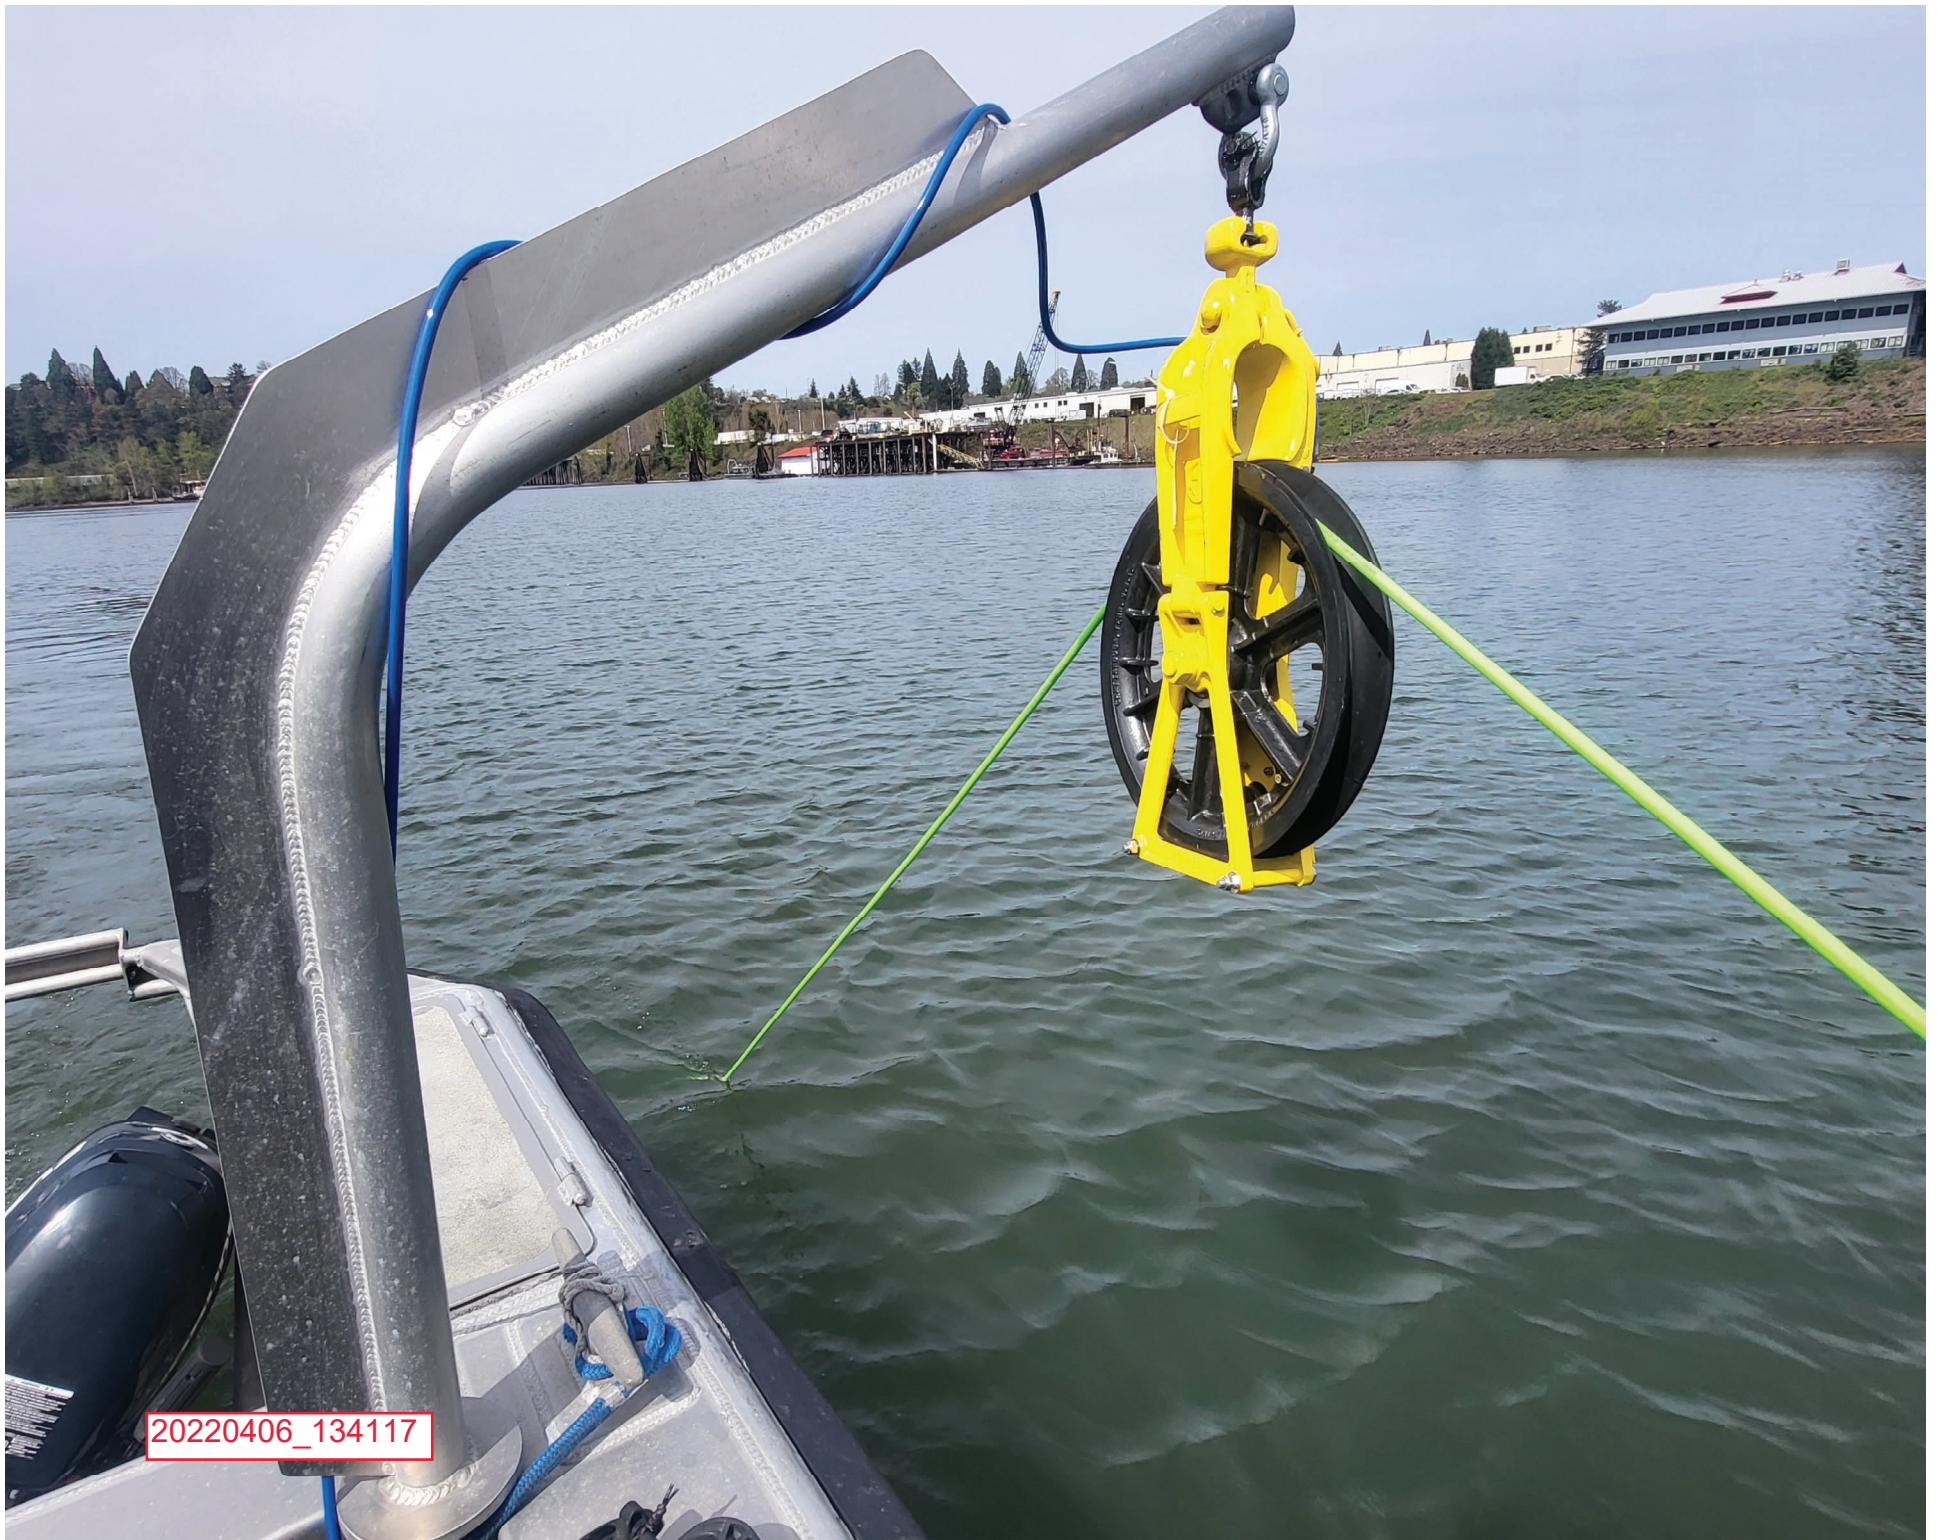
20220406\_134117

20220406_134117	CRG	Magnetometer Towing Operations	NE	4/6/2022	1341	45 deg 34' 00.29" N	122 deg 43' 00.06" W
20220406_173141	CRG	Rtk Daily Control "Check Out" Observation	E	4/6/2022	1731	45 deg 37' 10.58" N	122 deg 48' 18.63" W
20220406_082050	CRG	Ship Being Removed from Vigor Dry-Dock	E	4/6/2022	0820	45 deg 37' 11.59" N	122 deg 48' 18.67" W
20220406_134117	CRG	Magnetometer Towing Operations	NE	4/6/2022	0:00	45 deg 34' 00.29" N	122 deg 43' 00.06" W
20220406_173141	CRG	Rtk Daily Control "Check Out" Observation	E	4/6/2022	0:00	45 deg 37' 10.58" N	122 deg 48' 18.63" W
20220407_102151	CRG	Control Work on Ngs Benchmark "Wall 1961"	W	4/7/2022	0:00	45 deg 34' 30.83" N	122 deg 42' 49.39" W
20220407_141457	CRG	Mobile Lidar Scanning	W	4/7/2022	0:00	45 deg 35' 26.79" N	122 deg 45' 19.13" W
20220407_142332	CRG	Ship Entering Vigor Dry Dock	W	4/7/2022	0:00	45 deg 35' 26.79" N	122 deg 45' 19.13" W

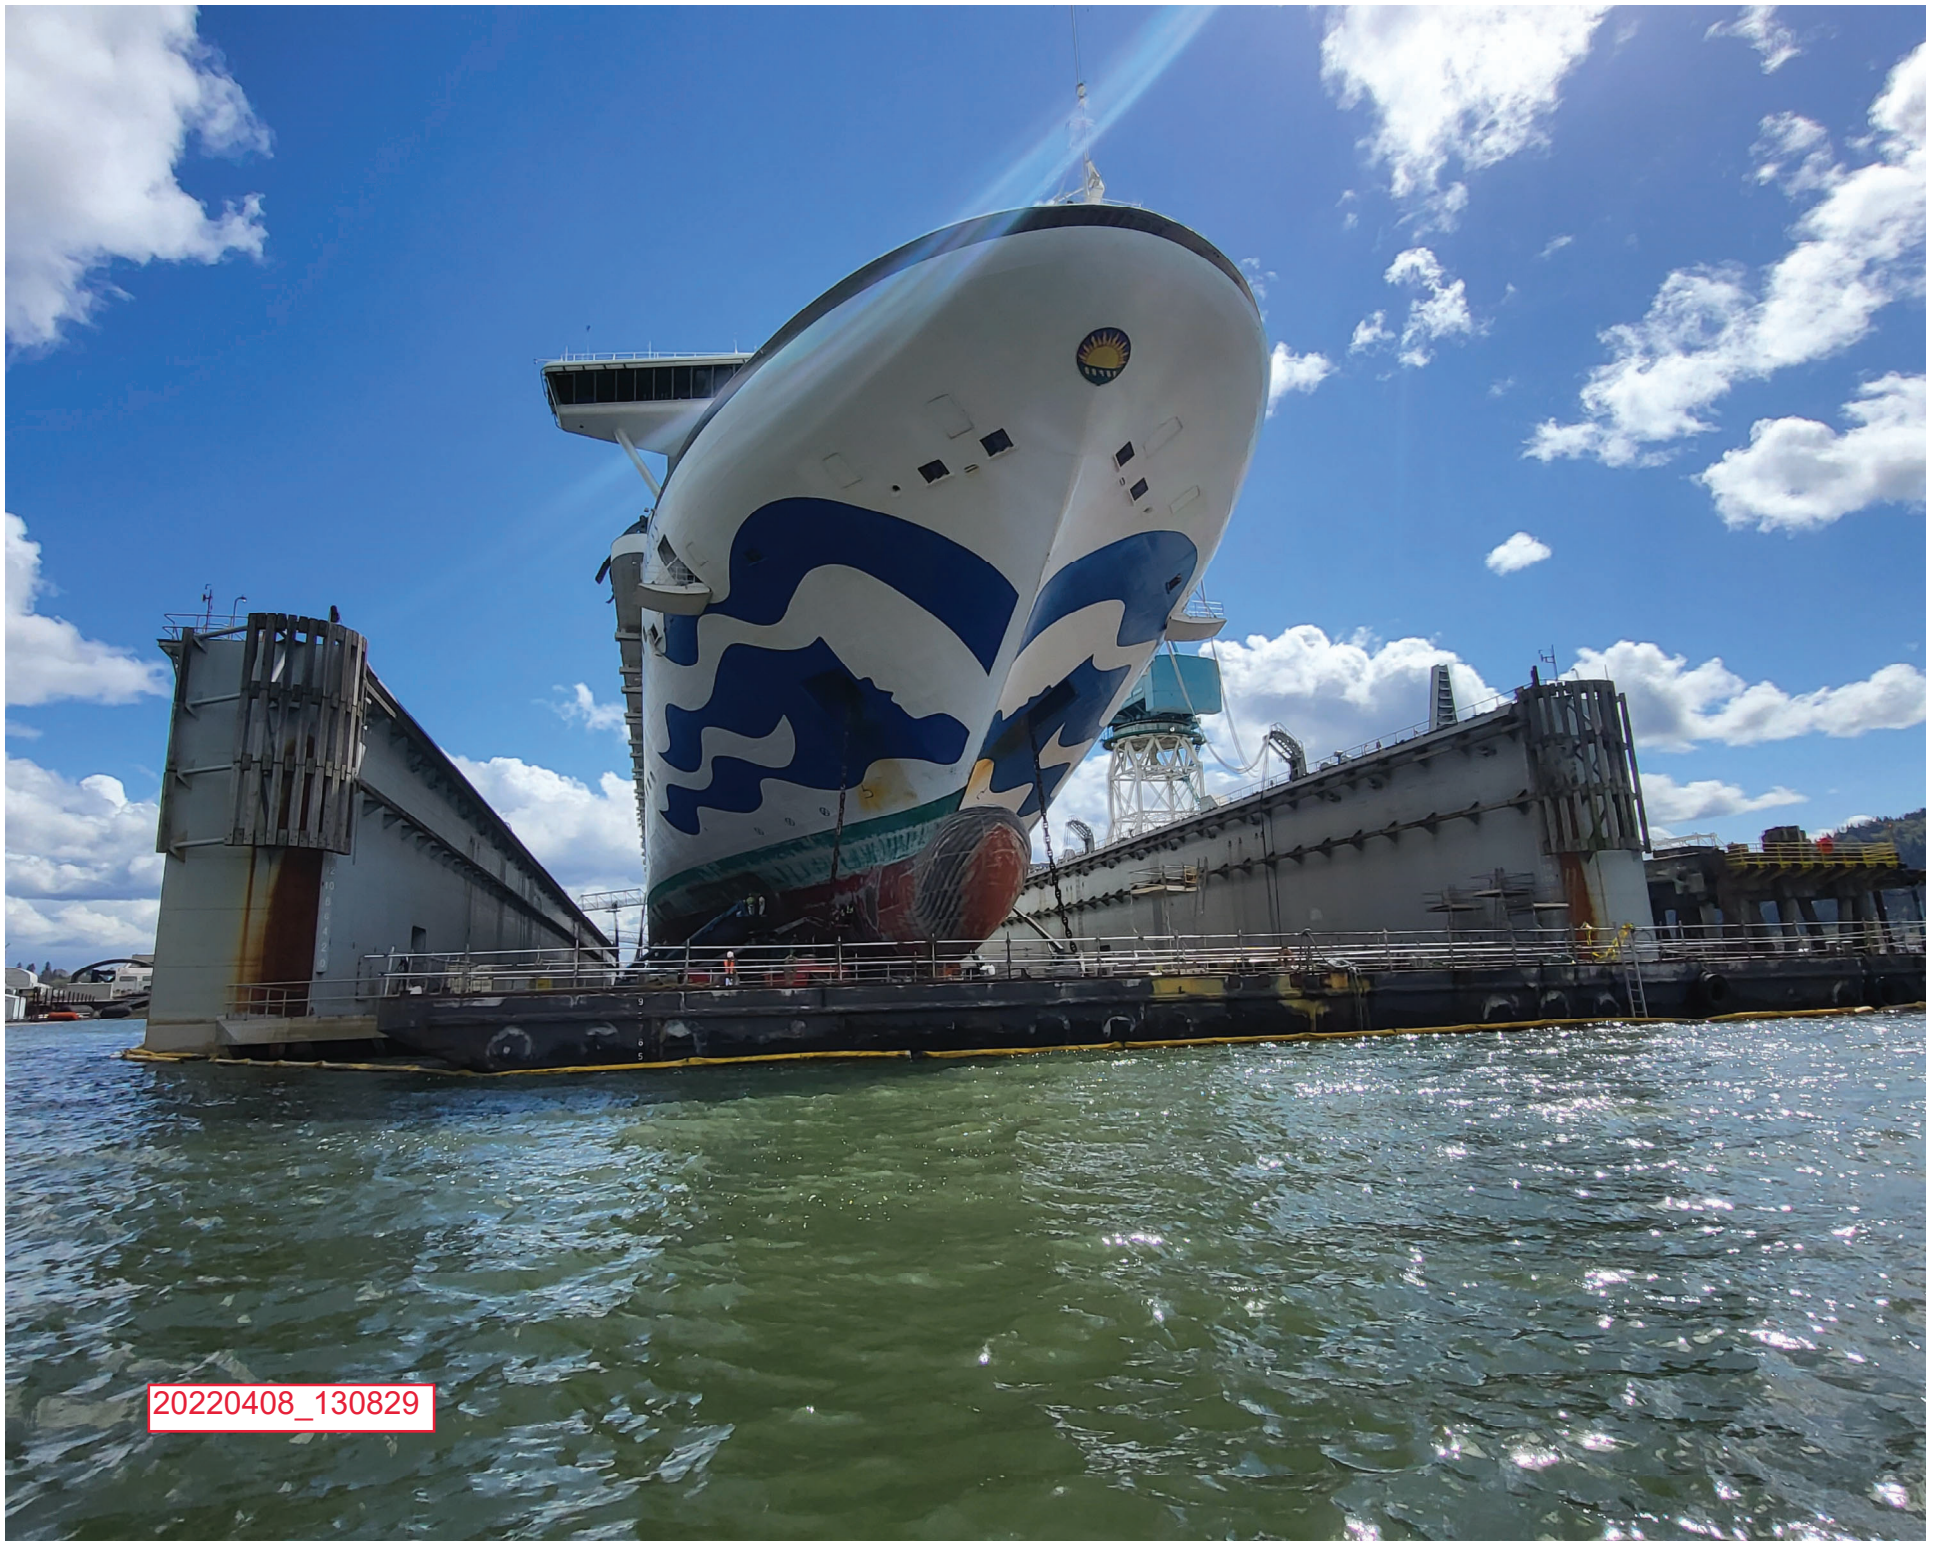
20220408\_130829

20220408_130829	CRG	Front Of Vigor Dry Dock with Large Ship	S	4/8/2022	1308	45 deg 34' 08.61" N	122 deg 43' 56.34" W
20220408_151605	CRG	Transient Sailboats within Swan Basin	SW	4/8/2022	1516	45 deg 33' 44.71" N	122 deg 42' 31.77" W
