**STRUCTURE CONDITION ASSESSMENT REPORT
REVISION 0**

**REMEDIAL DESIGN SERVICES
SWAN ISLAND BASIN PROJECT AREA
CERCLA Docket No. 10-2021-001**

**PORTLAND HARBOR SUPERFUND SITE
PORTLAND, MULTNOMAH COUNTY, OREGON**

November 2023

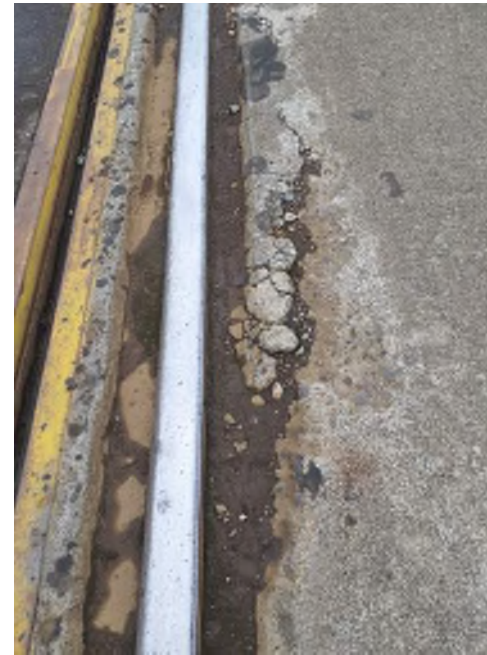
Photo 02: Pier D Superstructure
Bent 50 between Piles E and G
Concrete spalls around crane rail
Moata ID: 73693

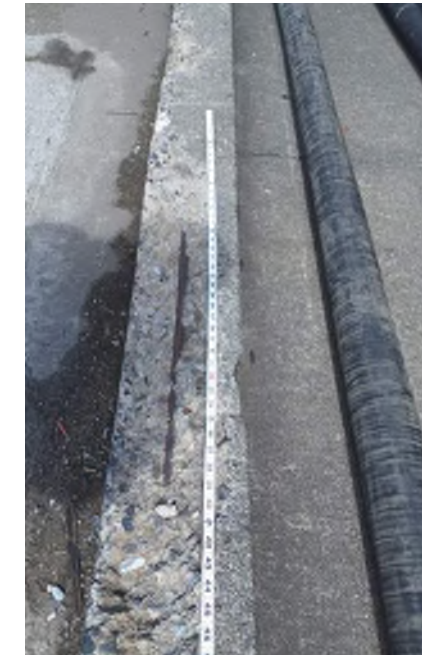
Photo 03: Pier D Superstructure
Bullrail between Bents 22 and 23
Concrete spall exposing reinforcement
Moata ID: 73720

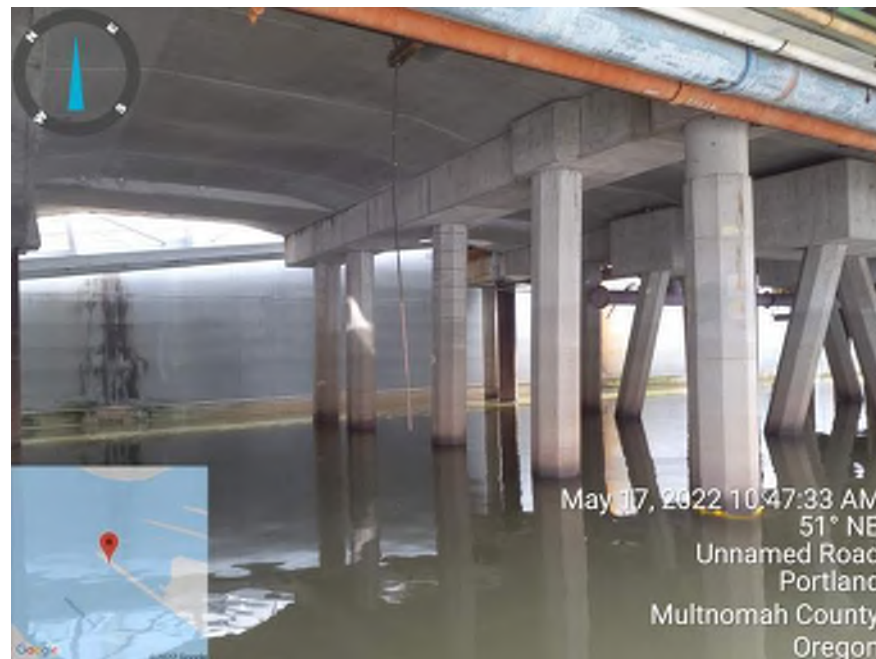
Photo 04: Pier D Substructure
Substructure between Bents 13 and 14
Typical condition of substructure above water
Moata ID: Not Applicable

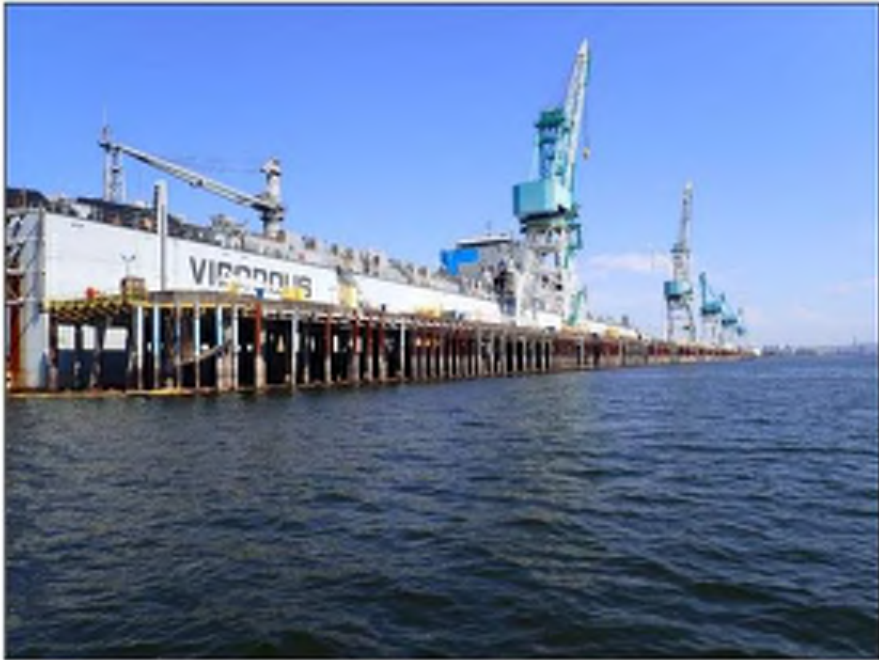
Photo 01: Pier D overview,
Pier D, looking North

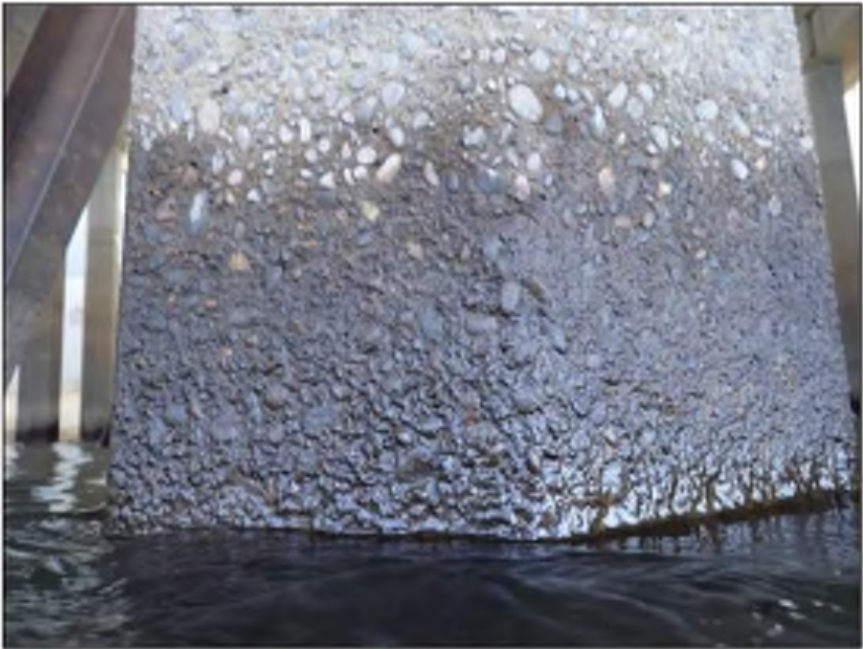
Photo 02: Pier D Substructure
Typical condition of concrete piles at waterline

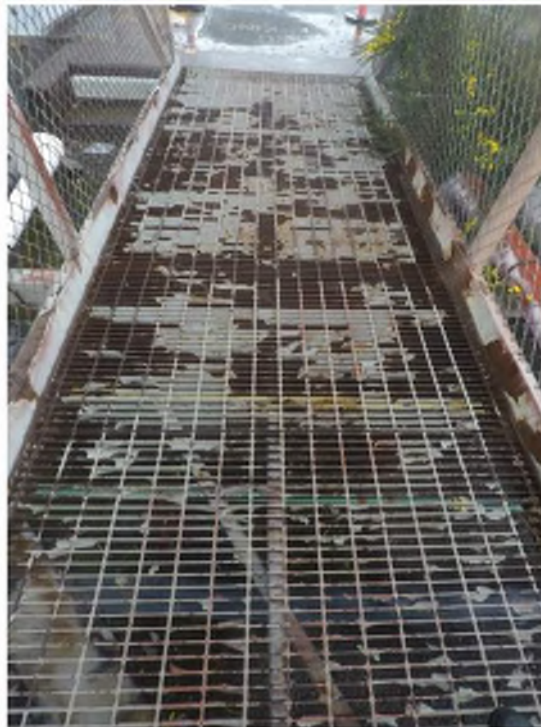
Photo 03: East Pier Superstructure
Steel Grate Between Pier End to Bent 1
Typical condition of steel grate (minor corrosion)
Moata ID: Not Applicable

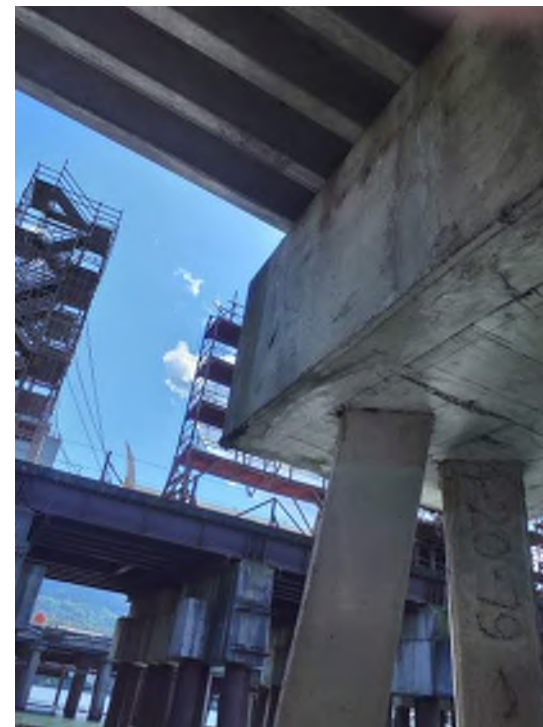
Photo 04: East Pier Superstructure
Pile Cap between Bents 2 and 3
Concrete spall on the bottom of the pile cap
Moata ID: 74982

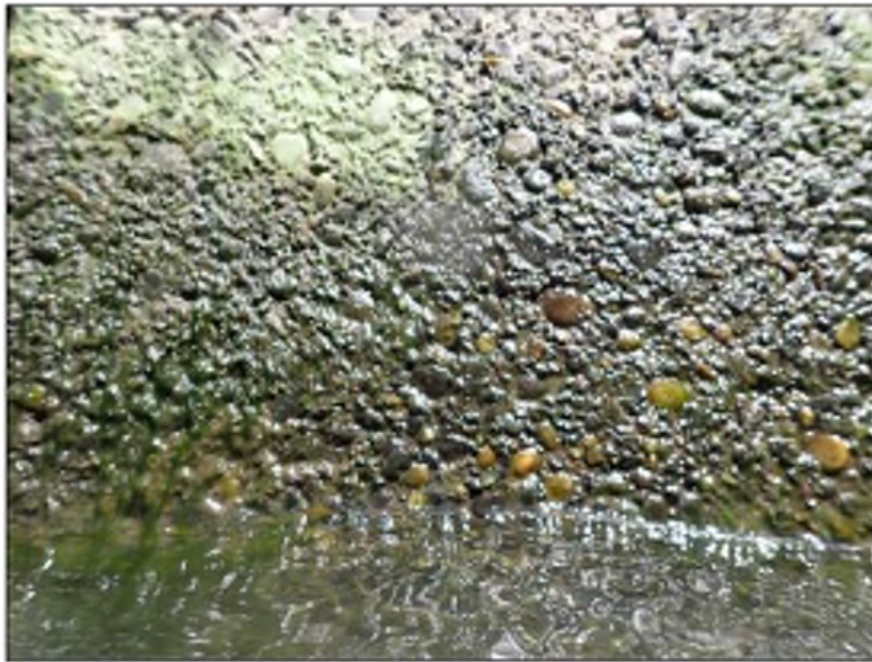
Photo 01: East, West, and Demo Piers Substructure
Typical condition of concrete bearing piles at waterline

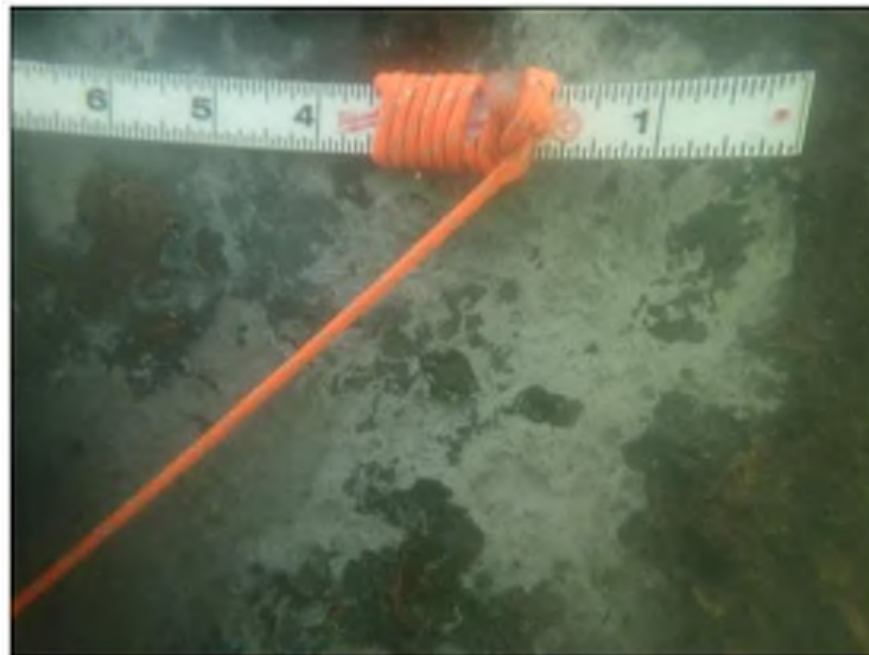
Photo 03: East, West, and Demo Piers Substructure
Typical cleaned surface of steel piles at mid-depth

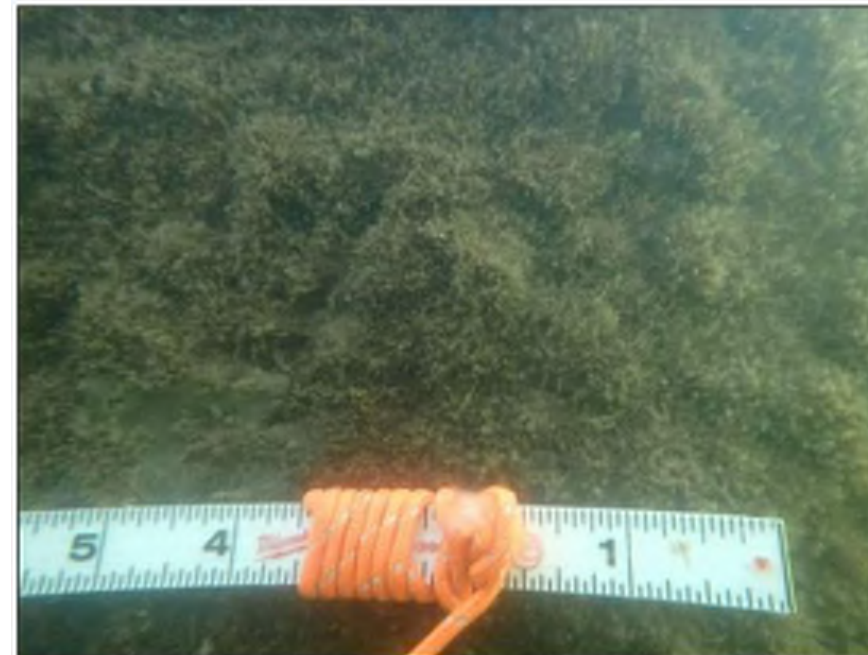
Photo 04: East, West, and Demo Piers Substructure
Typical condition of steel piles at mid-depth

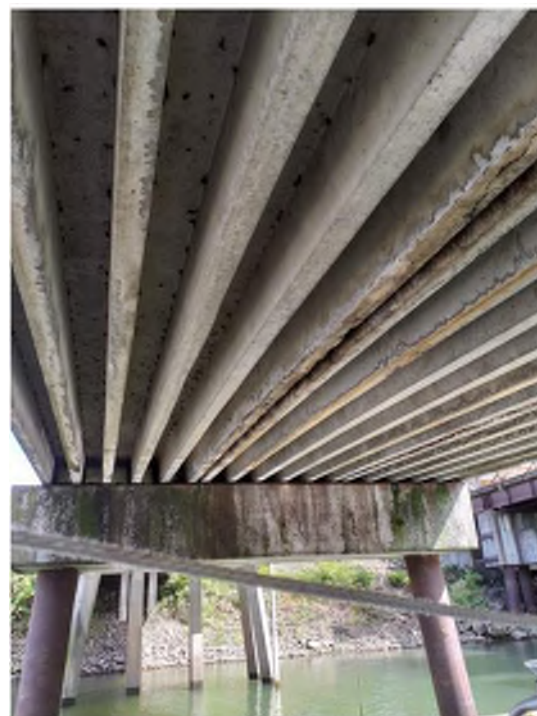
Photo 03: West Pier Substructure
Concrete Girders between Bent 3 to Bent 4
Concrete spalls exposing reinforcement due to corrosion
Moata ID: 74980

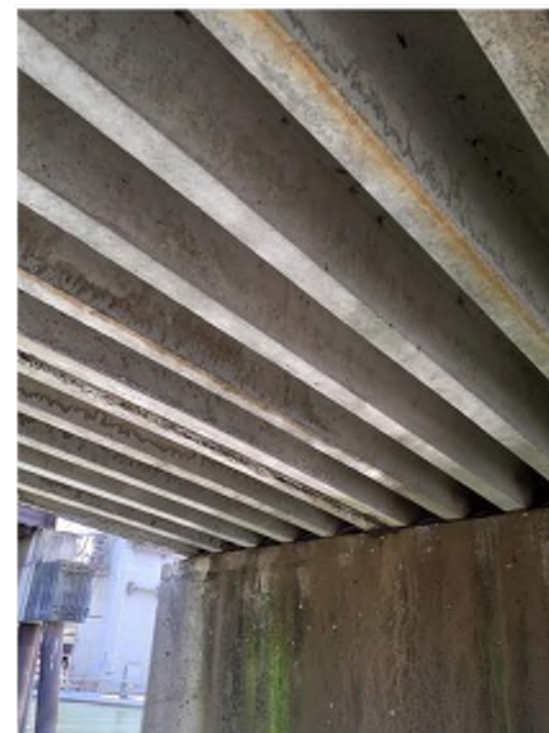
Photo 04: West Pier Substructure
Concrete Girders between Bent 3 to Bent 4
Concrete spalls exposing reinforcement due to corrosion
Moata ID: 74980

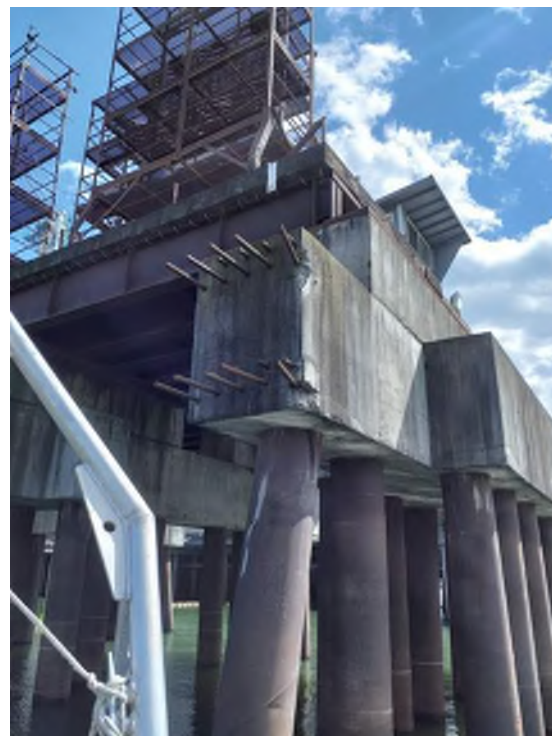
Photo 03: Demo Pier Substructure
Pile Cap at Bents 7 Pile J
Impact spalls at corner of the pile cap
Moata ID: 74979

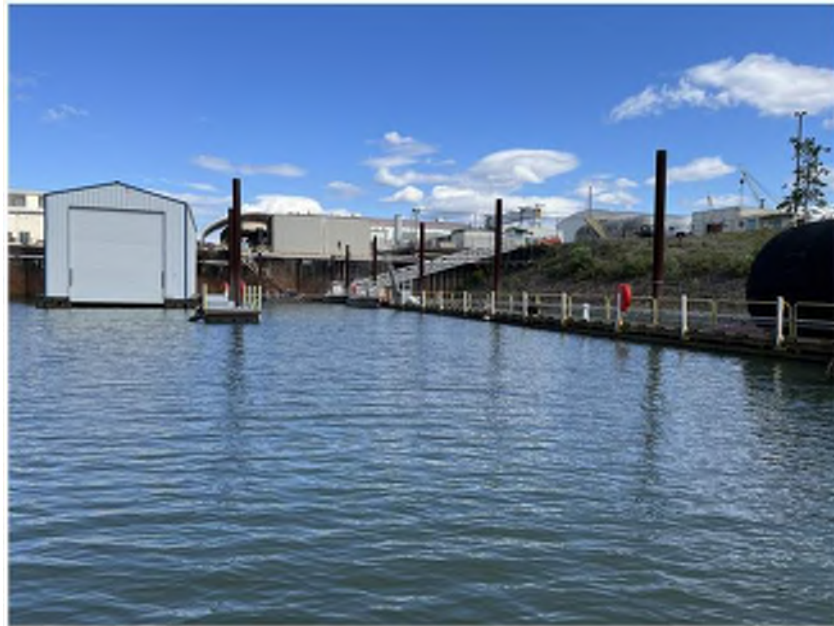
Photo 01: Ship Commerce Center Floating Dock Overview
Ship Commerce Center Floating Dock, Looking East
Moata ID: Not Applicable

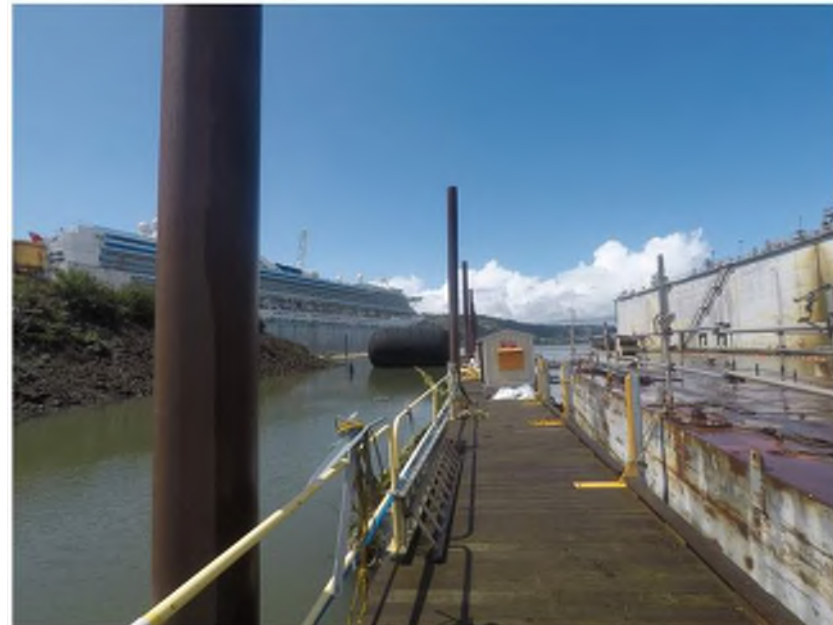
Photo 02: Ship Commerce Center Floating Dock Floats
Float docking
Typical condition of the float docking
Moata ID: Not Applicable

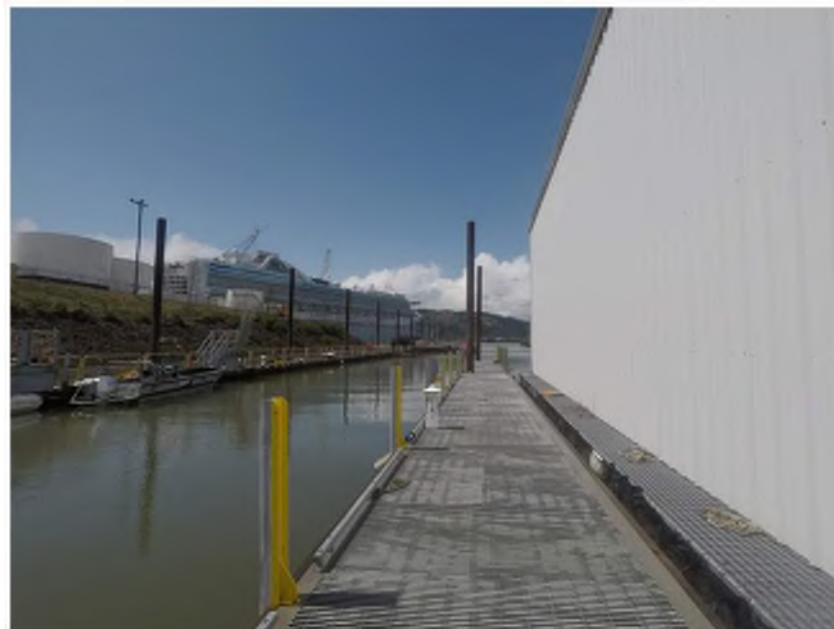
Photo 03: Ship Commerce Center Floating Dock Floats
Steel Grate
Typical condition of steel grating
Moata ID: Not Applicable

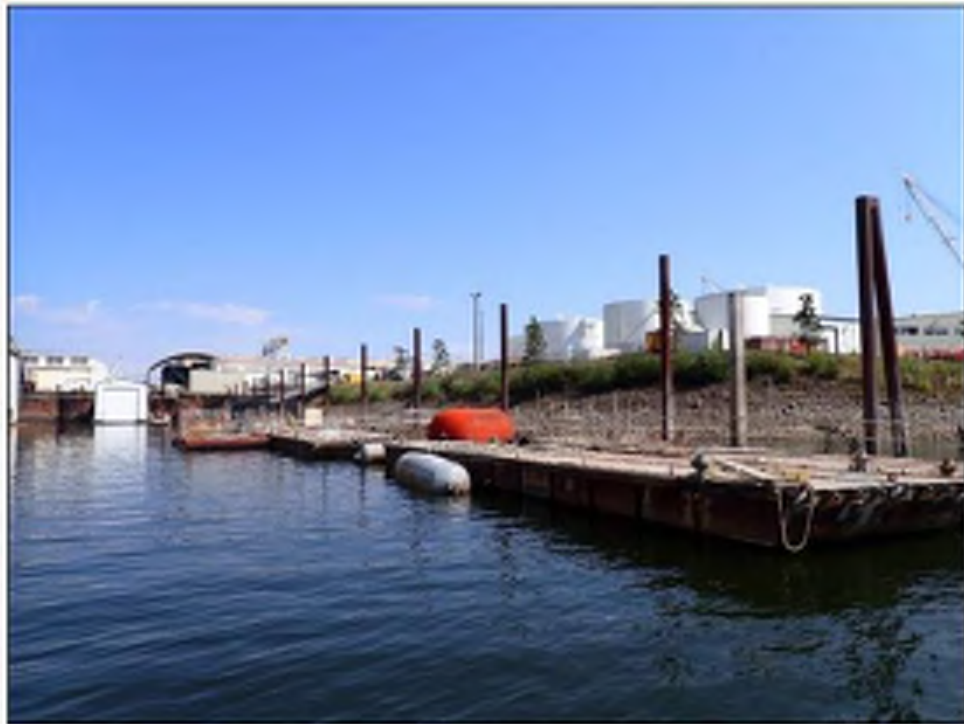
Photo 01: Ship Commerce Center Floating Dock Overview
Ship Commerce Center Floating Dock, looking east

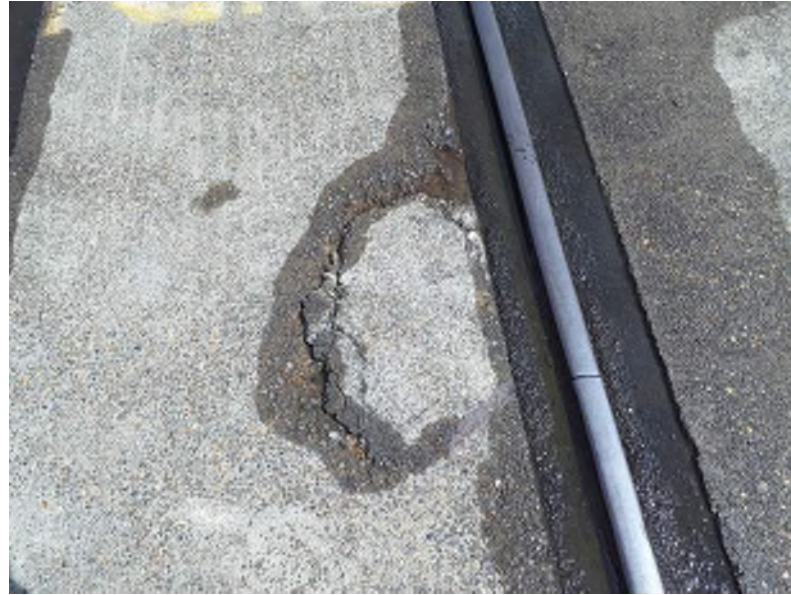
Photo 01: Pier C Superstructure
Concrete Deck Between Bents 45 and 46
Concrete closed spall on the top of the deck
Moata ID: 73677

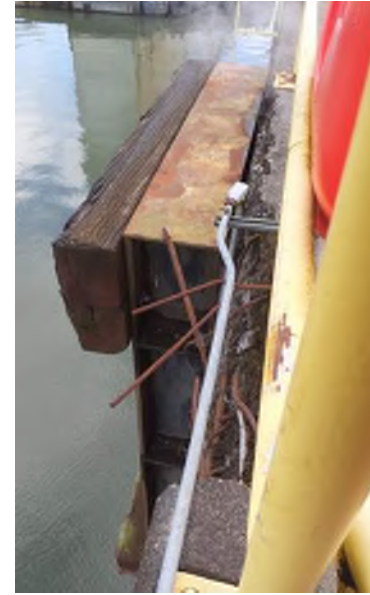
Photo 02: Pier C Superstructure
Concrete Bullrail Between Bents 25 and 26
Concrete open spall exposing reinforcement
Moata ID: 73679

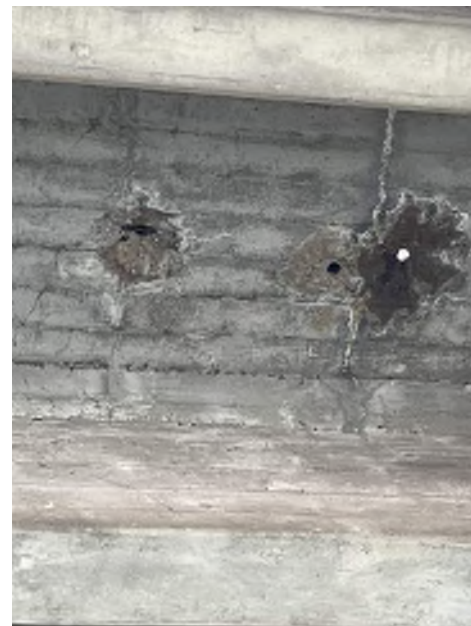
Photo 04: Pier C Superstructure
Underside of Concrete Deck Between Bents 4 and 5
Concrete open spall exposing reinforcement
Moata ID: 75112

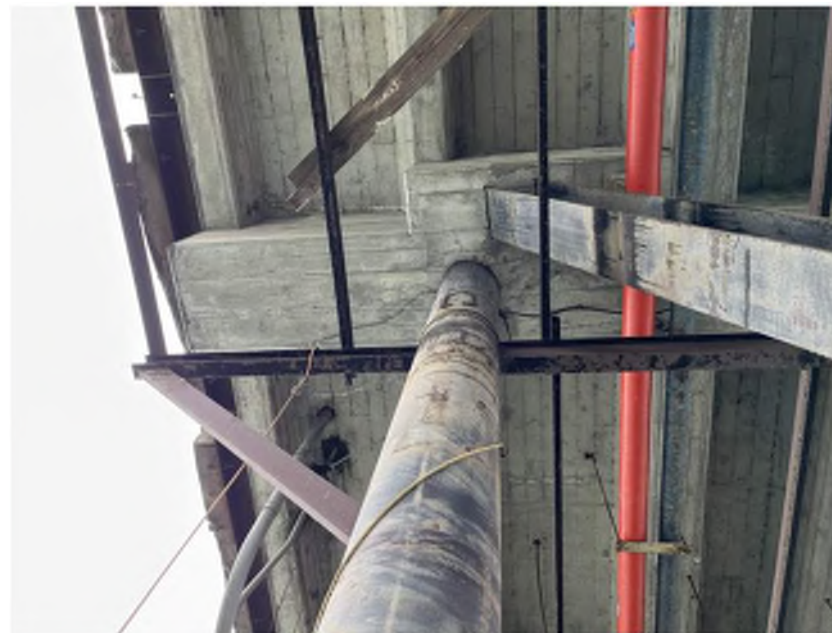
Photo 05: Pier C Superstructure
Concrete Pile Cap at Pile C Bent 40
Concrete closed spall on the bottom of the pile cap
Moata ID: 75133

73682	40 to 41	N/A	Pier / Wharf	Mooring	Cleat / Bollard	Steel	Severe (SV)	One of the mooring hardware is missing.
73683	40 to 41	N/A	Pier / Wharf	Mooring	Cleat / Bollard	Steel	Severe (SV)	Same as 73682
75133	40	C	Pier / Wharf	Substructure	Pile Cap	Reinforced Concrete	Major (MJ)	Pile cap of Pile C has 48" long x 24" wide closed spall with cracks on the bottom of the pile cap.

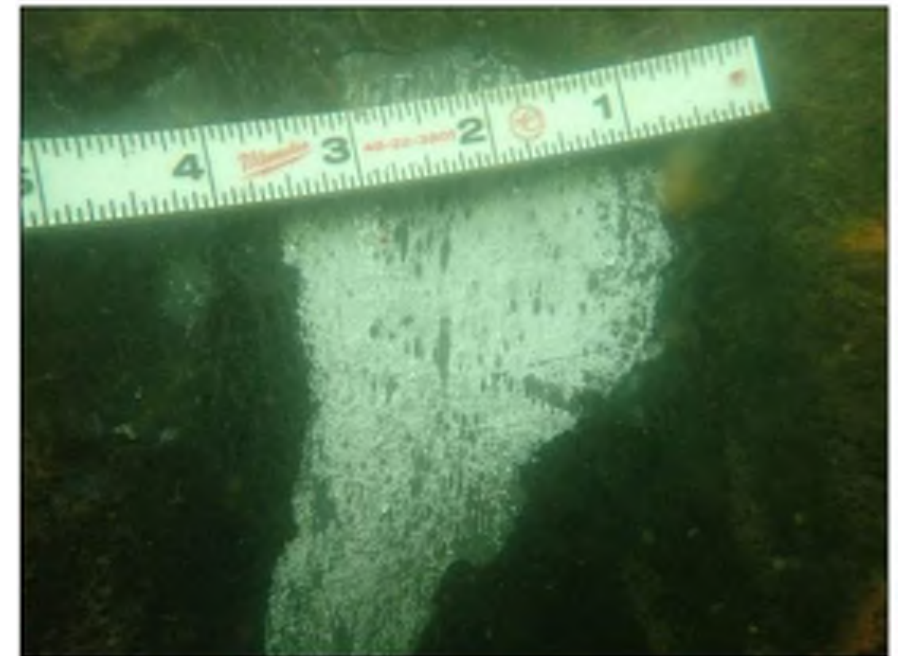
Photo 03: Pier C Substructure
Typical cleaned surface of steel piles below waterline

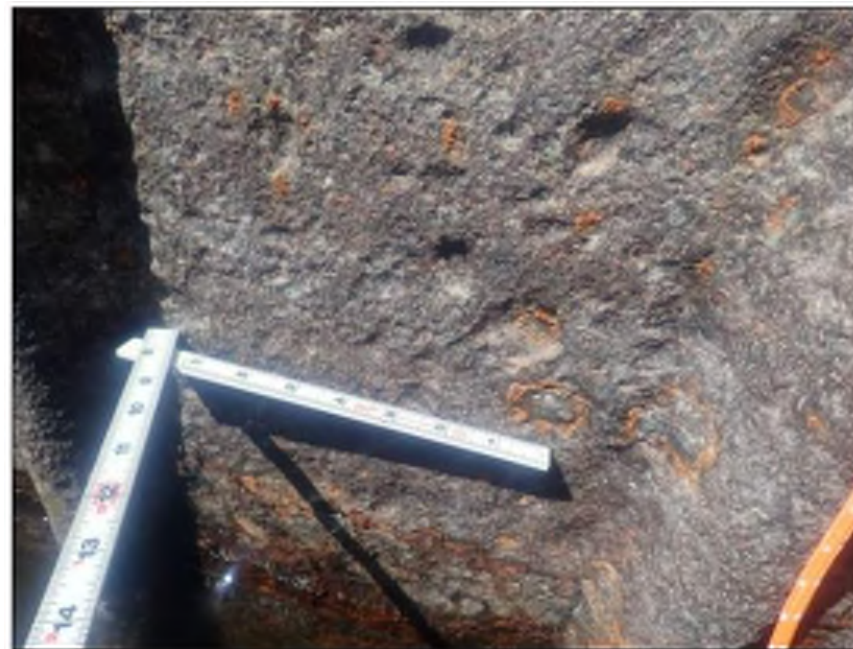
Photo 02: Pier A Substructure
Typical pitting on sheet pile cells at waterline

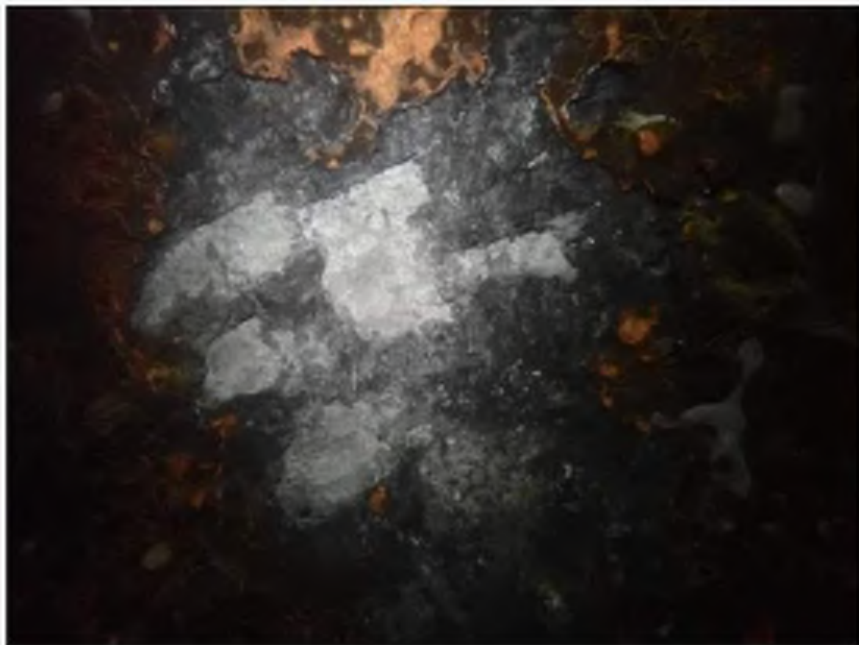
Photo 04: Pier A Substructure
Typical cleaned steel below waterline

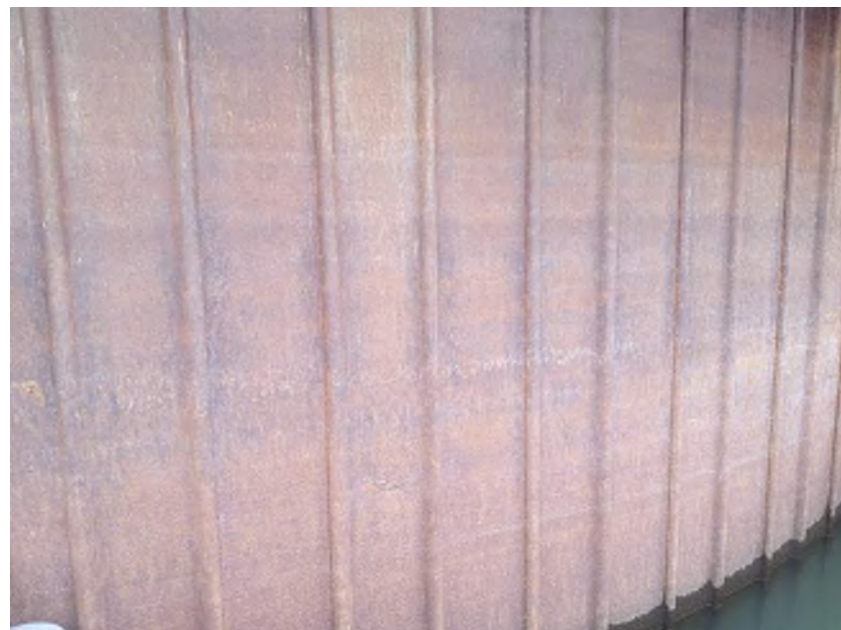
Photo 04: Quay Wall Substructure
Sheet Pile C-C
Typical condition of sheet piles above water
Moata ID: Not Applicable

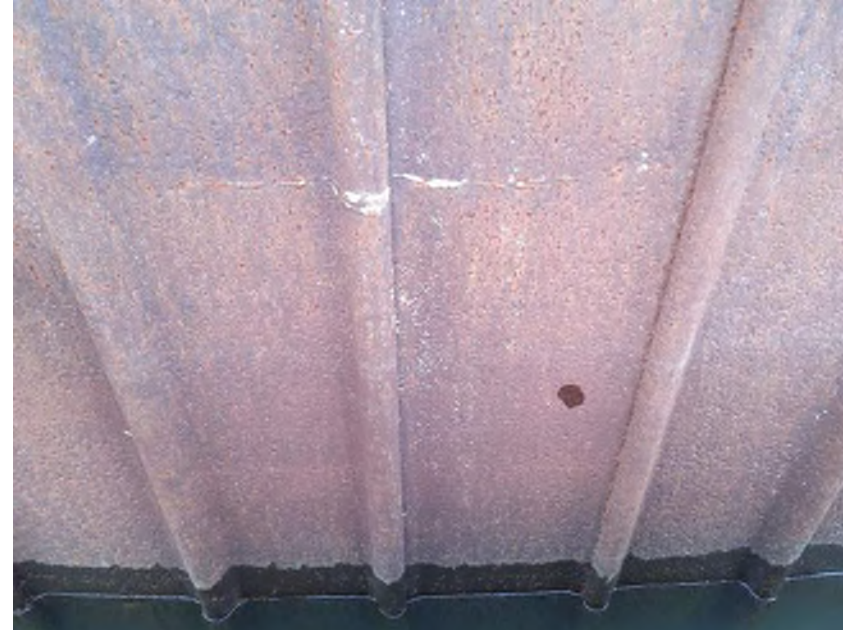
Photo 05: Quay Wall Substructure
Sheet Pile C-C
Typical condition of sheet piles above water
Moata ID: Not Applicable

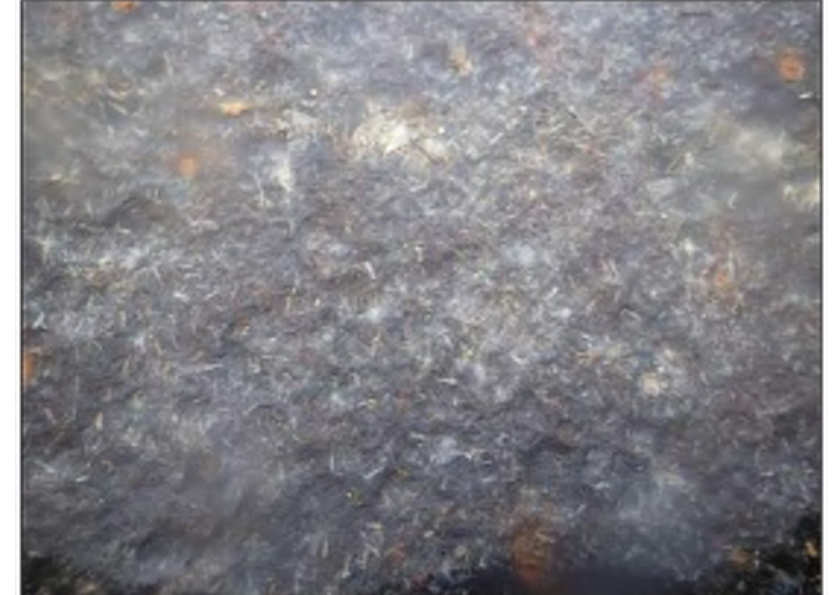
Photo 03: Quay Wall Substructure
Typical pitting on steel sheet pile cells at waterline

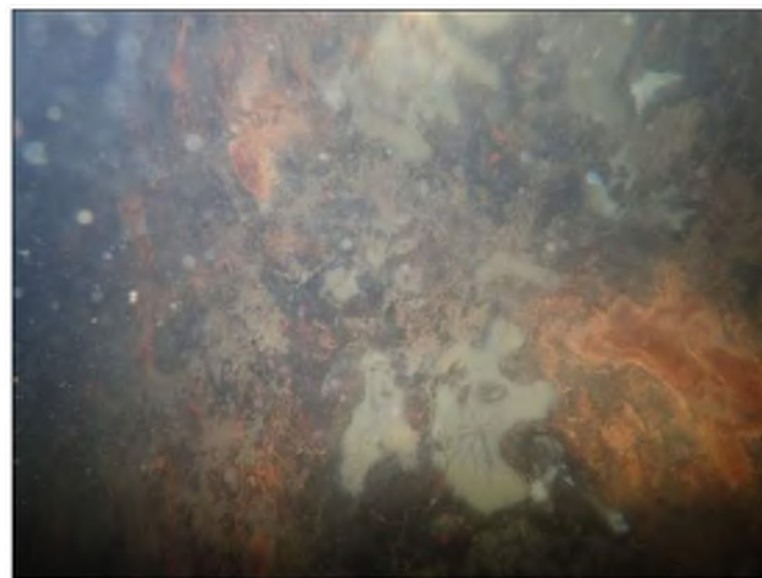
Photo 05: Quay Wall Substructure
Typical condition of steel sheet pile cells at mid-depth

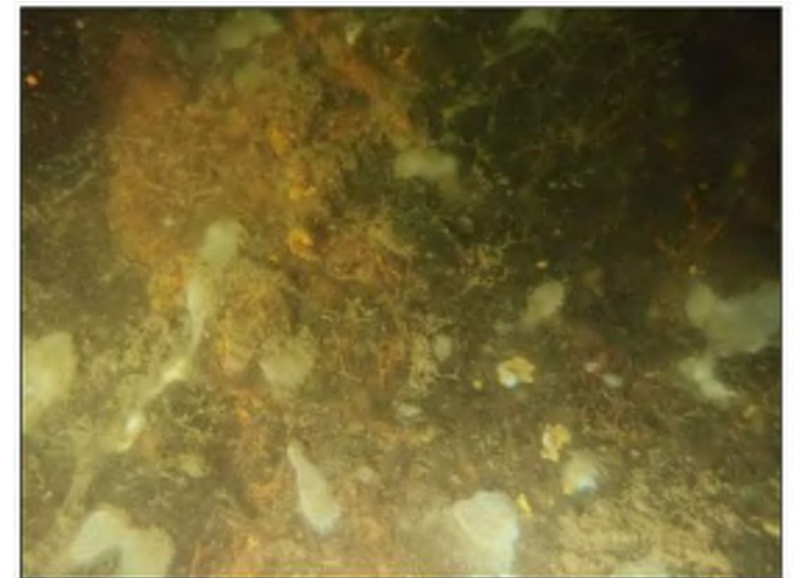
Photo 06: Quay Wall Substructure
Typical condition of steel sheet pile cells at channel bottom

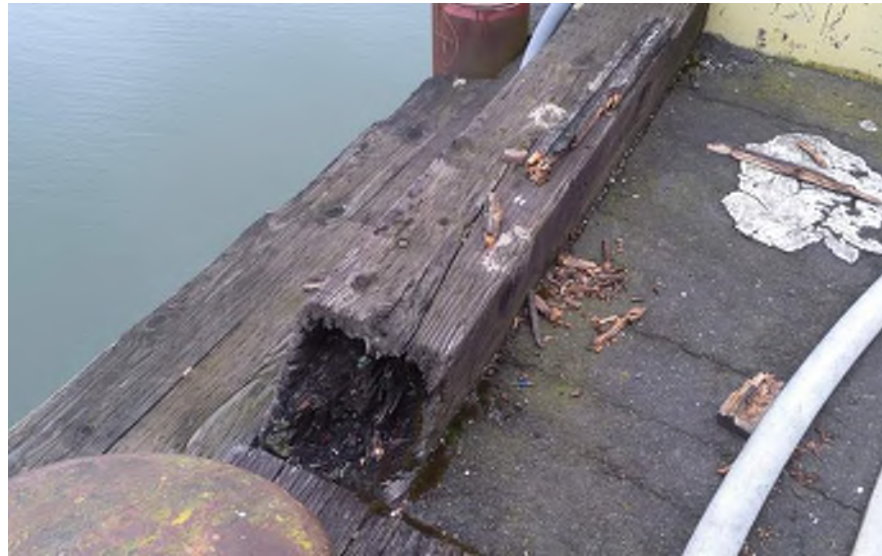
Photo 01: Lagoon Wharf Superstructure
Timber Bullrail between Bents 133 and 134
Loss of section on bullrail
Moata ID: 73540

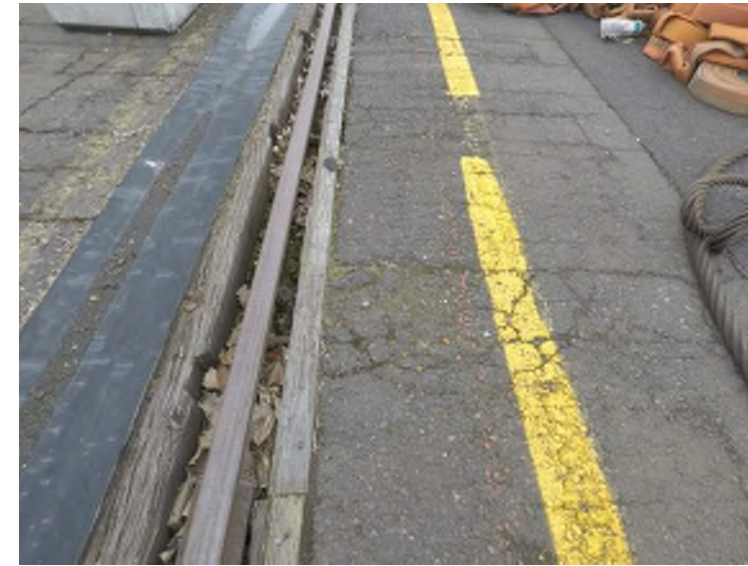
Photo 02: Lagoon Wharf Superstructure
Asphalt Pavement Overview
Typical condition of asphalt pavement
Moata ID: Not Applicable

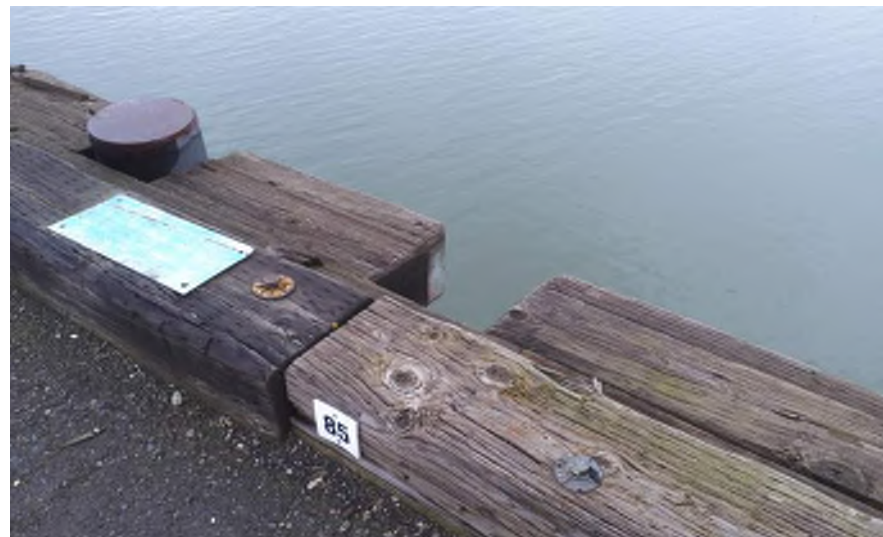
Photo 03: Lagoon Wharf Fender System
Adjacent to Bent 85
Missing fender pile
Moata ID: 73552

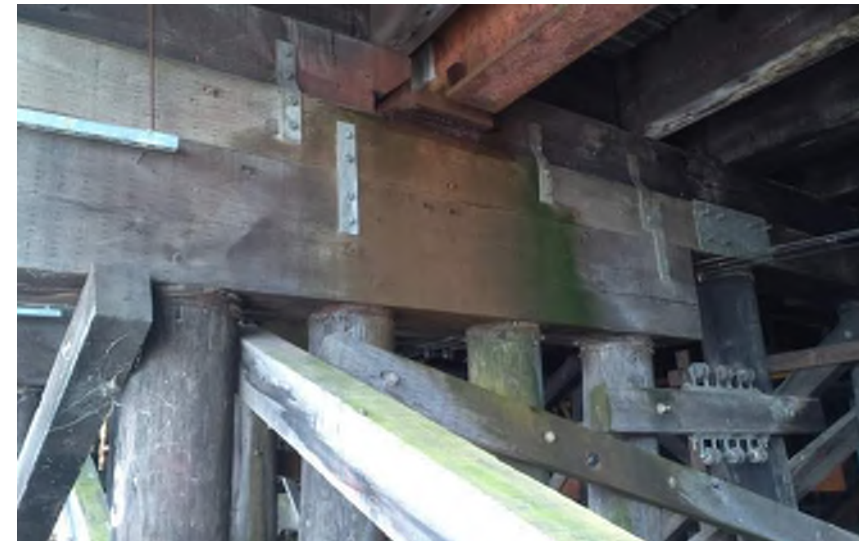
Photo 04: Lagoon Wharf Substructure
Adjacent to Bent 3
Typical condition of pile caps
Moata ID: 73586

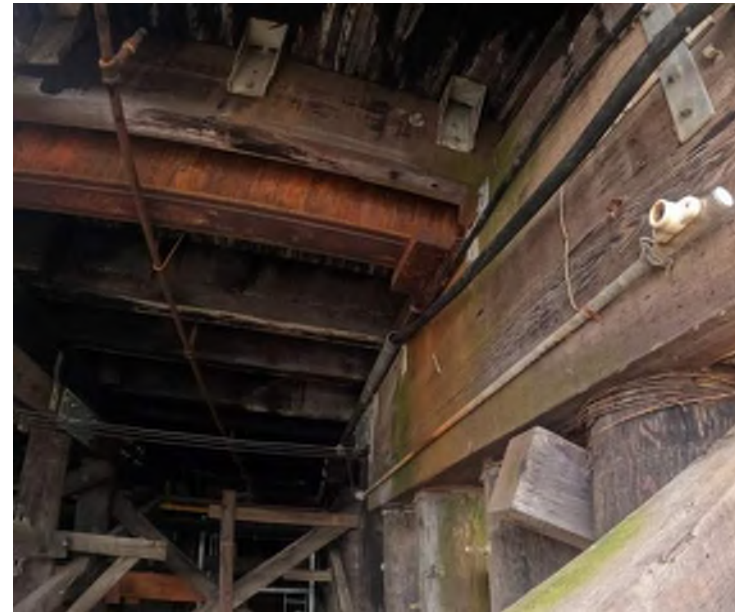
Photo 06: Lagoon Wharf Substructure
Typical condition of crane rail
Moata ID: 73587

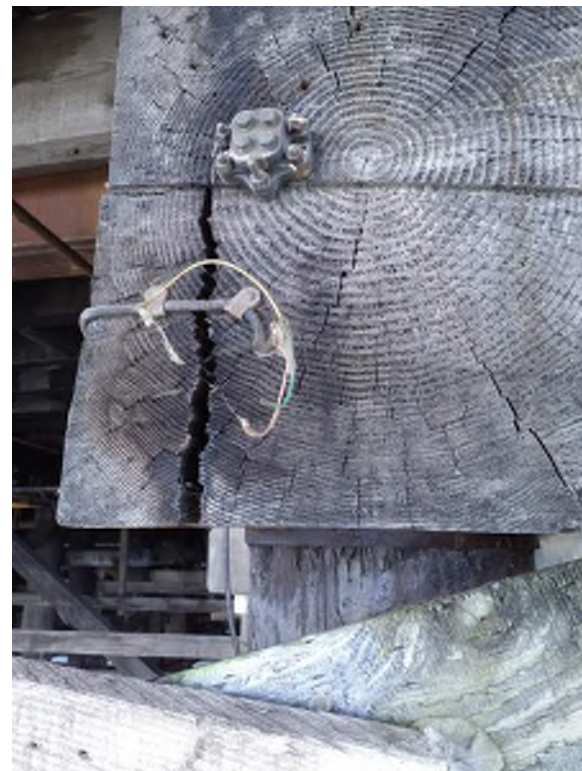
Photo 07: Lagoon Wharf Substructure
Adjacent to Bent 72
Split on the pile cap
Moata ID: 73610

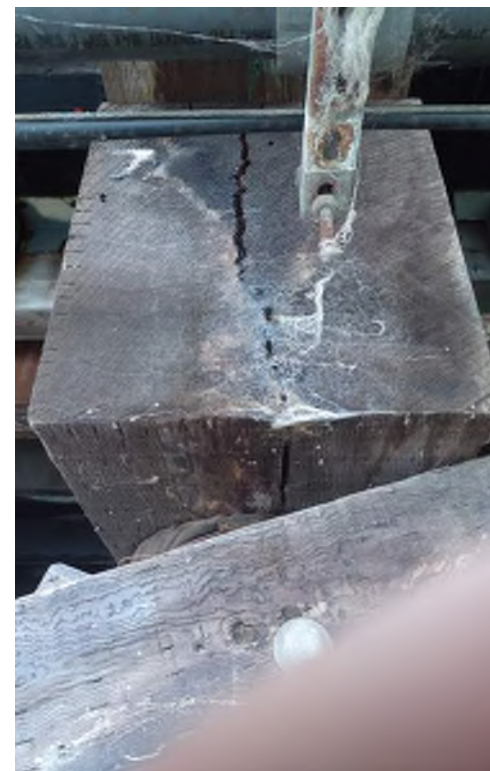
Photo 08: Lagoon Wharf Substructure
Adjacent to Bent 16
Split on the pile cap
Moata ID: 73784

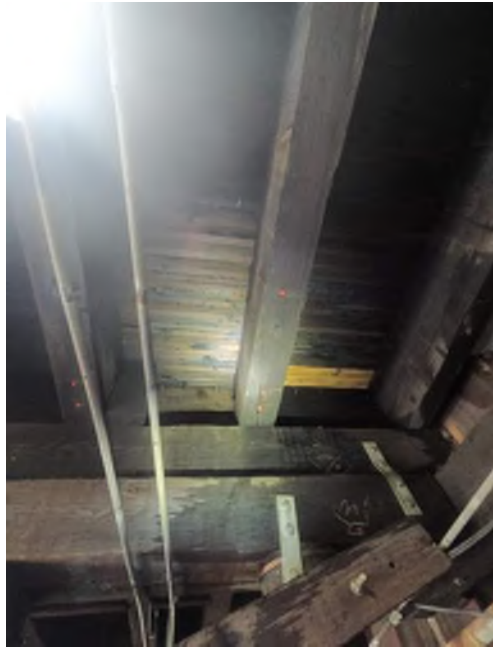
Photo 10: Lagoon Wharf Substructure
Typical condition of the deck underside
Moata ID: Not Applicable

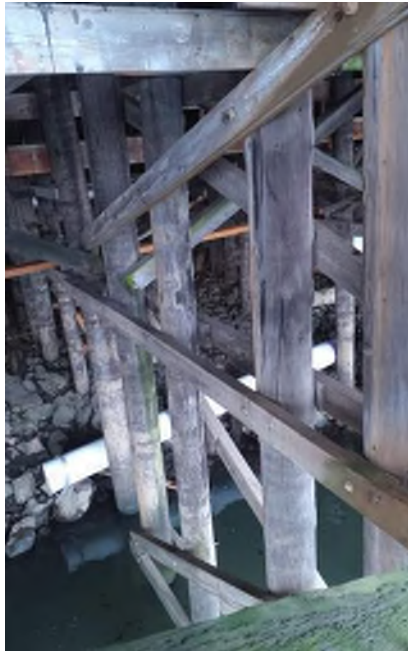
Photo 11: Lagoon Wharf Substructure
Adjacent to Bent 13
Typical condition of the piles
Moata ID: 73582

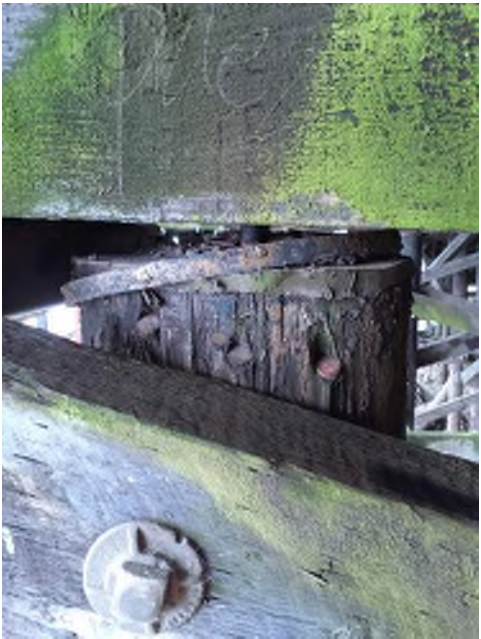
Photo 12: Lagoon Wharf Substructure
Adjacent to Bent 129
Pile fully non-bearing
Moata ID: 74274

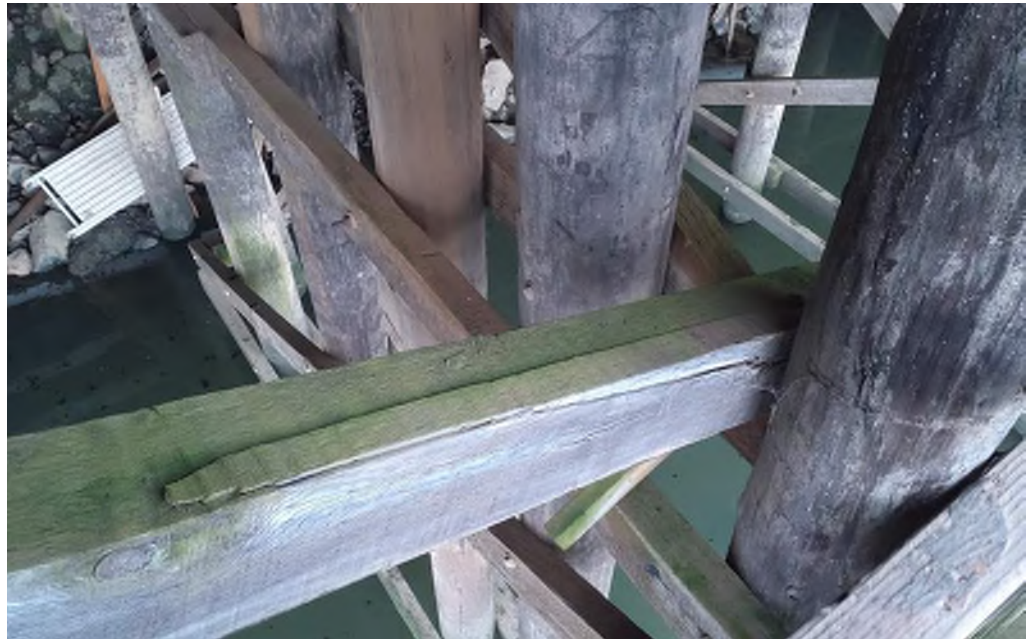
Photo 13: Lagoon Wharf Substructure
Adjacent to Bent 16
Split on the timber cross-bracing
Moata ID: 73580

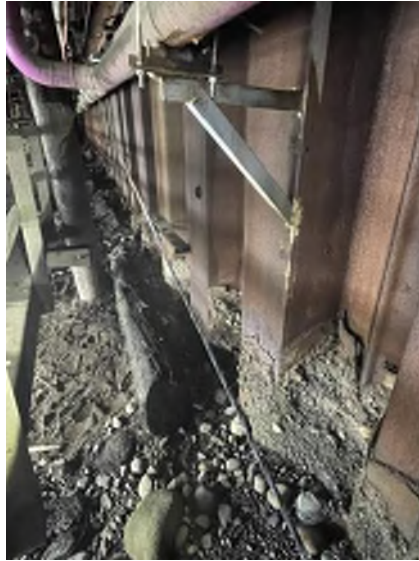
Photo 14: Lagoon Wharf Substructure
Steel Sheet Piles between Bents 59 and 67
Corroded steel sheet piles
Moata ID: Not Applicable

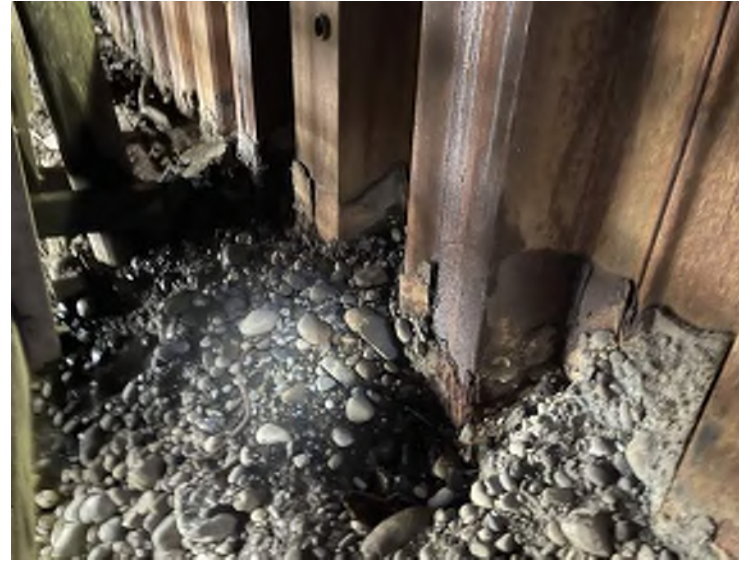
Photo 15: Lagoon Wharf Substructure
Steel Sheet Piles between Bents 52 and 58
Typical condition of at bottom of steel sheet piles
Moata ID: Not Applicable

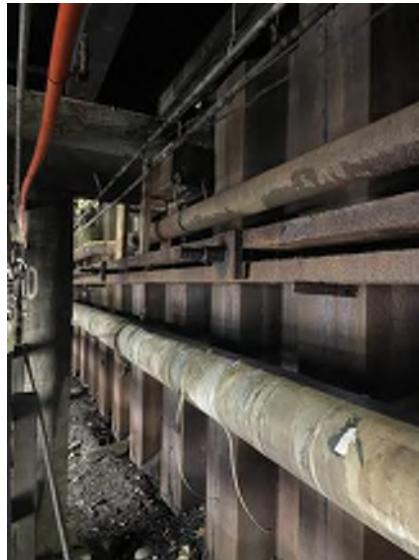
Photo 16: Lagoon Wharf Substructure
Steel Sheet Piles between Bents 85 and 92
Typical condition of walers
Moata ID: Not Applicable

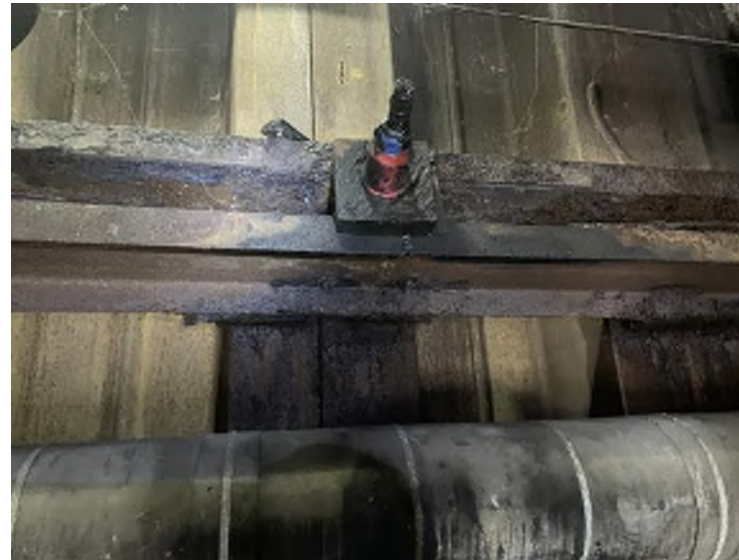
Photo 17: Lagoon Wharf Substructure
Steel Sheet Piles between Bents 77 and 84
Corroded steel waler
Moata ID: Not Applicable

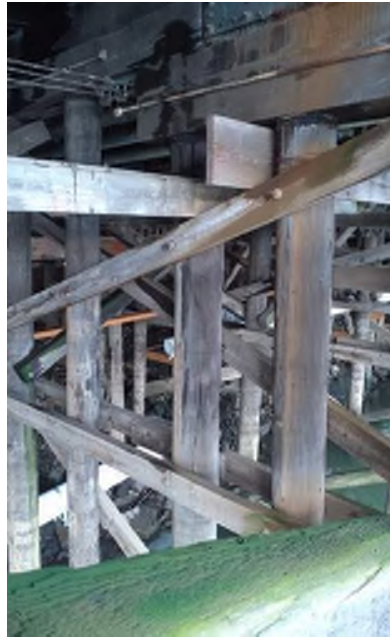
Photo 18: Lagoon Wharf Substructure
Adjacent to Bent 13
Typical condition of piles
Moata ID: 73582

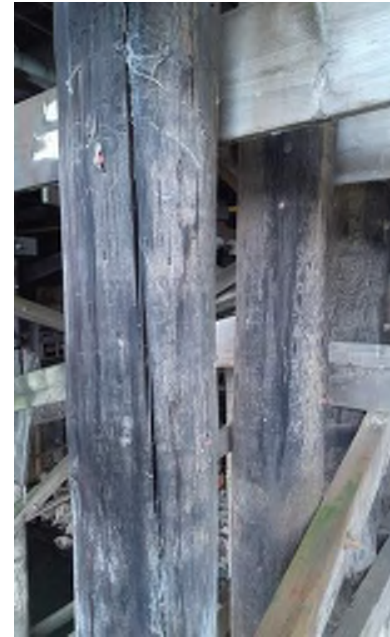
Photo 19: Lagoon Wharf Substructure
Adjacent to Bent 17
Split on the timber pile
Moata ID: 73579

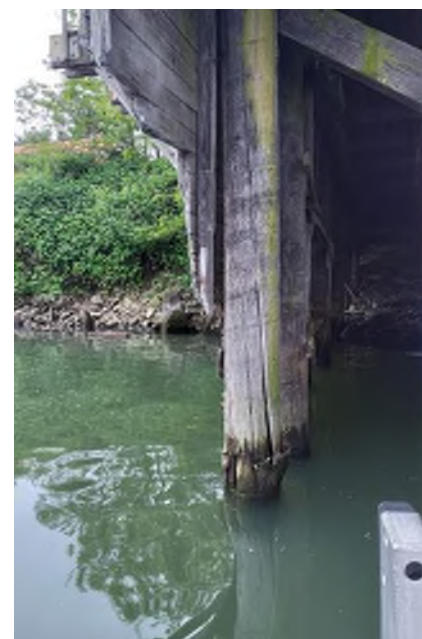
Photo 21: Lagoon Wharf Substructure
Adjacent to Pile A Bent 135
Split on the timber pile
Moata ID: 74984

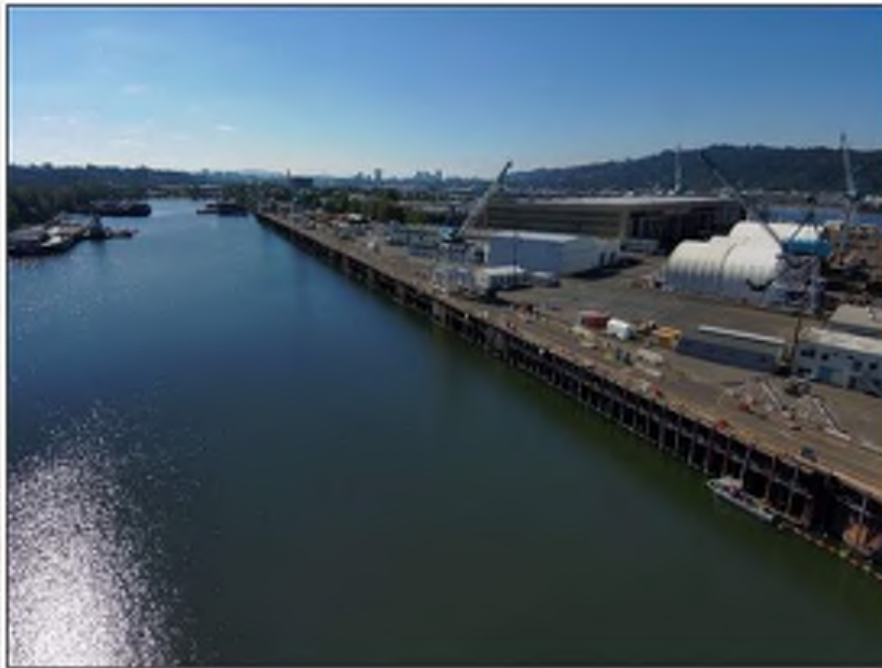
Photo 01: Lagoon Wharf overview
Lagoon Wharf, looking east
