**STRUCTURE CONDITION ASSESSMENT REPORT
REVISION 0**

**REMEDIAL DESIGN SERVICES
SWAN ISLAND BASIN PROJECT AREA
CERCLA Docket No. 10-2021-001**

**PORTLAND HARBOR SUPERFUND SITE
PORTLAND, MULTNOMAH COUNTY, OREGON**

November 2023

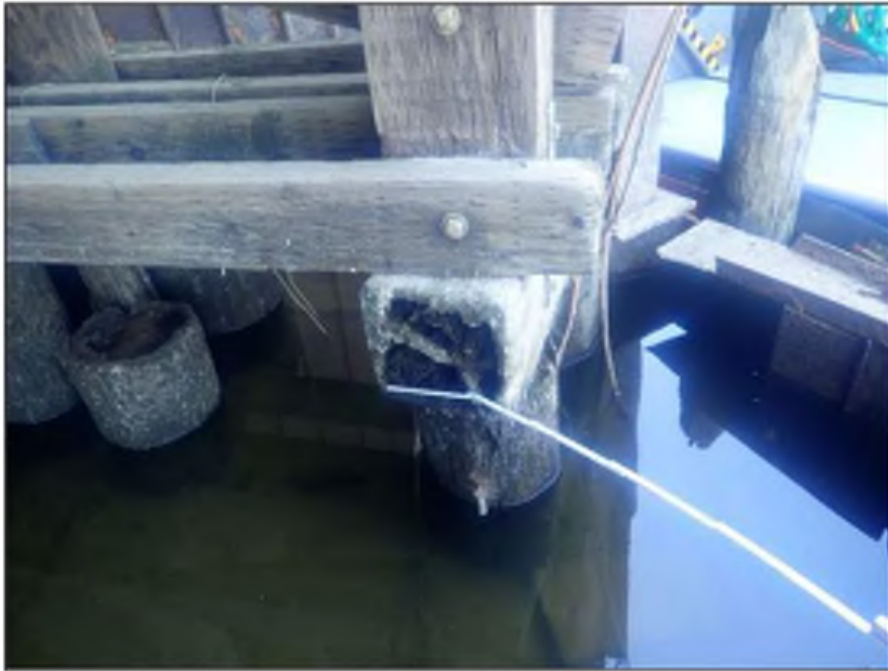
Photo 07: Lagoon Wharf Substructure
Core decay in water support square piles at bent 0

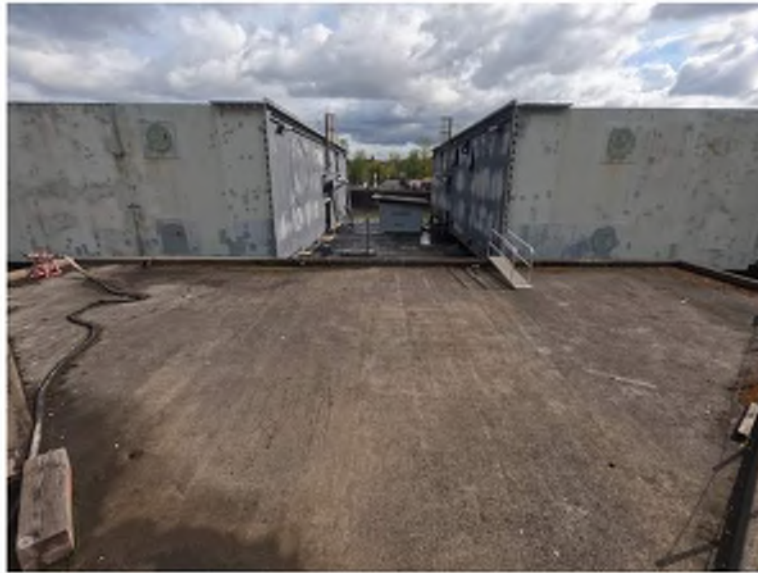
Photo 01: Lay Berth 306 Superstructure
Overview of Concrete Deck
Typical condition of concrete deck
Moata ID: Not Applicable

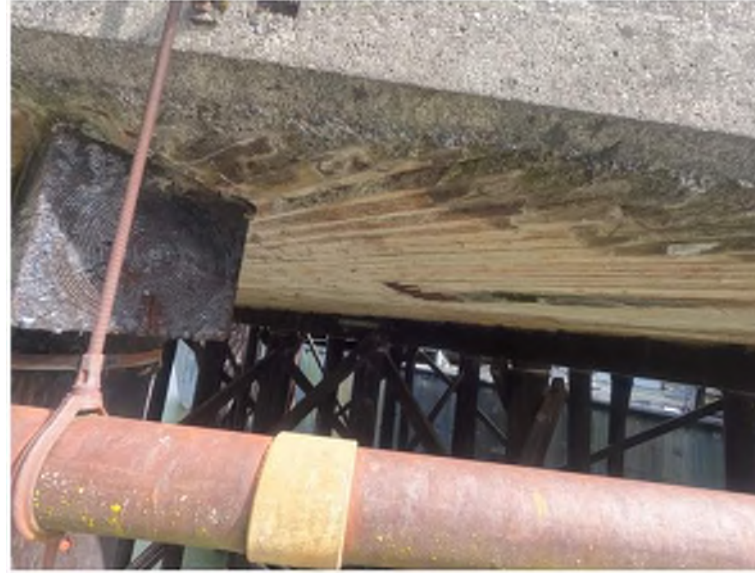
Photo 02: Lay Berth 306 Superstructure
Underside of Concrete Deck Overview
Typical condition of underside of concrete deck
Moata ID: Not Applicable

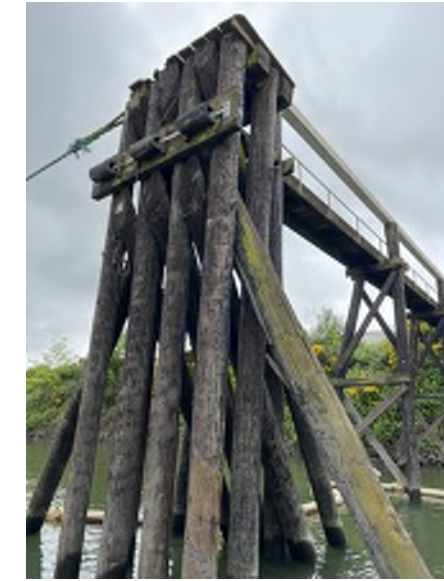
Photo 03: Lay Berth 306 Dolphin
Dolphin D1 Overview
Typical configuration of dolphin
Moata ID: 75029

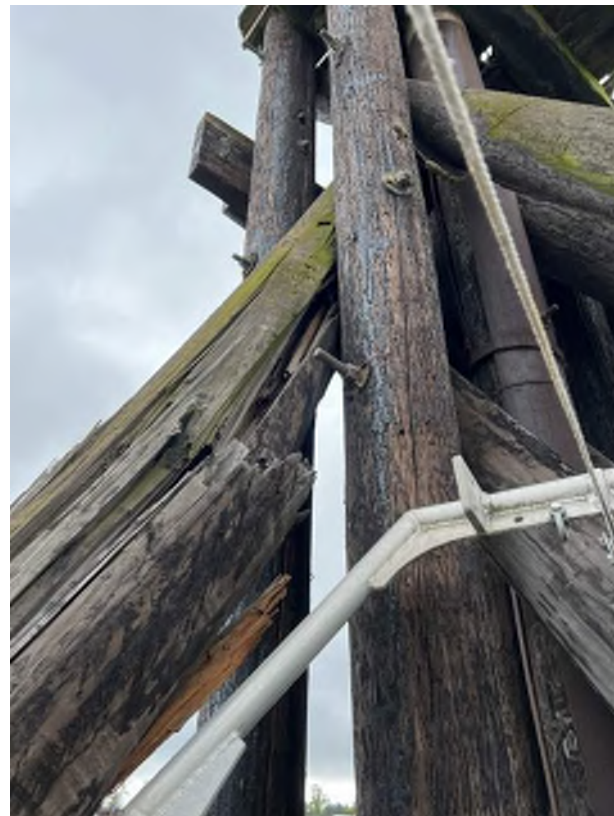
Photo 04: Lay Berth 306 Dolphin
Dolphin D1
Partially broken pile
Moata ID: 75029

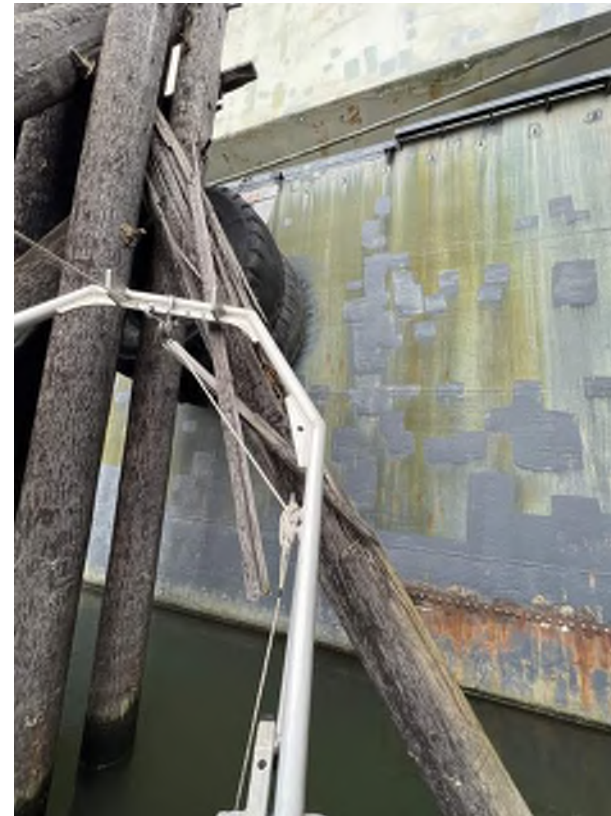
Photo 05: Lay Berth 306 Dolphin
Dolphin D3
Partially broken pile
Moata ID: 75036

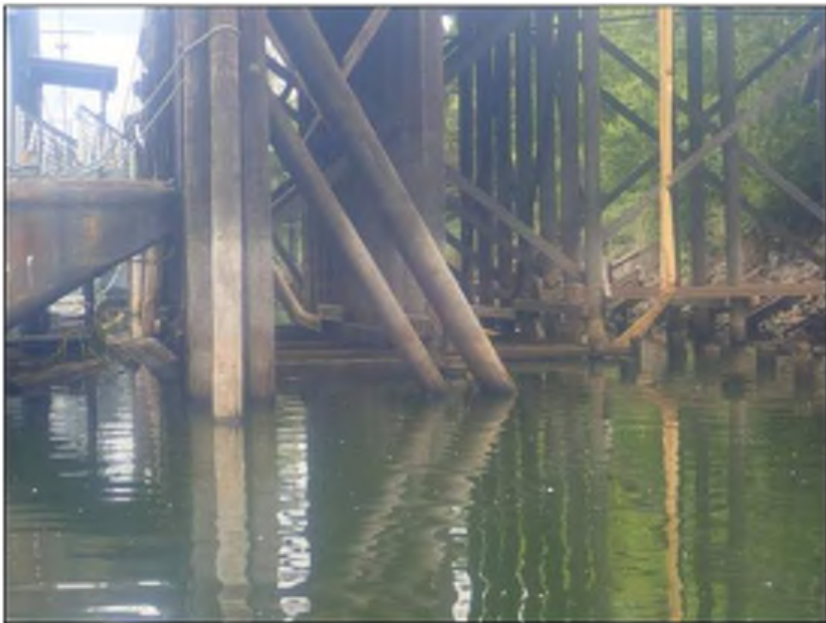
Photo 01: Lay Berths 306 & 307 Substructure
Typical substructure configuration

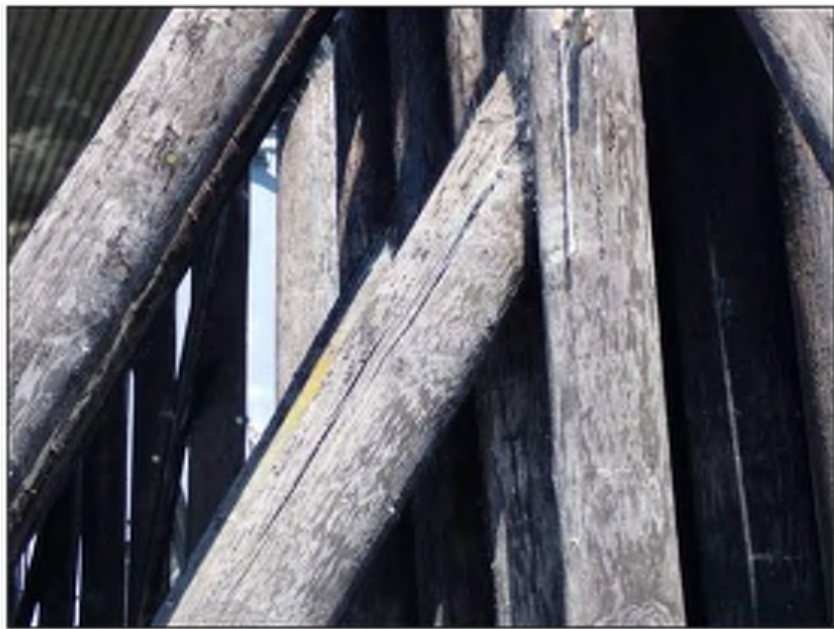
Photo 04: Lay Berths 306 & 307 Dolphins
Dolphin D4 pile 6
Internal decay in pile

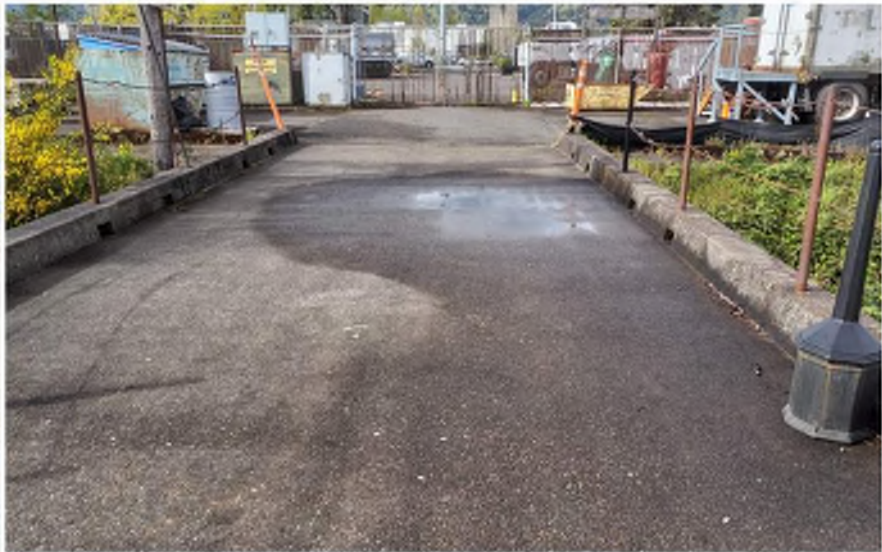
Photo 01: Lay Berth 307 Superstructure
 Overview of Concrete Deck
 Typical condition of concrete deck
 Moata ID: Not Applicable

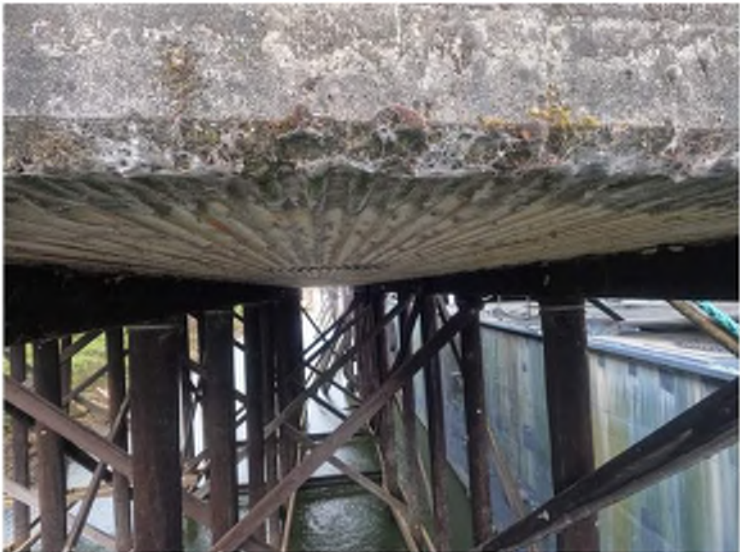
Photo 02: Lay Berth 307 Superstructure
 Underside of Concrete Deck Overview
 Typical condition of underside of concrete deck
 Moata ID: Not Applicable

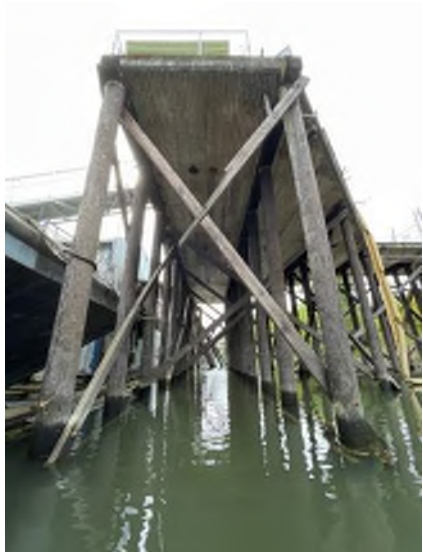
Photo 03: Lay Berth 307 Substructure
 Cross-Bracing at Bent 1
 Broken cross-bracing
 Moata ID: 75042

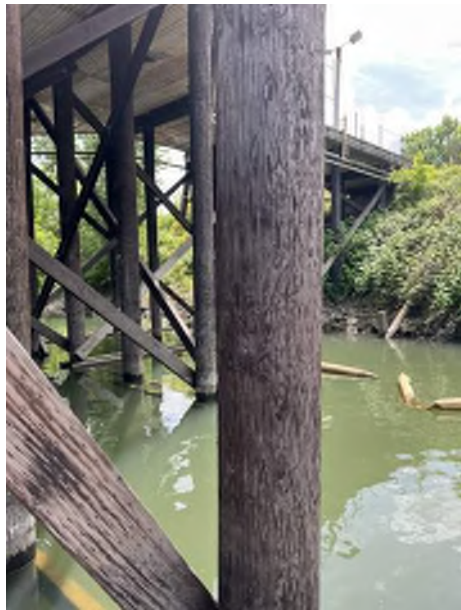
Photo 04: Lay Berth 307 Substructure
 Pile B Bent 1
 Typical condition of piles
 Moata ID: 75063

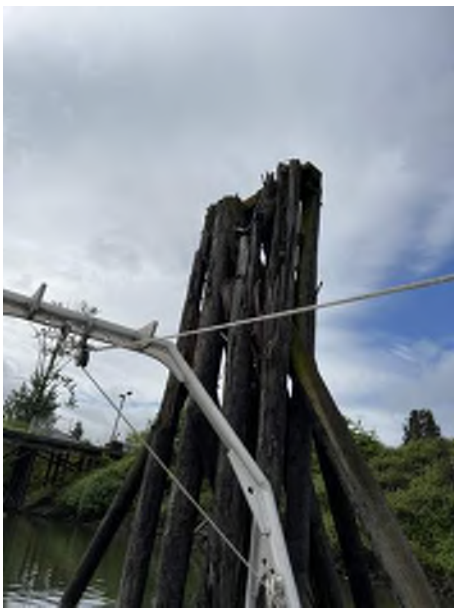
Photo 05: Lay Berth 307 Dolphin
 Dolphin D6
 Broken piles
 Moata ID: 75063

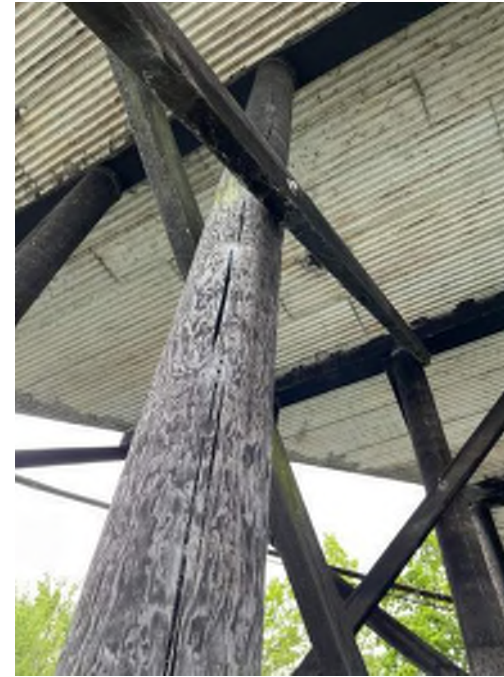
Photo 02: Lay Berth 308 Substructure
Bent 7 Pile B
Typical condition of piles
Moata ID: 75057

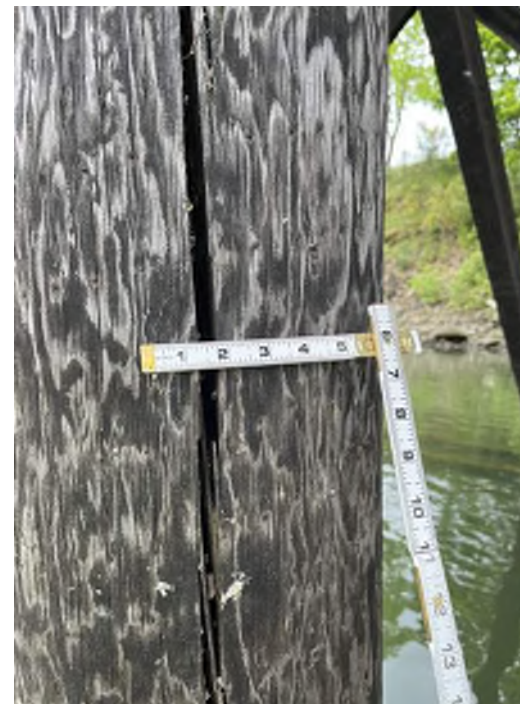
Photo 04: Lay Berth 308 Substructure
Bent 7 Pile B
Split on the timber pile
Moata ID: 75057

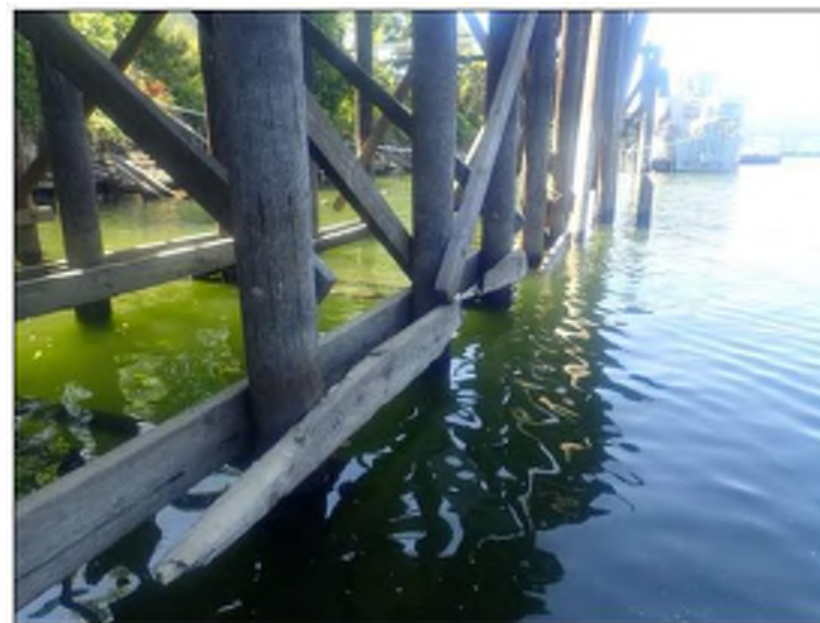
Photo 02: Lay Berth 308 Substructure
Typical condition of walers at waterline

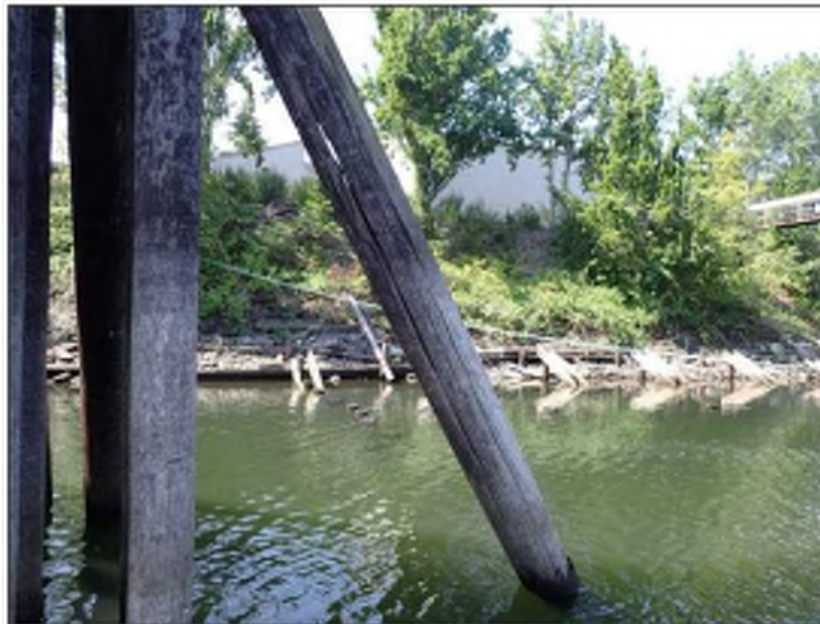
Photo 05: Lay Berth 308 Dolphins
Dolphin D11, Pile 11
Timber pile decay

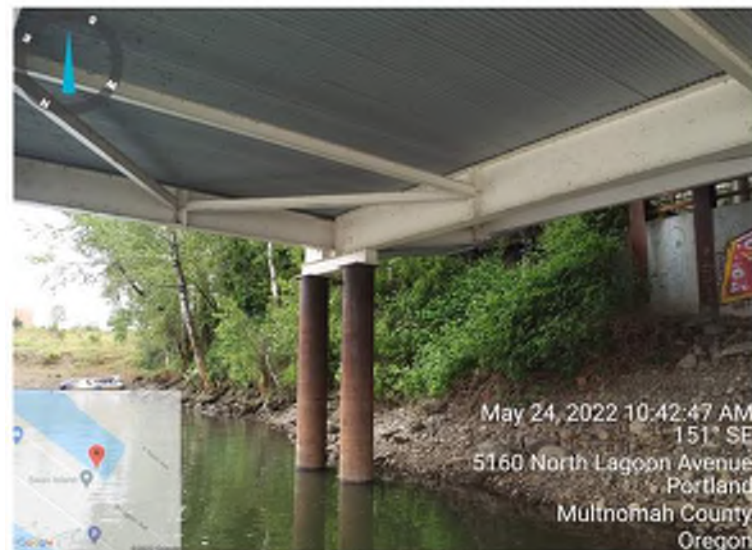
Photo 03: Wind Tunnel Substructure
Typical condition of substructure above water
Moata ID: Not Applicable

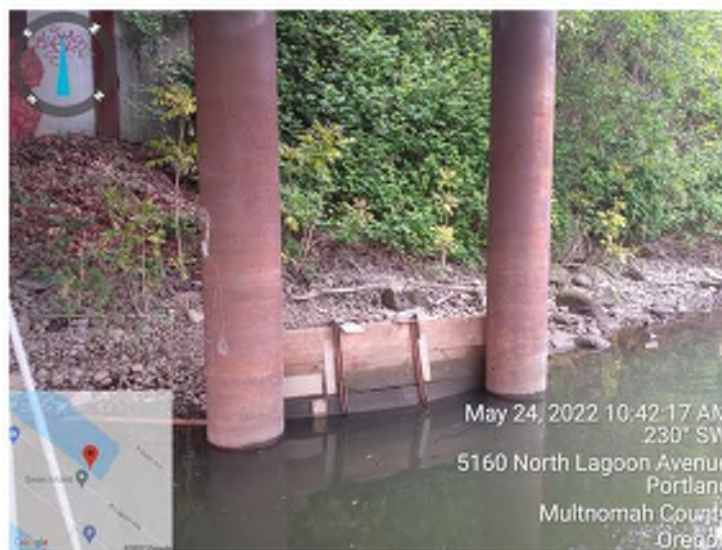
Photo 04: Wind Tunnel Substructure
Piles A and B, Bent 1
Typical condition of piles above water
Moata ID: Not Applicable

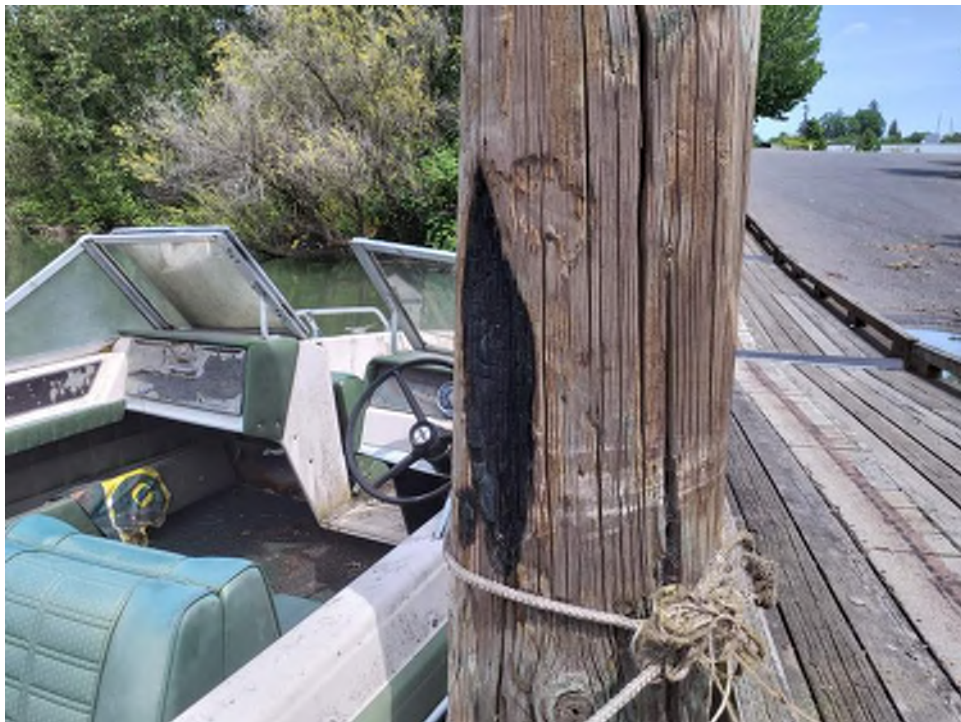
Photo 03: Swan Island Boat Ramp Piles
 Pile 3
 Loss of section on pile
 Moata ID: 74345

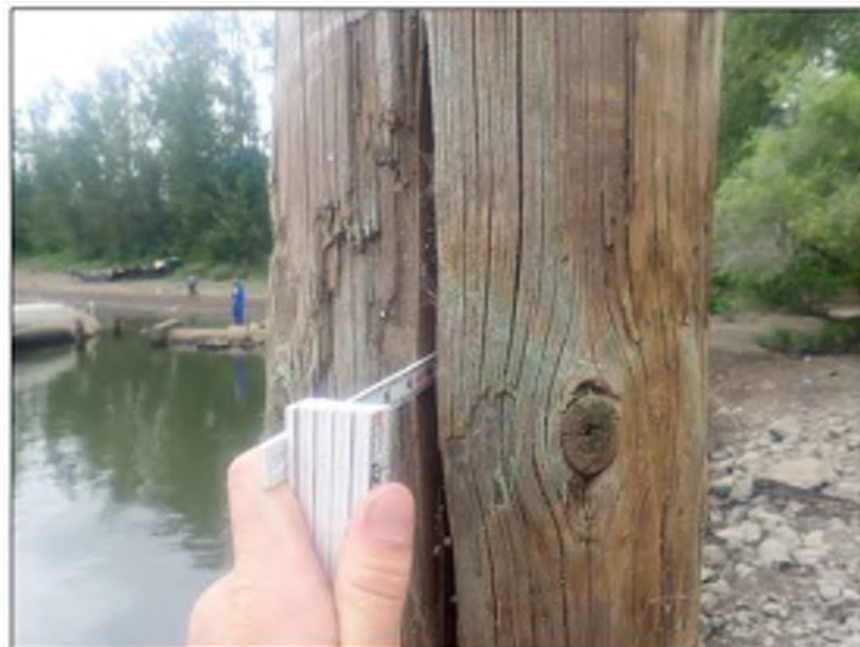
Photo 03: Swan Island Boat Ramp Piles
Typical checking on timber piles

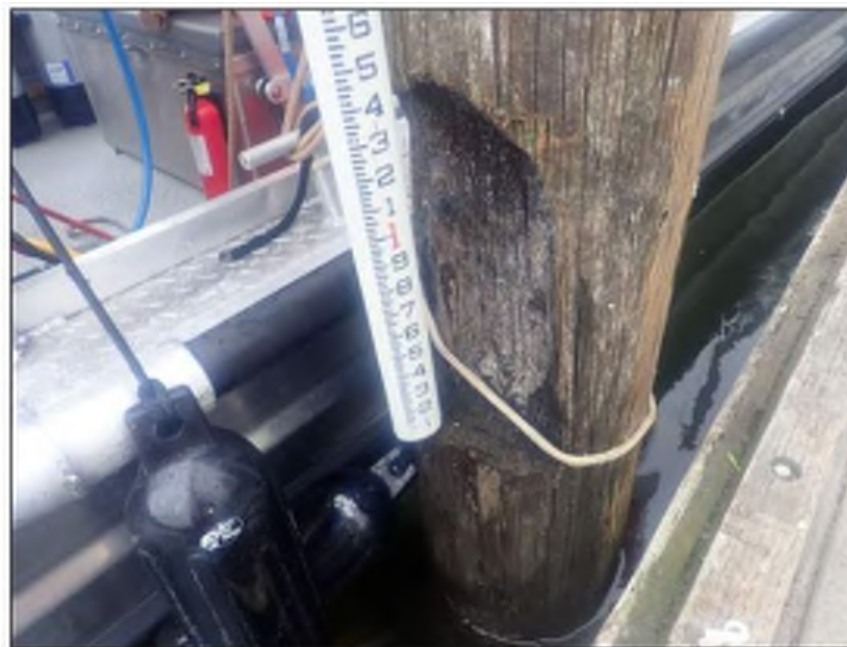
Photo 04: Swan Island Boat Ramp Piles
Pile 5
Loss of section

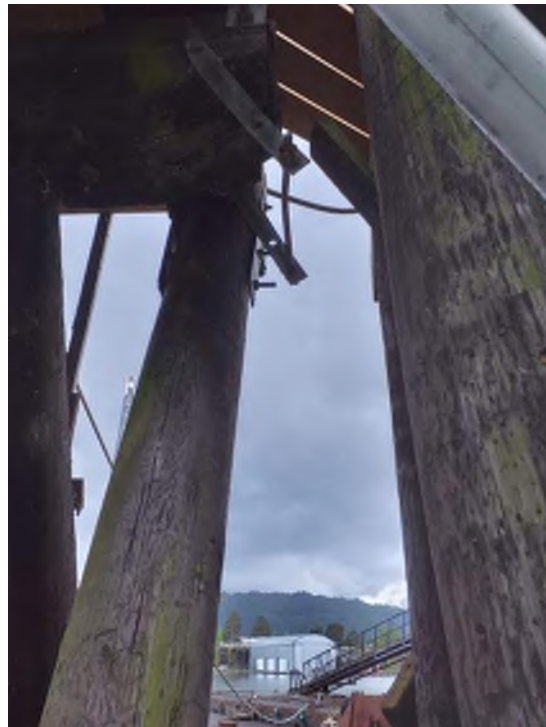
Photo 01: Berth 311 Dolphin
East Dolphin
Loss of connection between batter pile and deck
Moata ID: 74395

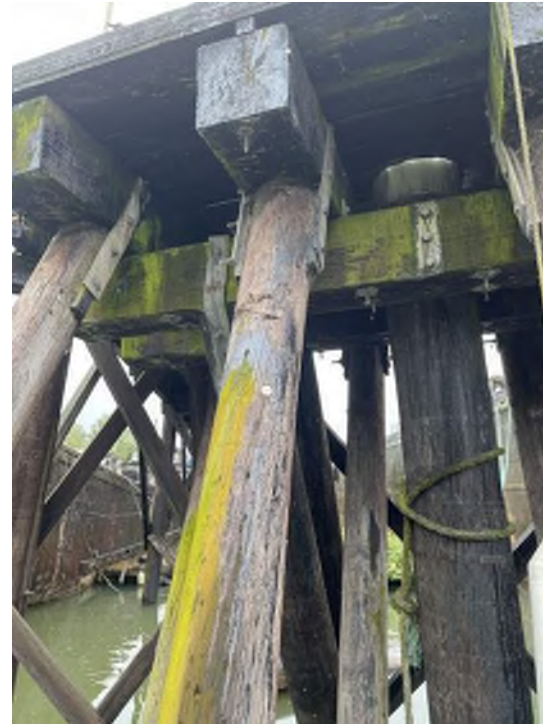
Photo 02: Berth 311 Dolphin
West Dolphin
Typical condition of piles
Moata ID: 74374

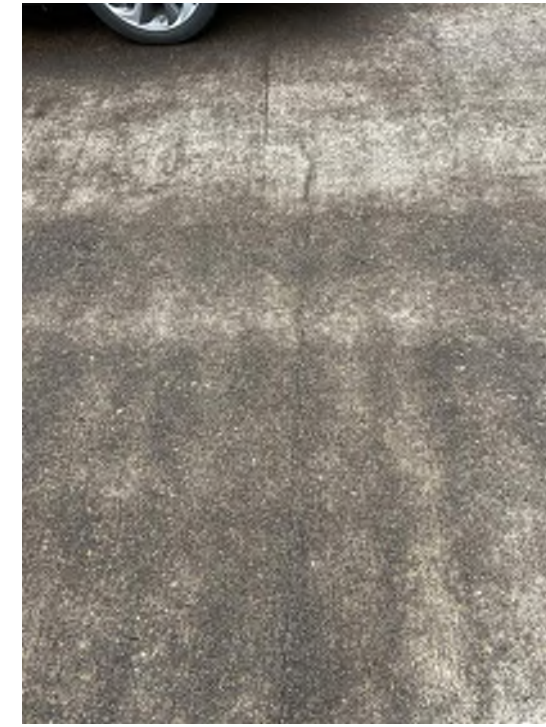
Photo 03: Berth 311 Trestle
West Trestle
Cracks on the concrete deck
Moata ID: 74378

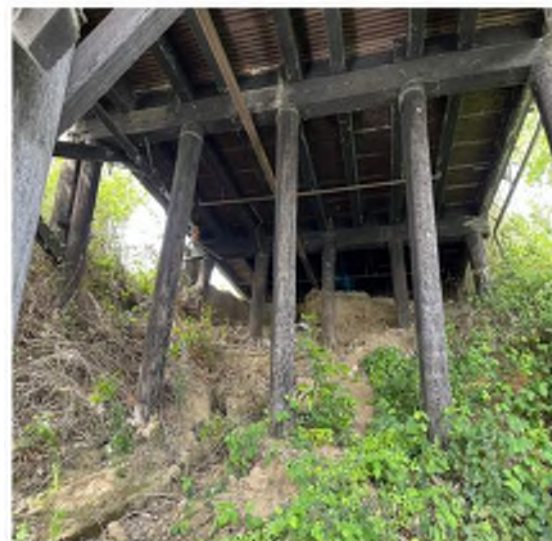
Photo 04: Berth 311 Trestle
West Trestle
Typical condition of piles
Moata ID: Not Applicable

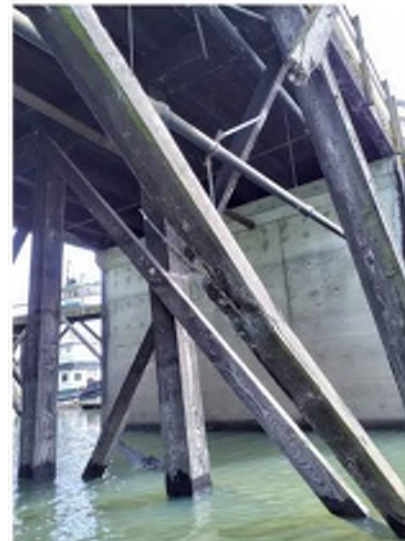
Photo 05: Berth 311 Trestle
West Trestle
Broken cross-bracing
Moata ID: Not Applicable

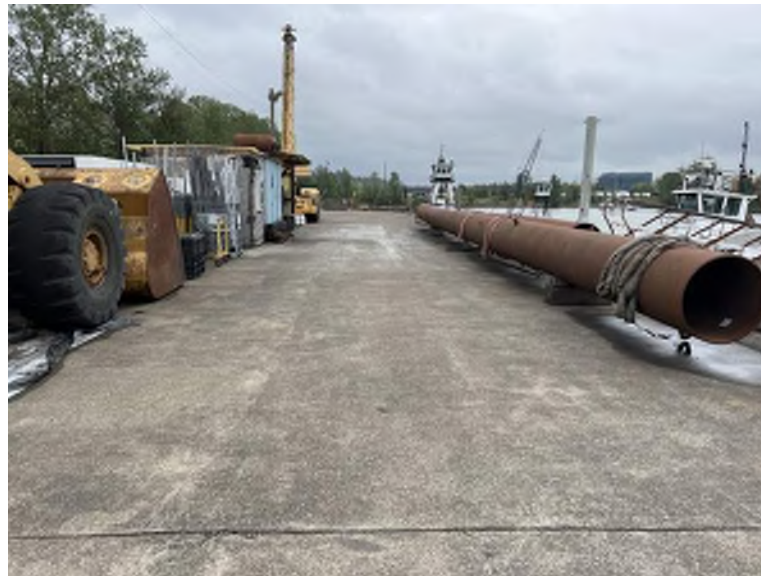
Photo 06: Berth 311 Main Pier
Concrete Deck of Main Pier
Typical condition of concrete deck
Moata ID: 74384

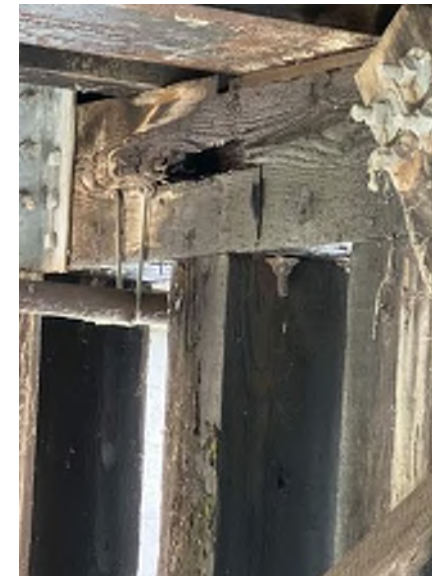
Photo 08: Berth 311 Main Pier
Pile Cap at Bent 2
Loss of section on pile cap
Moata ID: 74406

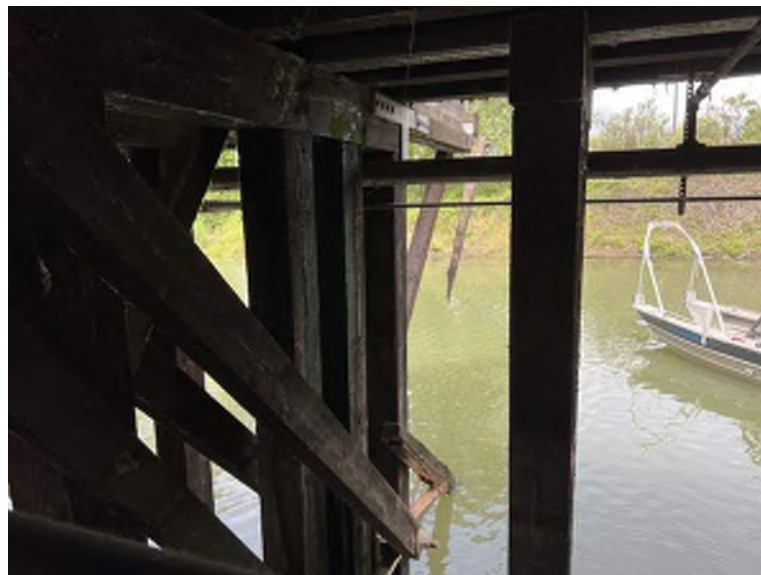
Photo 10: Berth 311 Main Pier
Cross-Bracing at Bent 26
Broken cross-bracing
Moata ID: 74410

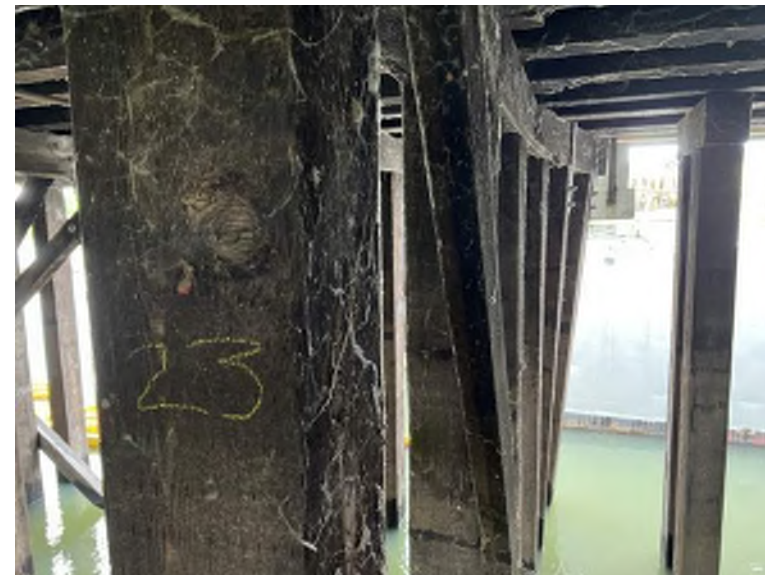
Photo 11: Berth 311 Main Pier
Pile Cap at Bent 23
Bent pile cap
Moata ID: 74404

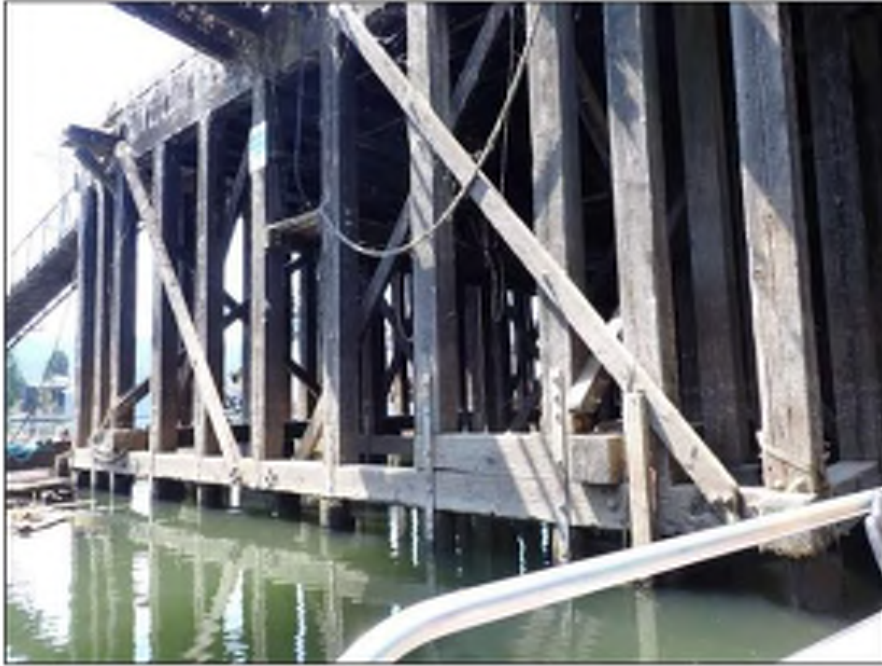
Photo 01: Berth 311 Substructure
Typical substructure configuration, looking west

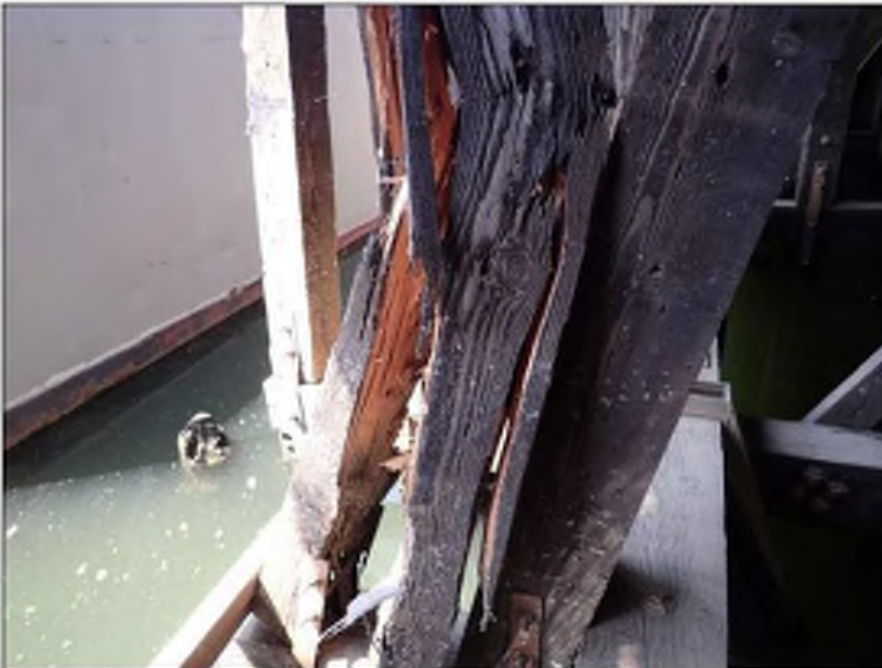
Photo 04: Berth 311 Substructure
Piles I and J Bent 23
Broken piles

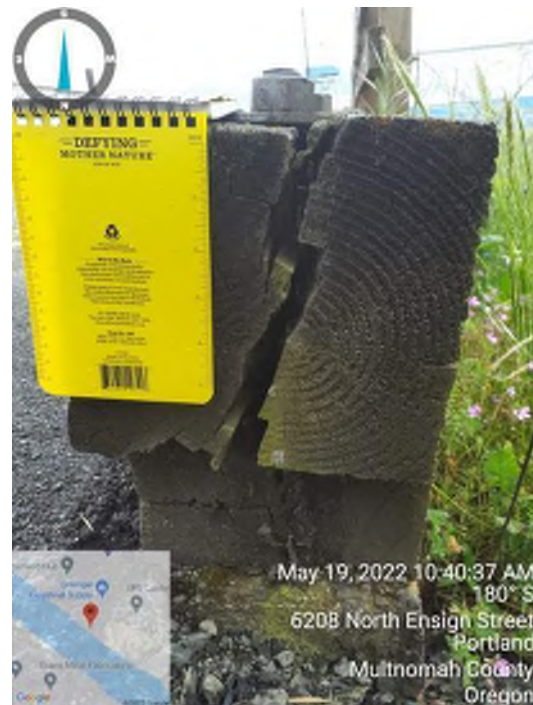
Photo 01: Dredge Base Superstructure
End of Bullrail
Split on the bullrail
Moata ID: 74436

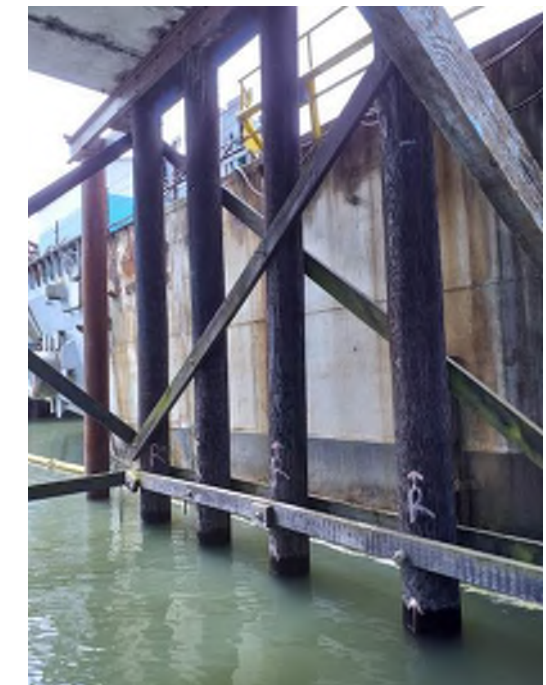
Photo 03: Dredge Base Substructure
Piles at Bent 6
Typical condition of piles
Moata ID: 74435

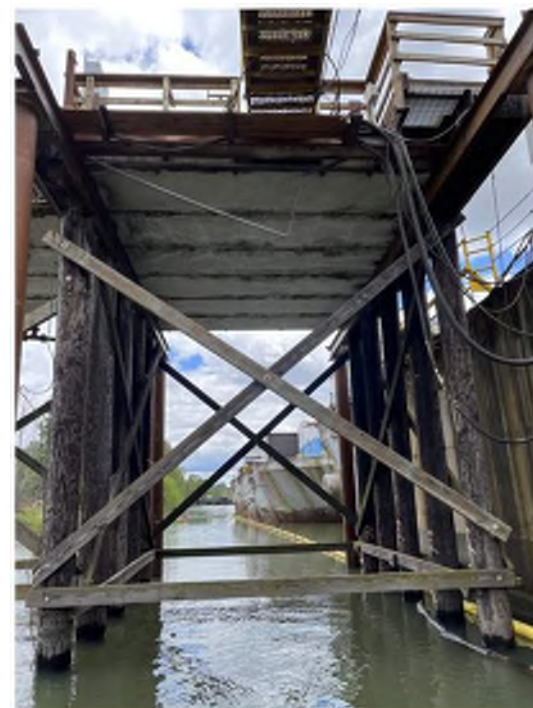
Photo 04: Dredge Base Substructure
Bents 5 and 6
Typical condition of substructure
Moata ID: Not Applicable

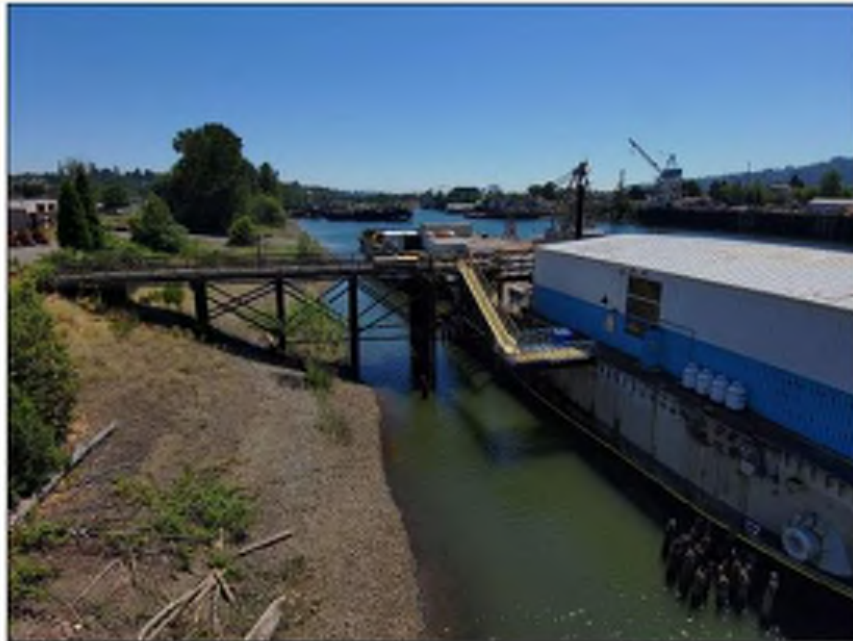
Photo 01: Dredge Base Overview
Navigation Base, looking east

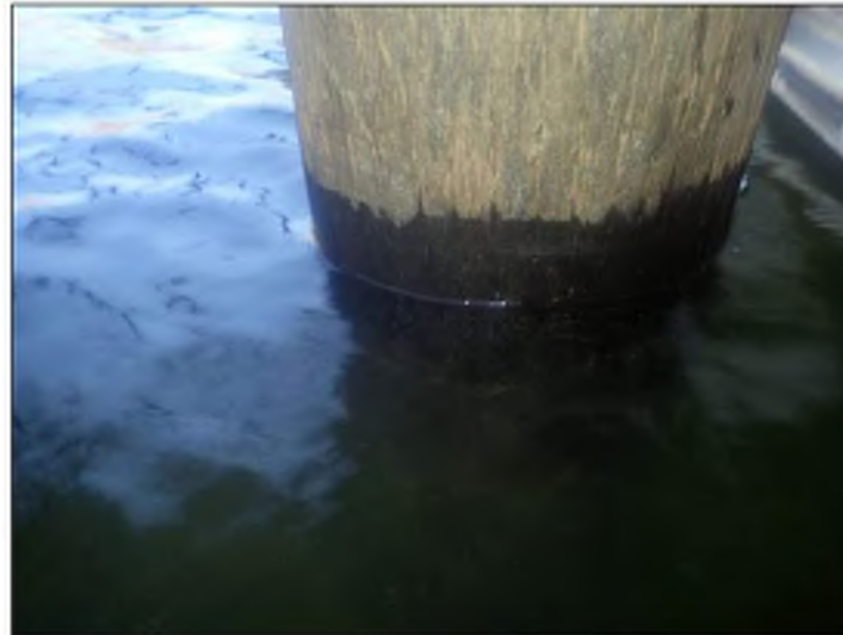
Photo 02: Dredge Base Overview
Typical condition of timber piles at waterline

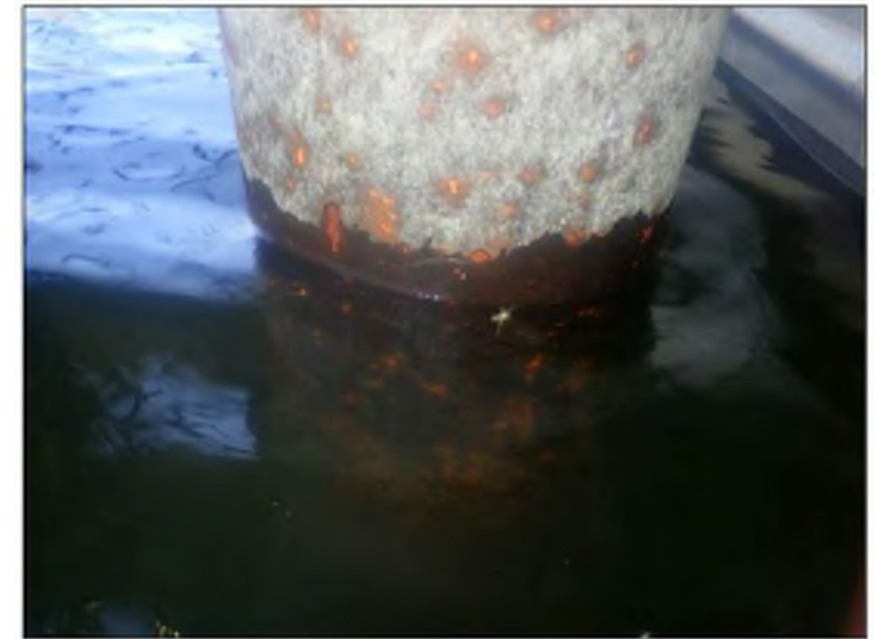
Photo 03: Dredge Base Overview
Typical condition of steel piles at waterline

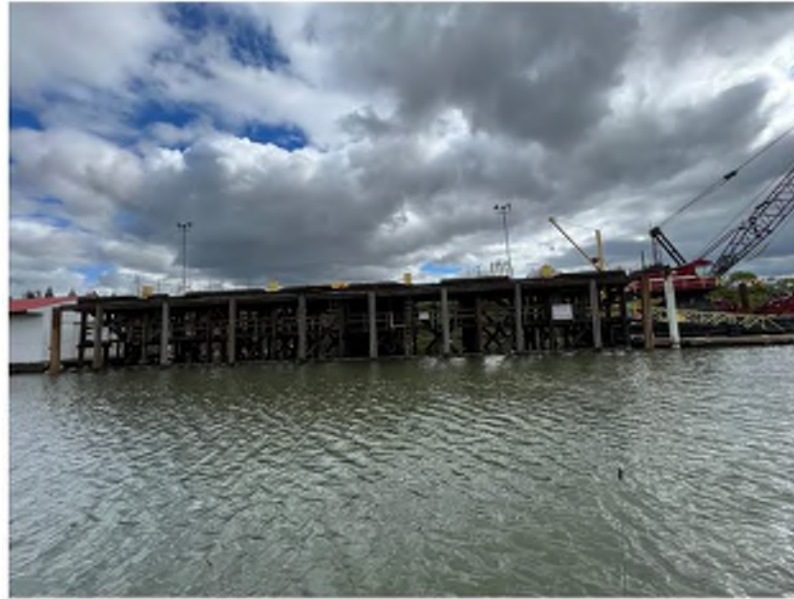
Photo 01: Marine Consortium Pier Overview
Marine Consortium Pier, Looking North
Moata ID: Not Applicable

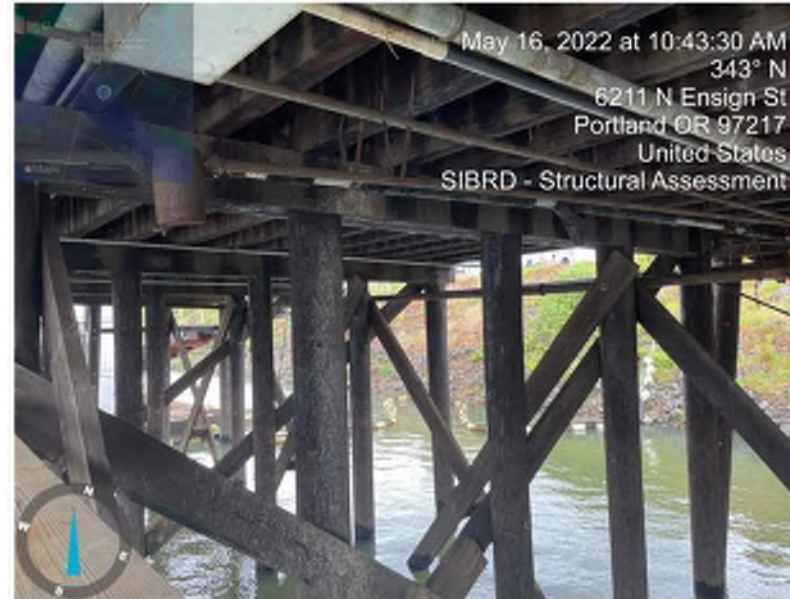
Photo 02: Marine Consortium Pier Substructure
Marine Consortium Pier Substructure Overview
Typical configuration of MC Pier substructure
Moata ID: Not Applicable

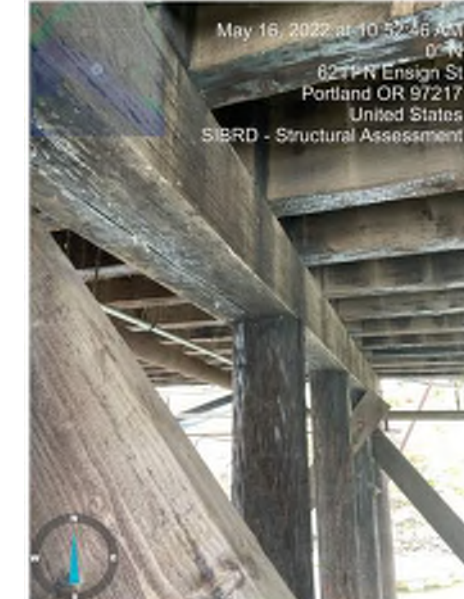
Photo 03: MC Pier Substructure
Marine Consortium Pier Pile Cap
Typical condition of pile caps
Moata ID: Not Applicable

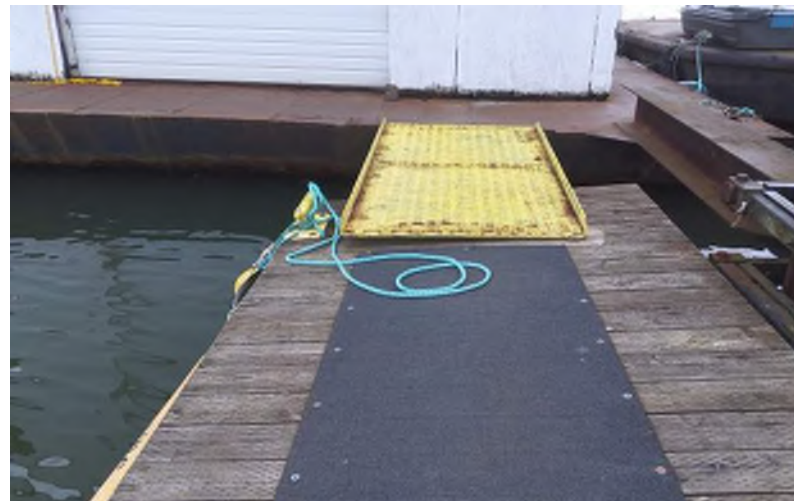
Photo 04: Marine Consortium Pier Floats
West Float
Typical condition of the float
Moata ID: Not Applicable

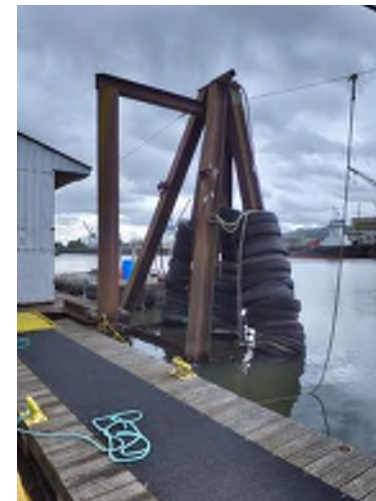
Photo 05: Marine Consortium Dolphin
Dolphin C
Typical configuration of dolphins
Moata ID: 74433

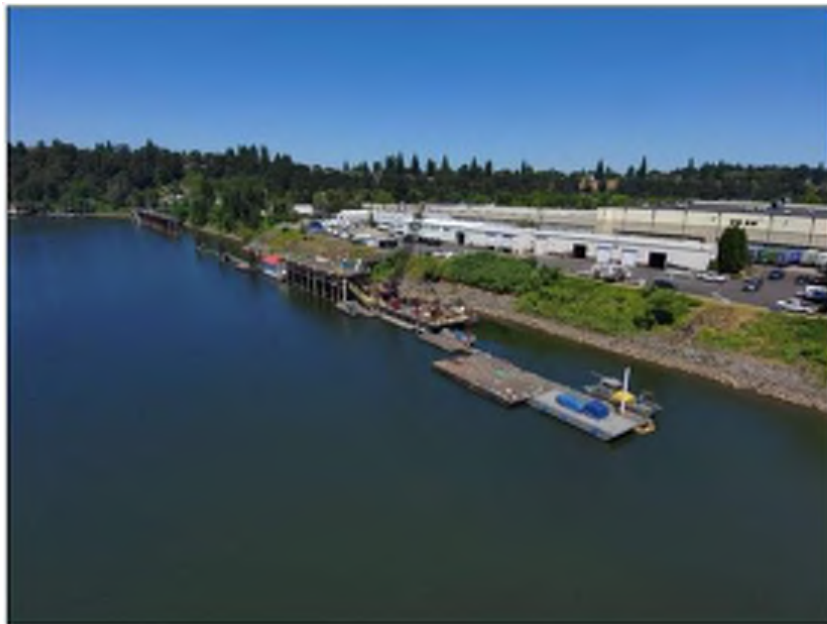
Photo 01: Marine Consortium Pier Overview
Marine Consortium Pier, looking north

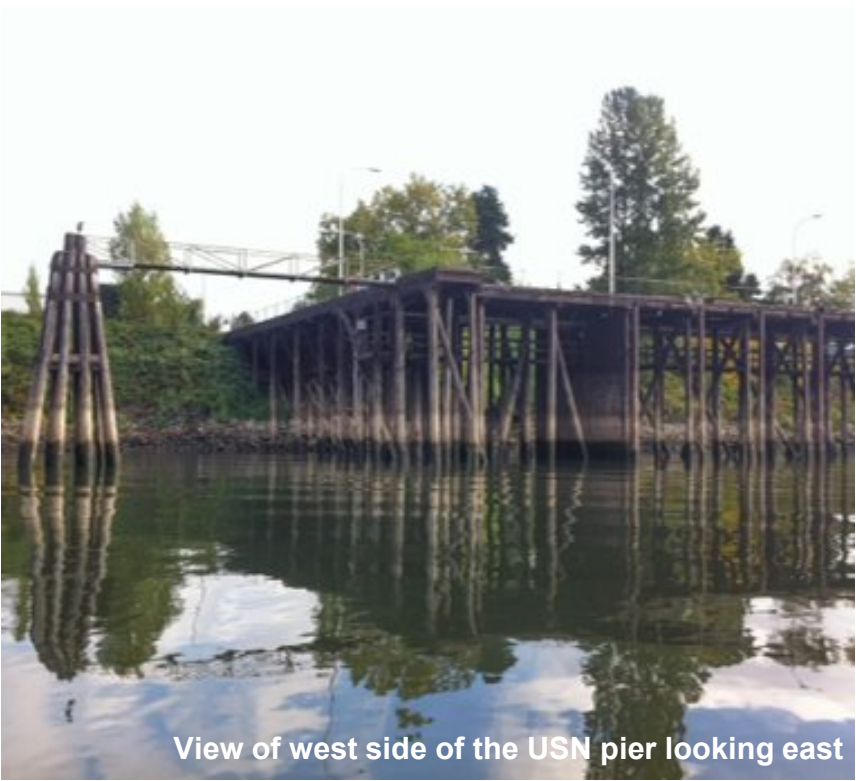
View of west side of the USN pier looking east

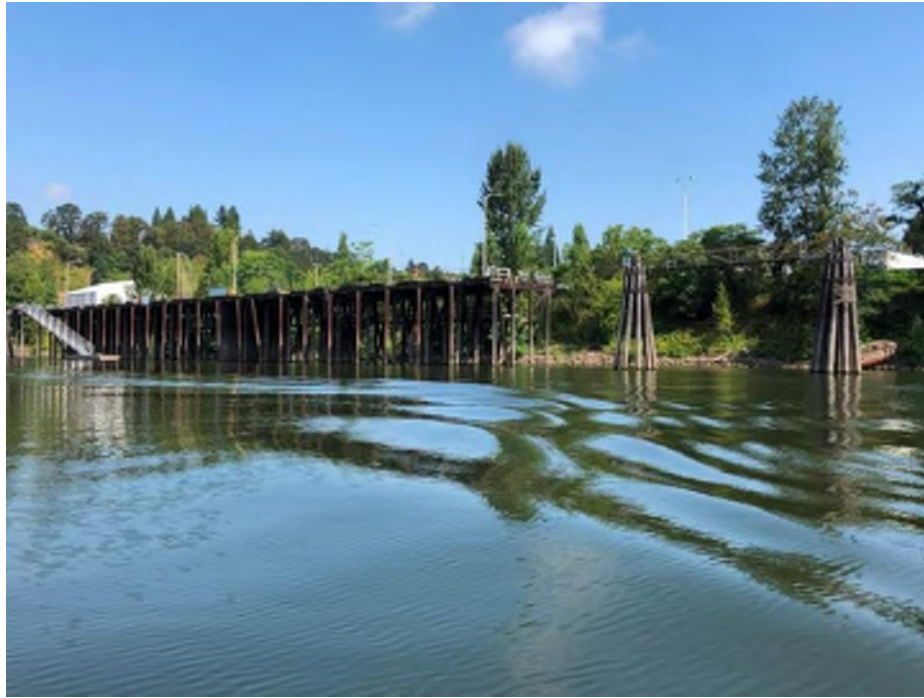
Photo 01: U.S. Navy Pier Overview
U.S. Navy Pier, looking north
Source: AME 2019 Report

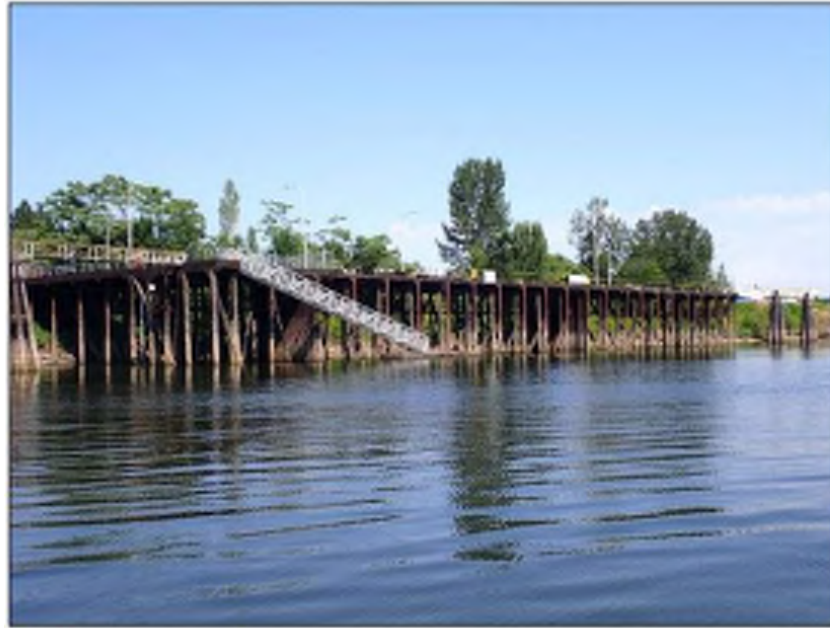
Photo 01: U.S. Navy Pier Overview
U.S. Navy Pier, looking east

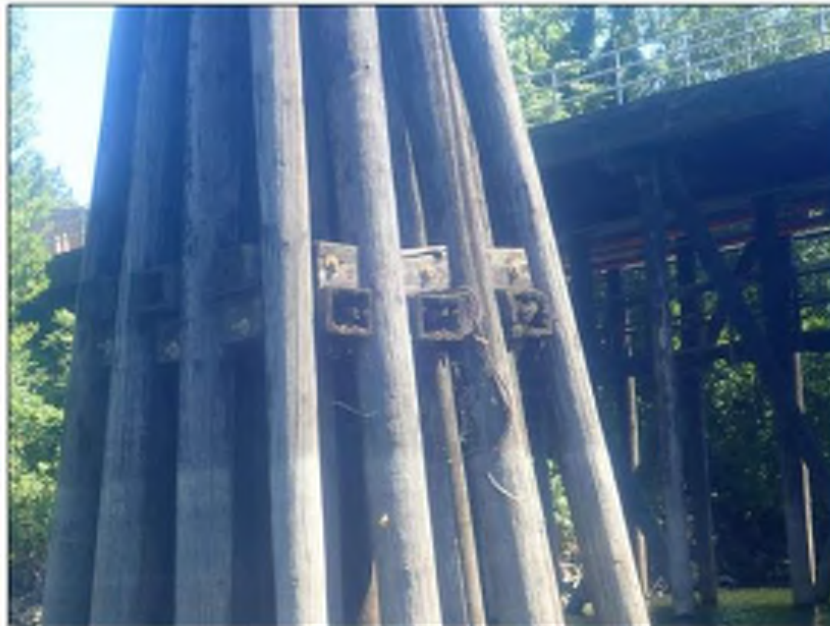
Photo 04: U.S. Navy Pier Dolphins
West Dolphin
Core decay in walers
