**STRUCTURE CONDITION ASSESSMENT REPORT
REVISION 0**

**REMEDIAL DESIGN SERVICES
SWAN ISLAND BASIN PROJECT AREA
CERCLA Docket No. 10-2021-001**

**PORTLAND HARBOR SUPERFUND SITE
PORTLAND, MULTNOMAH COUNTY, OREGON**

November 2023

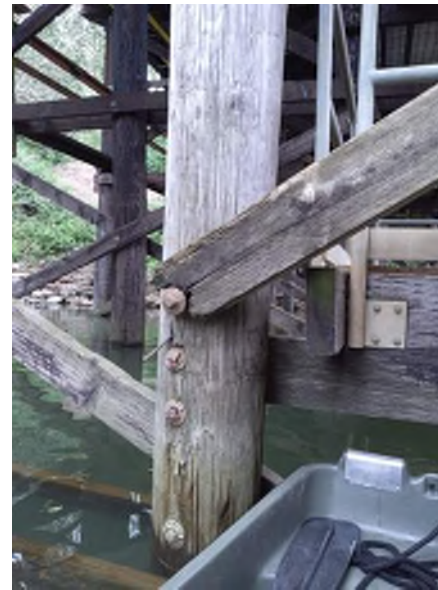
Photo 02: U.S. Coast Guard Dock and Pier Substructure
Cross-bracing Between Piles D and F at Bent 9
Broken cross-bracing
Moata ID: 74996

74996	9	D and F	Pier / Wharf	Substructure	Cross-bracing	Timber	Severe (SV)	Transverse bracing is broken.
74997	9	C	Pier / Wharf	Substructure	Pile / Sheet Pile	Timber	Moderate (MD)	The pile has gouge with 2" wide, 2.5" high and 1"depth at 1.5 feet above the waterline.
74998	6	D	Pier / Wharf	Substructure	Pile / Sheet Pile	Timber	Moderate (MD)	The pile has gouge with 10 inch wide 3.5 inch high and 1.5 feet above the waterline.

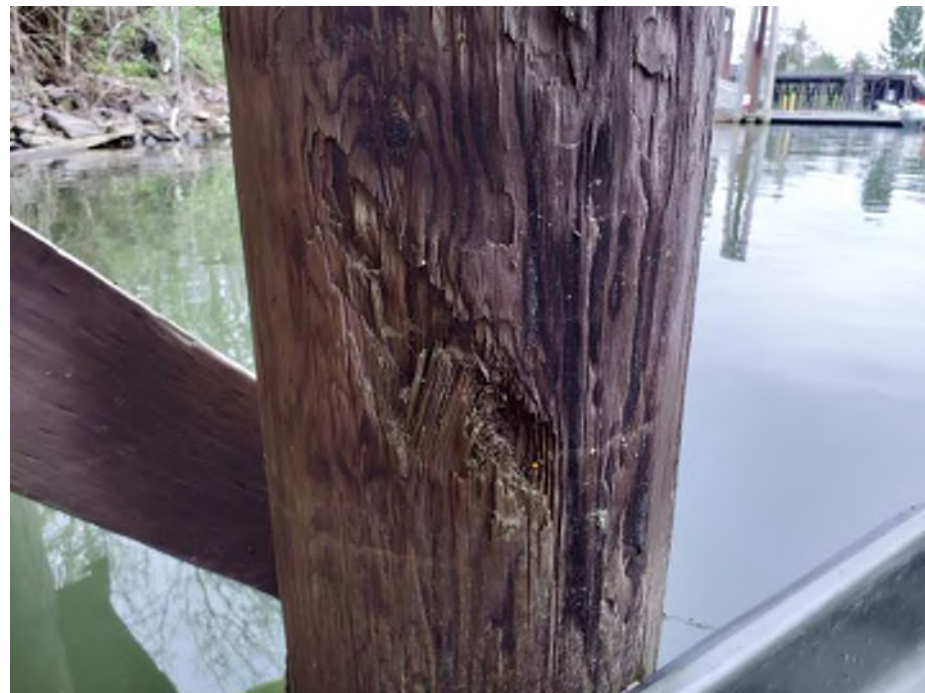
Photo 04: U.S. Coast Guard Dock and Pier Substructure
Pile D Bent 6
Loss of section on the pile
Moata ID: 74998

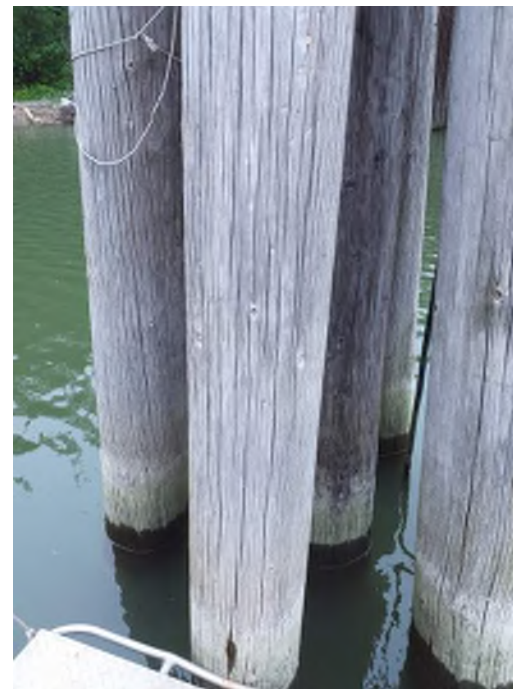
Photo 05: U.S. Coast Guard Dock and Pier Dolphin
Dolphin D11
Typical condition of Dolphins (Main Pier)
Moata ID: 75009

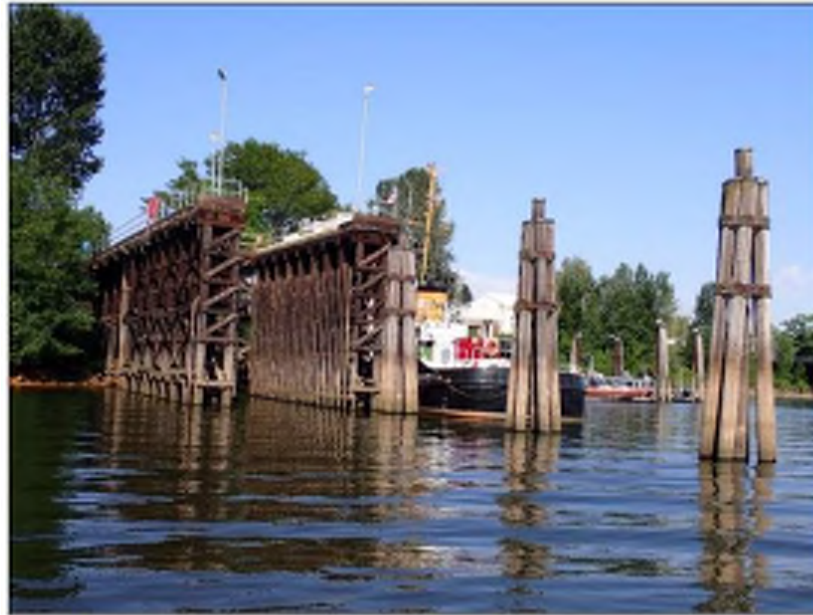
Photo 01: U.S. Coast Guard Dock and Pier Overview
U.S. Coast Dock and Pier, looking north

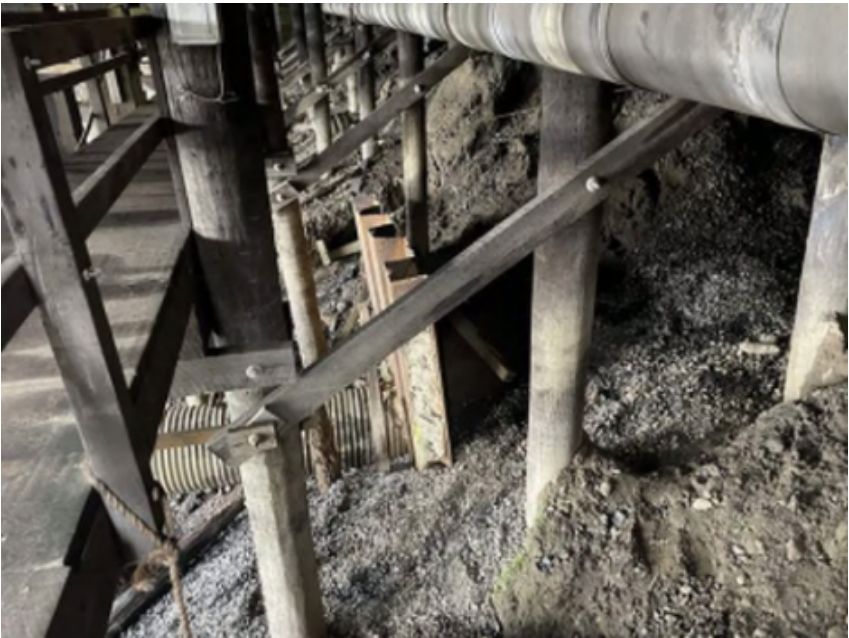
Asset Photo

Concrete anchor wall was not visible during inspection

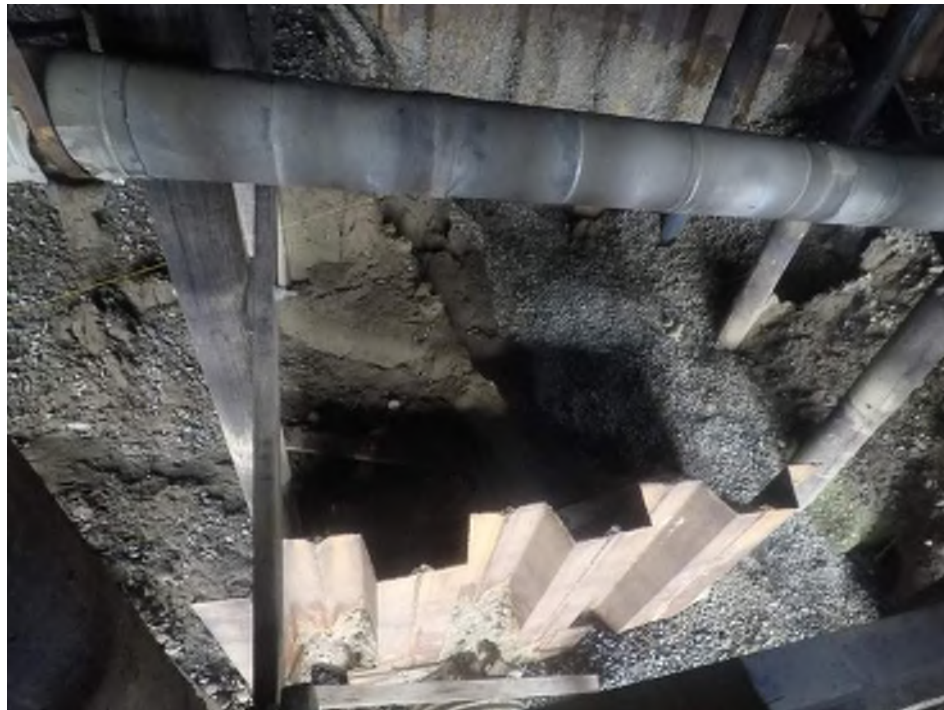
Photo 03: City Stormwater Outfall S1
Embankment erosion behind and adjacent to headwall

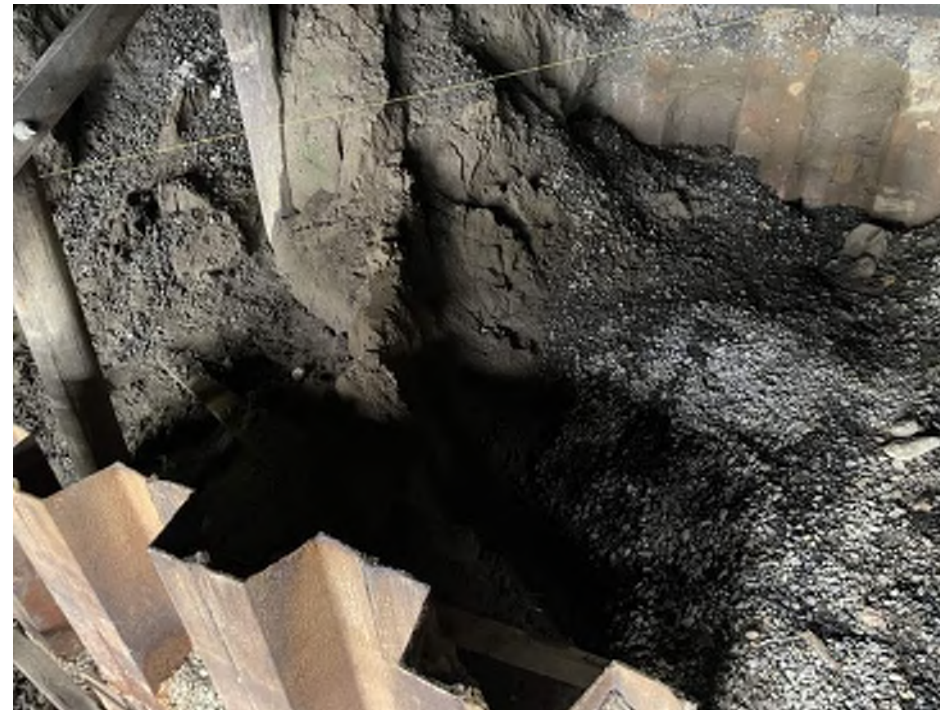
Photo 04: City Stormwater Outfall S1
Embankment erosion behind and adjacent to headwall

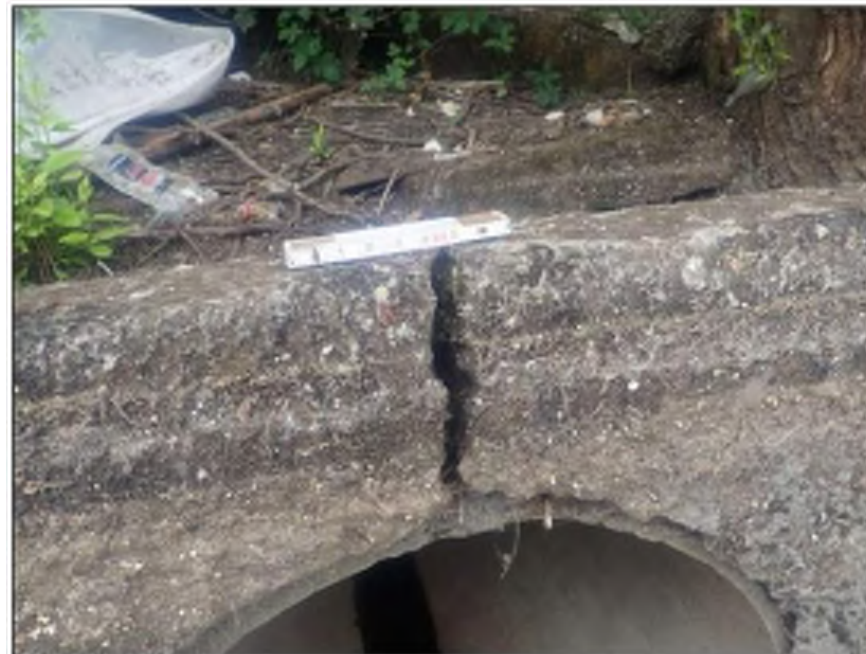
Photo 02: City Stormwater Outfall S2 Headwall
Crack in top of head wall

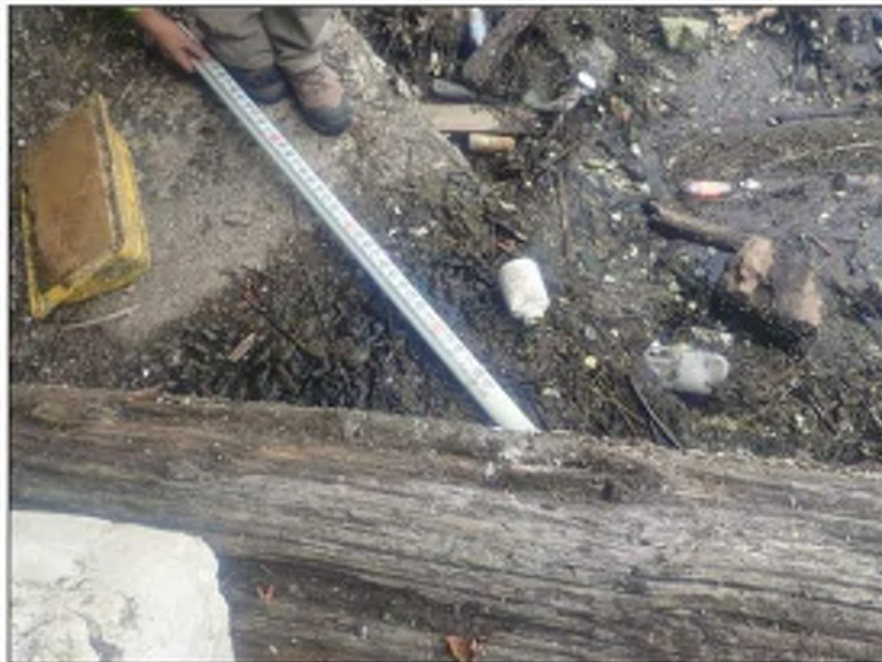
Photo 04: City Stormwater Outfall S2 Outfall Base
Abrasion on outfall surface

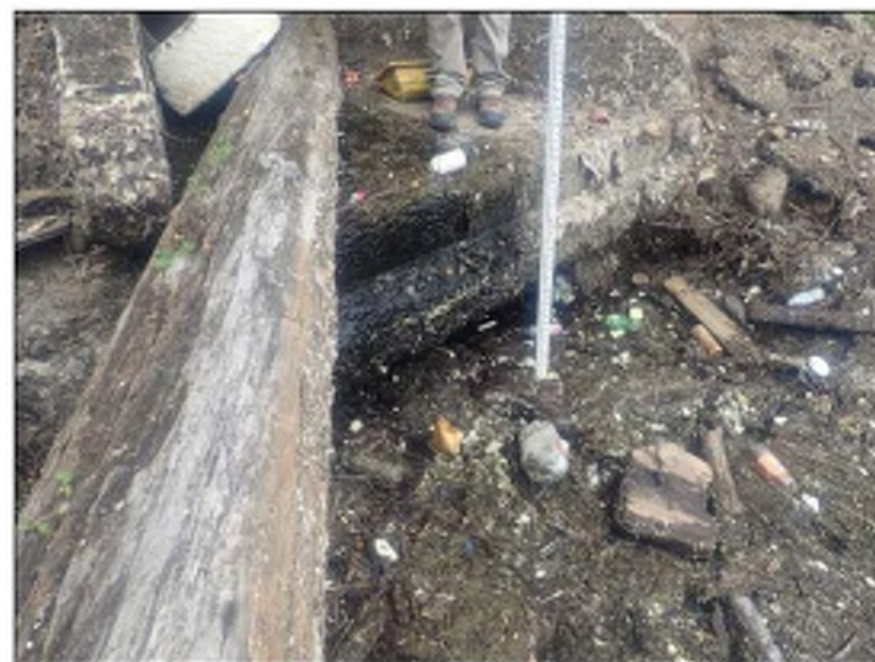
Photo 05: City Stormwater Outfall S2 Base
Undermining at outfall

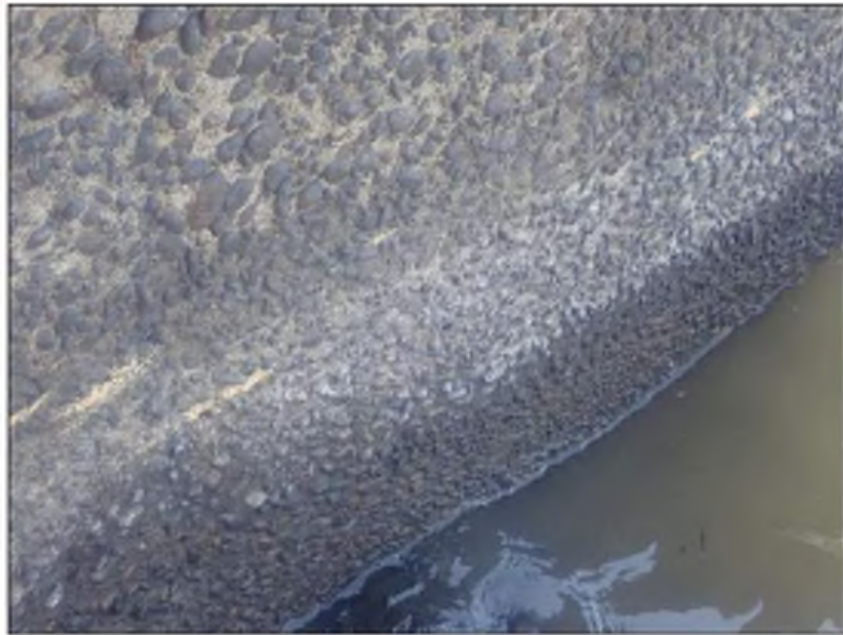
Photo 01: City Stormwater Outfall M1
Typical abrasion on concrete

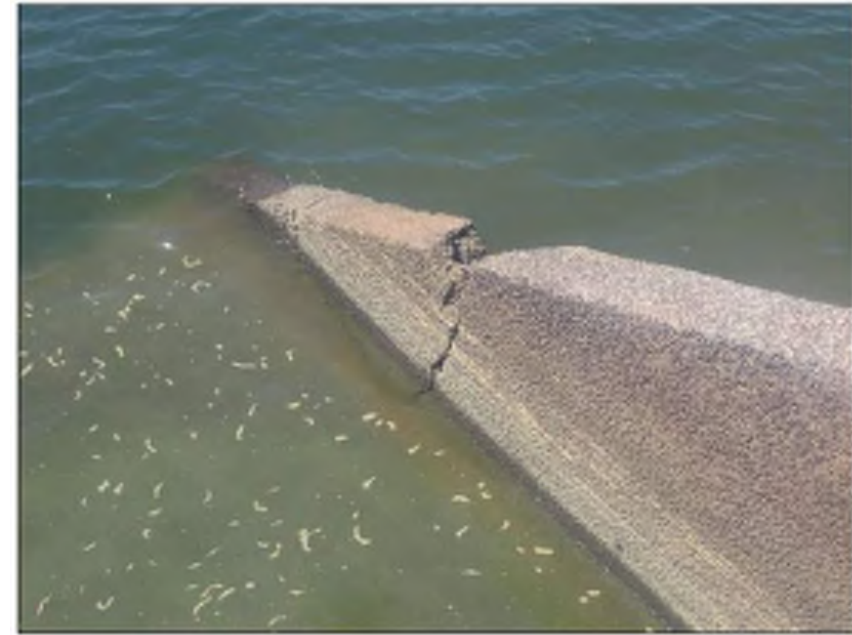
Photo 02: City Stormwater Outfall M1 Wingwalls
West Wingwall
Fractured west wingwall

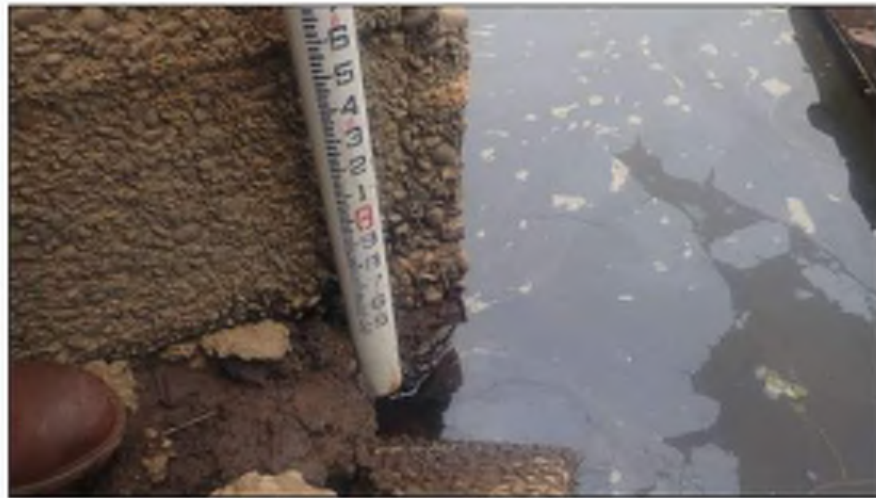
Photo 01: City Stormwater Outfall M2 Wingwalls
Typical condition of concrete at waterline

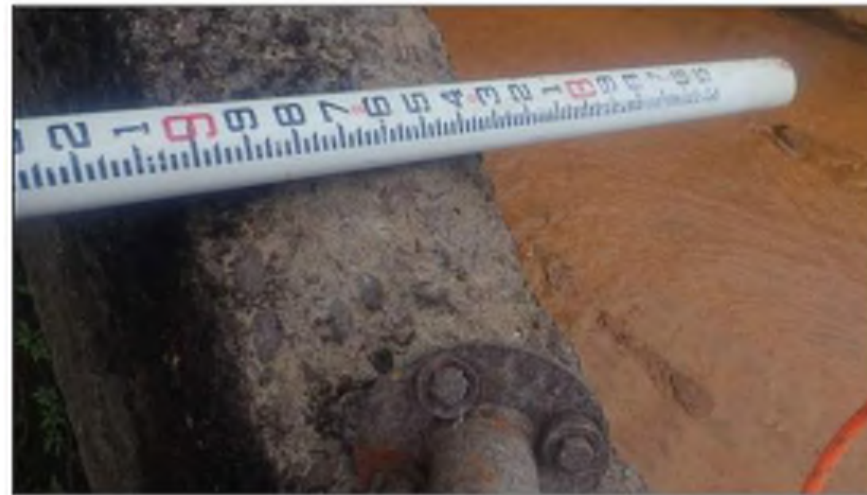
Photo 02: City Stormwater Outfall M2 Wingwalls
North Wingwall
Spall on north waingwall

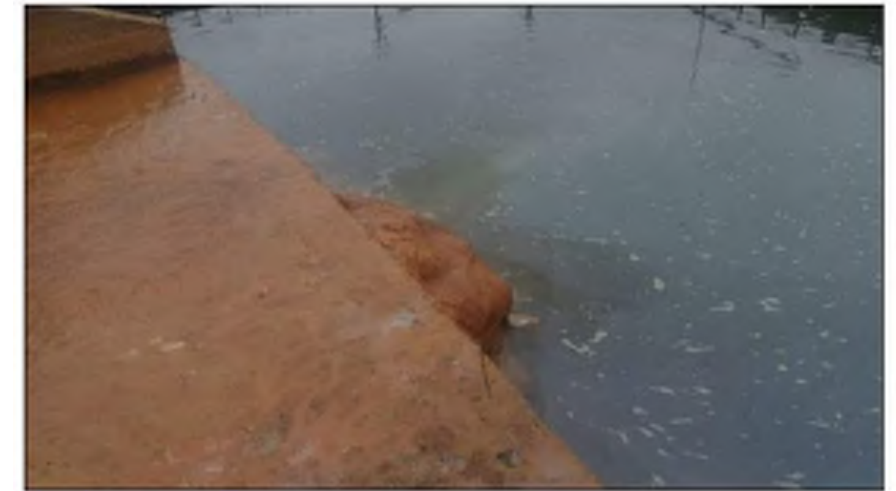
Photo 03: City Stormwater Outfall M2 Base
Material build-up at base of outfall
